Repair of Earthquake-Damaged Square R/C Columns with Glass Fiber-Reinforced Polymer

Sassan Eshghi¹, Vahid Zanjaniadeh²

Abstract: This paper presents an experimental study on seismic repair of damaged square reinforced concrete columns with poor lap splices, 90-degree hooks and widely spaced transverse bars in plastic hinge regions according to ACI detailing (pre.1971) and (318-02) using GFRP wraps. Three specimens were tested in "as built" condition and retested after they were repaired by glass fiber-reinforced plastic sheets. They were tested under numerous reversed lateral cyclic loading with a constant axial load ratio. FRP composite wraps were used for repairing of concrete columns in critically stressed areas near the column footings. Physical and mechanical properties of composite wraps are described. Seismic performance and ductility of the repaired columns in terms of the hysteretic response are evaluated and compared with those of the original columns. The results indicated that GFRP wraps can be an effective repair measure for poorly confined R/C columns due to short splice length and widely spaced ties with 90-degree anchorage hooks. Both flexural strength and ductili

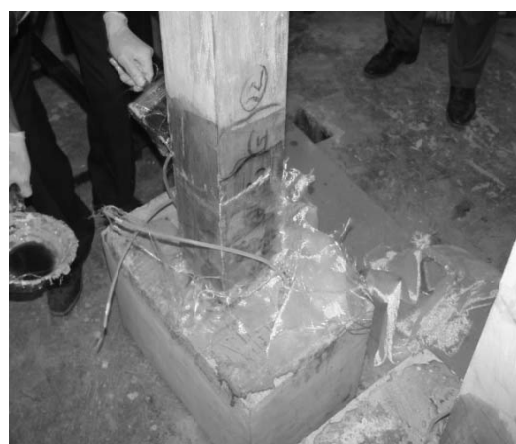
Fig.9 Installation of prefabricated composit sheets

sheets and the concrete surfaces. After the application of the first layer of the GFRP sheet, a second layer of vinyl ester sheet was applied on the surface of the first layer to allow impregnation of the second layer of the GFRP sheet.

The wrapping of the columns continued to the upper region of the column (Fig.9). All the repaired specimens were cured at least for 7 days to ensure that full strength had obtained before testing.
