# Repair of Earthquake-Damaged Square R/C Columns with Glass Fiber-Reinforced Polymer

**Abstract:** This paper presents an experimental study on seismic repair of damaged square reinforced concrete columns with poor lap splices, 90-degree hooks and widely spaced transverse bars in plastic hinge regions according to ACI detailing (pre.1971) and (318-02) using GFRP wraps. Three specimens were tested in "as built" condition and retested after they were repaired by glass fiber-reinforced plastic sheets. They were tested under numerous reversed lateral cyclic loading with a constant axial load ratio. FRP composite wraps were used for repairing of concrete columns in critically stressed areas near the column footings. Physical and mechanical properties of composite wraps are described. Seismic performance and ductility of the repaired columns in terms of the hysteretic response are evaluated and compared with those of the original columns. The results indicated that GFRP wraps can be an effective repair measure for poorly confined R/C columns due to short splice length and widely spaced ties with 90-degree anchorage hooks. Both flexural strength and ductility of repaired columns were im

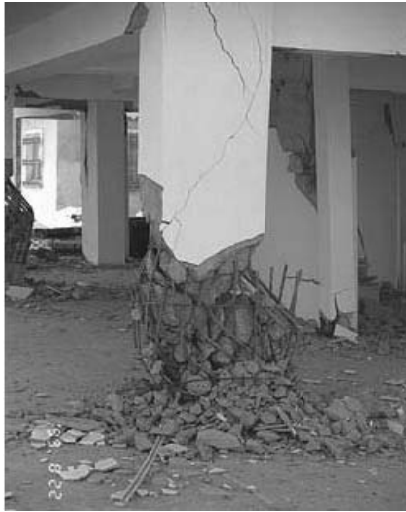
**Fig.1** Failure of lap splice due to widely spaced ties with 90° hooks (Izmit-1999)

The most common types of non-ductile details are short splice length and wide ties with 90° hooks. These details had led to considerable damages in recent earthquakes. Fig.1 and Fig.2 show two-column damage in Izmit and Northridge earthquakes due to such detailing.

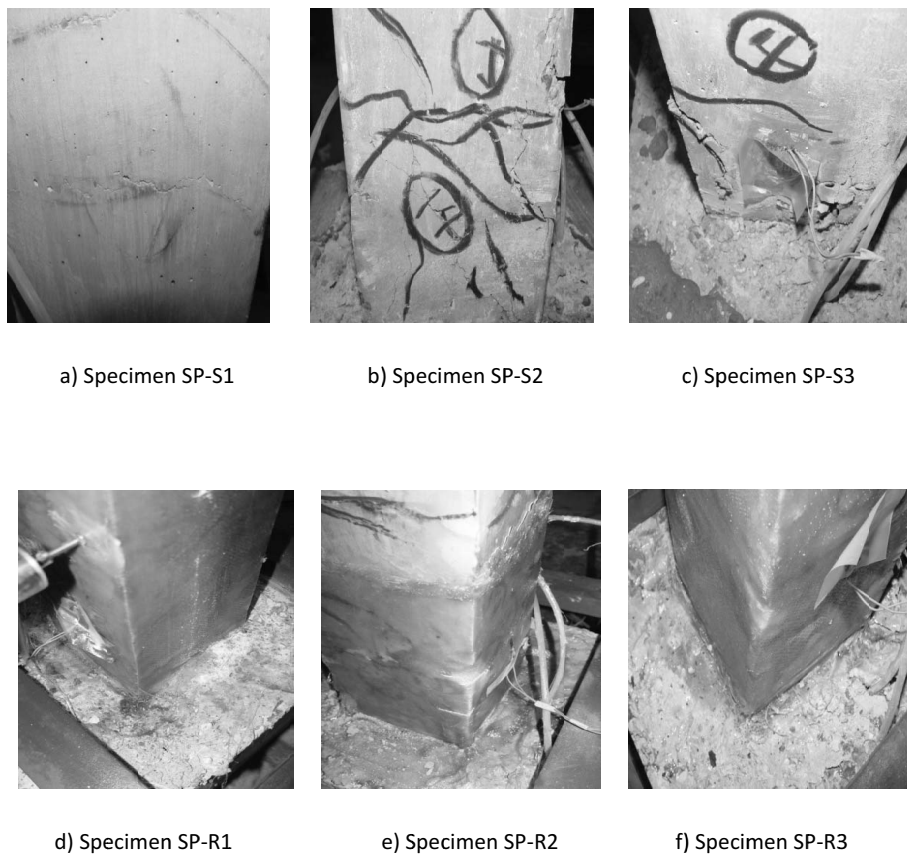
**Fig.12** Specimens at end of testing

splice length. Some flexural cracks appeared along the splice length during the test but the length and width of these cracks did not increase significantly (Fig.12a).

In specimen SP-S2 flexural cracks on the column face started as early as at 1% lateral drift ratio. At this time longitudinal cracks were formed at right and left sides of the specimen. During the second cycle at 3.5% drift as fairly large sections of the concrete cover spalled at the column footing interface. The lateral load strength diminished, indicating that bond along the spliced bars was deteriorating. Shear cracking was observed at 2.5% drift but these cracks were not significant throughout the test. Damage in this specimen was severer than that in the

previous one (Fig.12b).

Specimen Sp-S3 was subjected to a  $(0.15 A_g f'_c)$  constant axial load and initial flexural longitudinal cracks suddenly appeared at 1.5% drift ratio. In this test, cracking formed later but cracking propagation developed suddenly as the load applied. In this specimen the cover spalled completely at the corner at 4.5% drift ratio and the longitudinal bars were clearly visible. Along the splice length, there was severe damage. Shear cracks were observed at 3.5% drift ratio on the right and left faces of the columns and concrete crushing and spalling were observed just before the end of the test. In this specimen damage was generally severer than SP-S1 and SP-S2 (Fig.12c).

Stiffness of the repaired specimens had been deteriorated under large reversed cyclic loading. Large amount of the damages were concentrated in FRP sheets and some small sheet rupture was observed in high drift ratio. Damage in the concrete of repaired columns was slight. Vertical and horizontal flexural cracking, that occurred above the FRP jacket in past testing, opened and closed during retesting. Nevertheless, in the SP-R1, damage was very low and very little stress concentration was occurred in FRP sheets. Some new cracks were observed in all repaired specimens but they were not significant. At the end of the test, cracks in all specimens propagated along the columns but in SP-R3 the sustained damage was more serious than two others. Cracks in SP-R1 were little and narrow. During the test, cracks at the column footing interface of SP-R3 were very serious and some spalling and crushing were appeared. So it indicated that high axial load led to more serious damage in the specimens. SP-R1 behaved better and no delaminating or rupture across the fibers of the jackets was observed in this specimen

(Fig.12d, 12e, 12f).
