Experimental Studies on GFRP Repaired Hollow-Block Concrete Sections

Abstract: This study evaluates two different types of techniques for concrete hollow-block sections reinforced with traditional steel rebars and wire meshes, and compares their structural behaviour to that of an ordinary reinforced concrete beam section. The comparisons are based on the responses both before and after they were repaired with glass fibre reinforced polymers (GFRP). The specimens were subjected to concentrated loading up to initial failure. After failure, the specimens were repaired and loaded once again until ultimate failure. It was shown that the success of the repair by GFRP depended on the mode of failure of the hollow-block concrete beams.

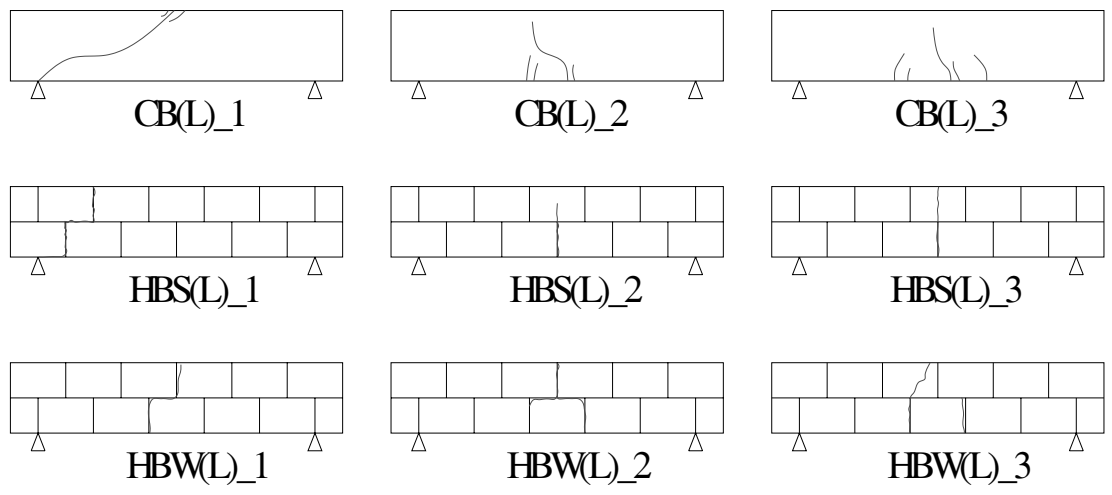
Figure 2(b) shows that failure modes of CB (L) and HBS (L) varied from flexural to shear failure. Here, it has to be noted that ratio of span-to-depth of the beam specimens is five. Flexural cracks in HBS (L) specimens always passed through the masonry joints located at the mid sections of the beams. HBW (L) beam specimen failed in flexure. Here, it has to be noted that the flexural cracks were initiating from masonry joints nearest to the mid-span. In two cases, two cracks developed in the bottom part and they were joined in the upper half. This indicates that the cracks propagated easier through the masonry joints.

Fig. 2(b) Crack Patterns for Long Beams

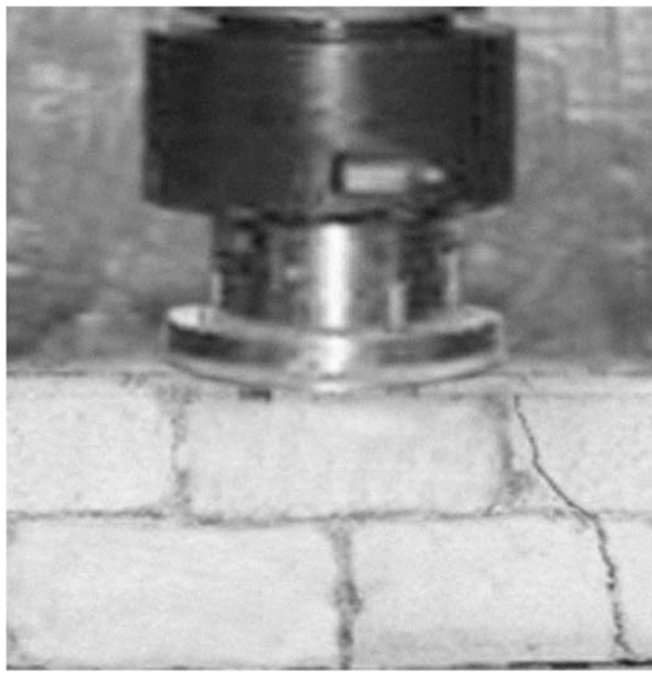
After the initial fracture, the cracks for both groups (small and long beams) opened relatively rapidly. In all cases of the beams failing in shear, the complete collapse of the specimens was prevented due to the dowel action of the reinforcing bars, as shown in Fig. 3.

Fig. 3 Shear Failure for Beam Tests

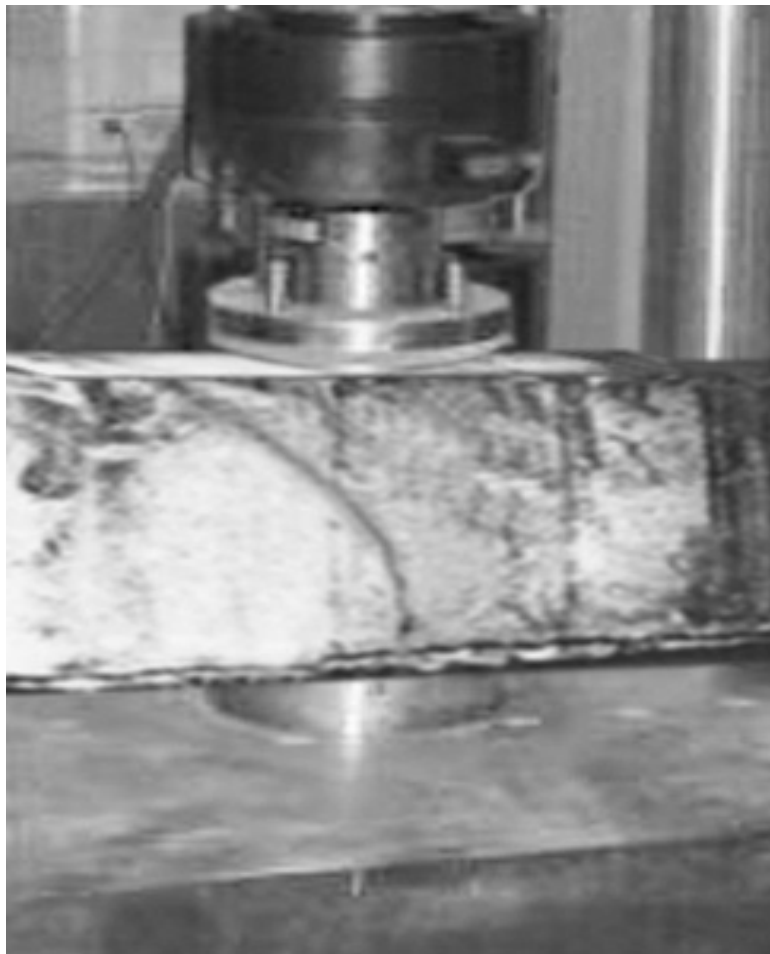
Fig. 4 Shear Failure of Beam with GFRP

For all the beam specimens repaired by GFRP sheets, it was observed that most of the crack patterns recorded was similar to those of the original beams. These cracks either resulted in fracture of the GFRP layer or resulted in its delamination from the two vertical sides of the beams, as shown in Fig. 4.

The ratios of the load carrying capacities of the beams after repair to their load carrying capacities before repair (P_{rep}/P_{vir}) are presented in column 7 of Table 1. It is seen that the ratio of restored load carrying capacities for the CB(S) and HBS(S) were 47% and 76%, respectively. The load carrying capacities of all the remaining beams were restored. CB(S) and HBS(S) failed at lower loads and higher deformations without having increased toughness. These beams failed in shear. This implies that the repair of shear damaged beams was not efficient.
