Experimental Studies on GFRP Repaired Hollow-Block Concrete Sections

Abstract: This study evaluates two different types of techniques for concrete hollow-block sections reinforced with traditional steel rebars and wire meshes, and compares their structural behaviour to that of an ordinary reinforced concrete beam section. The comparisons are based on the responses both before and after they were repaired with glass fibre reinforced polymers (GFRP). The specimens were subjected to concentrated loading up to initial failure. After failure, the specimens were repaired and loaded once again until ultimate failure. It was shown that the success of the repair by GFRP depended on the mode of failure of the hollow-block concrete beams.

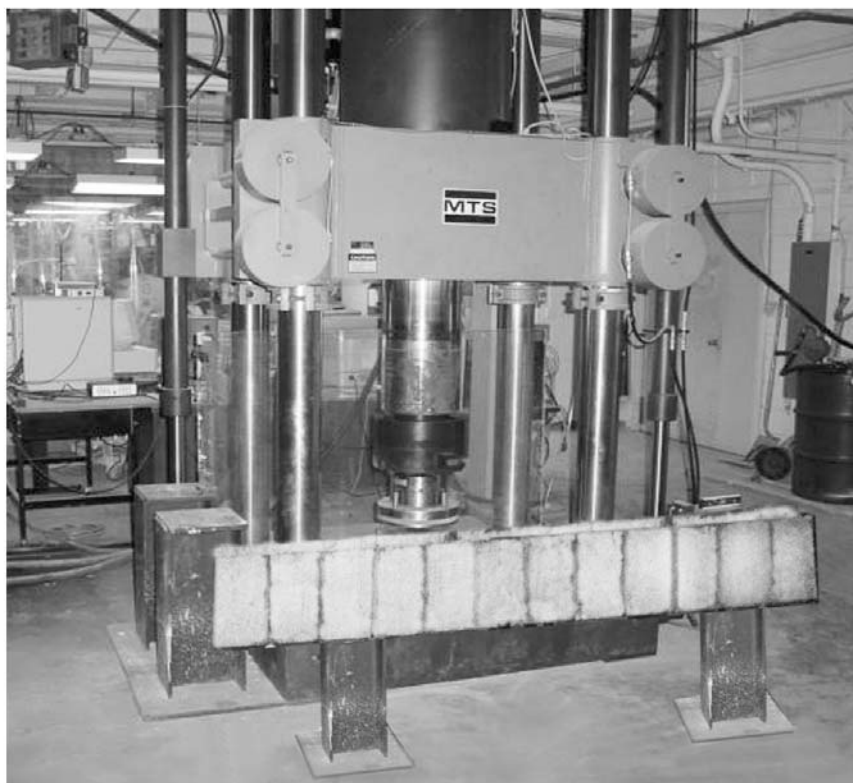
Fig.1 Test Set-up

concentrated load acting at mid-span, as shown in Fig 1.

The specimens were tested using a 980 kN Universal testing Machine; a dial gauge having a travel of 25 mm was used to record the vertical deflection at the bottom of the mid-span of the beam.

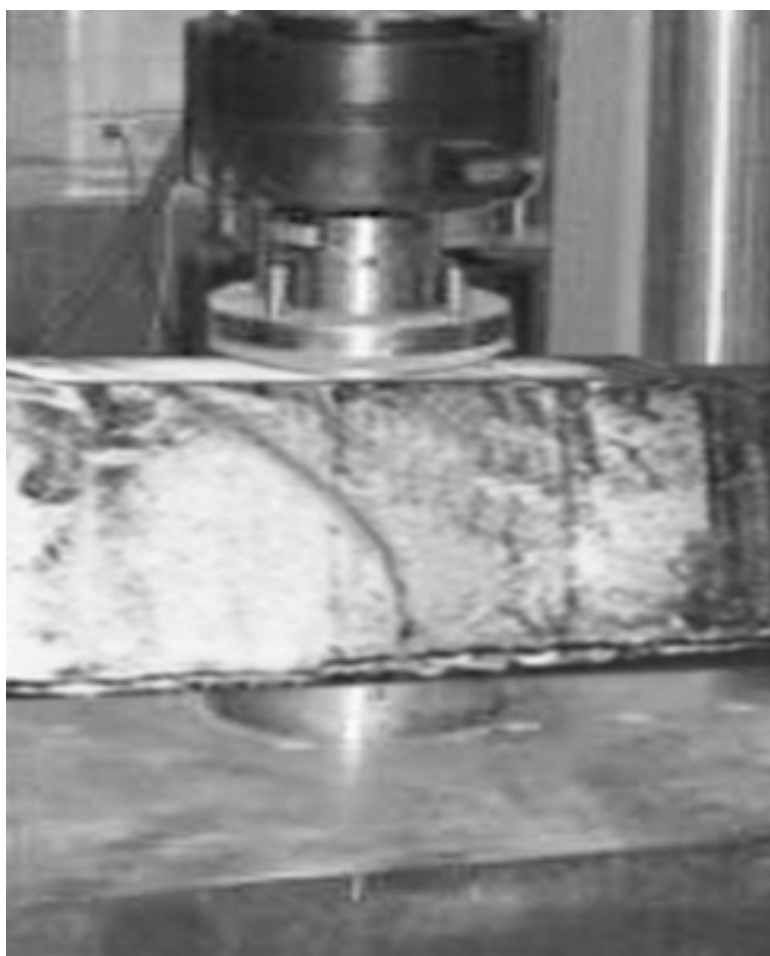
Fig. 4 Shear Failure of Beam with GFRP

For all the beam specimens repaired by GFRP sheets, it was observed that most of the crack patterns recorded was similar to those of the original beams. These cracks either resulted in fracture of the GFRP layer or resulted in its delamination from the two vertical sides of the beams, as shown in Fig. 4.

The ratios of the load carrying capacities of the beams after repair to their load carrying capacities before repair (P_{rep}/P_{vir}) are presented in column 7 of Table 1. It is seen that the ratio of restored load carrying capacities for the CB(S) and HBS(S) were 47% and 76%, respectively. The load carrying capacities of all the remaining beams were restored. CB(S) and HBS(S) failed at lower loads and higher deformations without having increased toughness. These beams failed in shear. This implies that the repair of shear damaged beams was not efficient.
