# Experimental Studies on GFRP Repaired Hollow-Block Concrete Sections

**Abstract:** This study evaluates two different types of techniques for concrete hollow-block sections reinforced with traditional steel rebars and wire meshes, and compares their structural behaviour to that of an ordinary reinforced concrete beam section. The comparisons are based on the responses both before and after they were repaired with glass fibre reinforced polymers (GFRP). The specimens were subjected to concentrated loading up to initial failure. After failure, the specimens were repaired and loaded once again until ultimate failure. It was shown that the success of the repair by GFRP depended on the mode of failure of the hollow-block concrete beams.

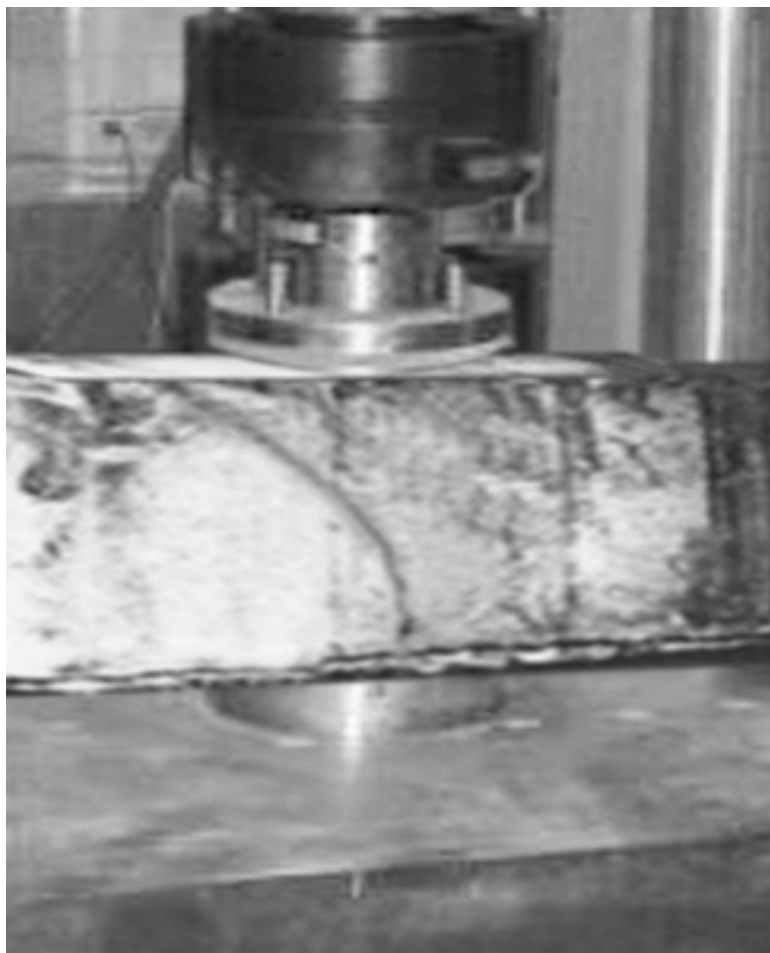
**Fig. 4** Shear Failure of Beam with GFRP

For all the beam specimens repaired by GFRP sheets, it was observed that most of the crack patterns recorded was similar to those of the original beams. These cracks either resulted in fracture of the GFRP layer or resulted in its delamination from the two vertical sides of the beams, as shown in Fig. 4.

The ratios of the load carrying capacities of the beams after repair to their load carrying capacities before repair ( $P_{rep}/P_{vir}$ ) are presented in column 7 of Table 1. It is seen that the ratio of restored load carrying capacities for the CB(S) and HBS(S) were 47% and 76%, respectively. The load carrying capacities of all the remaining beams were restored. CB(S) and HBS(S) failed at lower loads and higher deformations without having increased toughness. These beams failed in shear. This implies that the repair of shear damaged beams was not efficient.
