# Experimental Studies on GFRP Repaired Hollow-Block Concrete Sections

**Abstract:** This study evaluates two different types of techniques for concrete hollow-block sections reinforced with traditional steel rebars and wire meshes, and compares their structural behaviour to that of an ordinary reinforced concrete beam section. The comparisons are based on the responses both before and after they were repaired with glass fibre reinforced polymers (GFRP). The specimens were subjected to concentrated loading up to initial failure. After failure, the specimens were repaired and loaded once again until ultimate failure. It was shown that the success of the repair by GFRP depended on the mode of failure of the hollow-block concrete beams.

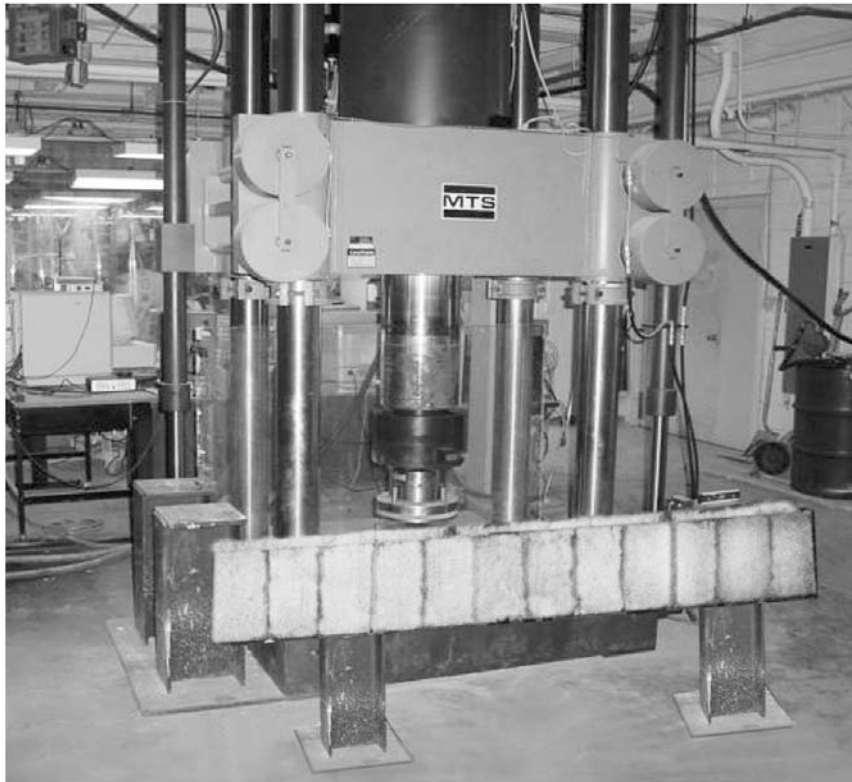
**Fig.1** Test Set-up

concentrated load acting at mid-span, as shown in Fig 1.

The specimens were tested using a 980 kN Universal testing Machine; a dial gauge having a travel of 25 mm was used to record the vertical deflection at the bottom of the mid-span of the beam.
