Technical Note

Repair effectiveness of CFRP and steel plates in RC beams with web opening: effect of plate thickness

A. Ahmed A¹, S. Naganathan^{1,*}, K. Nasharuddin¹, M.M. Fayyadh²

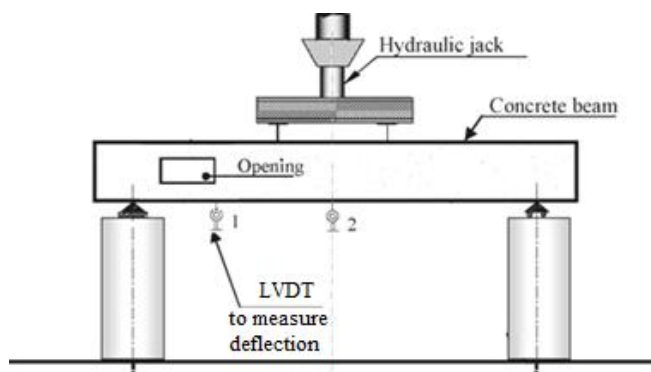
All beams were tested as simple supported beams subjected to a four-point load, as illustrated in Fig. 1. A universal testing machine with 300 kN capacity was used in order to apply the load on a steel distribution I- beam, which was used to generate the two concentrated loads on the beam. The load was applied gradually with a speed of 4 kN/min and was then released with the same average. Two linear variable differential transformers (LVDT) were used in each test to monitor vertical deflection at two locations, edge of the opening and mid-span of the beam as shown in Fig. 1. For each beam, one strain gauge was attached to the main flexure steel bars below the opening, as shown in Fig. 2 (a). For all the beams, two strain gauges were attached directly to the CFRP and steel plate on the sides of beams to monitor strain variation in CFRP and steel plates, as shown in Fig. 2 (b). All the used electrical devices (load cell, LVDT, and strain gauges) are attached to the data logger in order to monitor the variation in load, deflection and strain values, corresponding to applied loads. The readings were carried out at each 5 kN load step and up to the ultimate applied load. All the beams were subjected to failure load at the pre-repair stages. The beams were then unloaded by bringing back the loading to zero.

Fig. 1 Test set-up

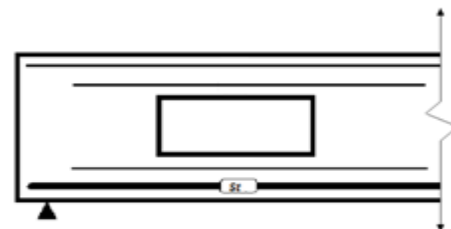
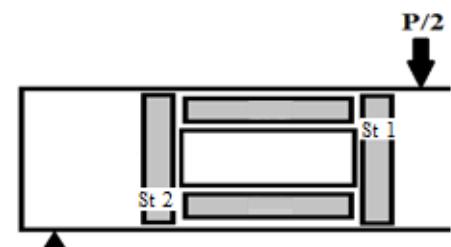
(a)

(a) Flexural bar

(b) Externally bonded plates
Fig. 2 Locations of strain gauge

The load-strain relationship of steel reinforcement is presented in this section. The strain gauge (St) was attached onto the main steel reinforcement bar at the middle of the opening in the bottom chord. Fig. 6 shows the load against steel bar strain of the strain gauge (St) at the pre and post repair stages. For all the beams at the pre-repair stage, the strain gauge (St) shows an increase in strain value with the

The behaviour of load-strain relationship for externally bonded CFRP and steel plates is presented in this section. Strain gauge are fixed at two locations, one locations is on the opening corner near the support (ST2) and another location is at the opening corner near the point of applied load (ST1), as shown in Fig. 2(b). The load against strain curves for beams B1, B2, B3 and B4 are shown in Figs. 7, 8, 9 and 10, respectively. The recorded strains indicate that the value of strain for all beams did not reach the ultimate

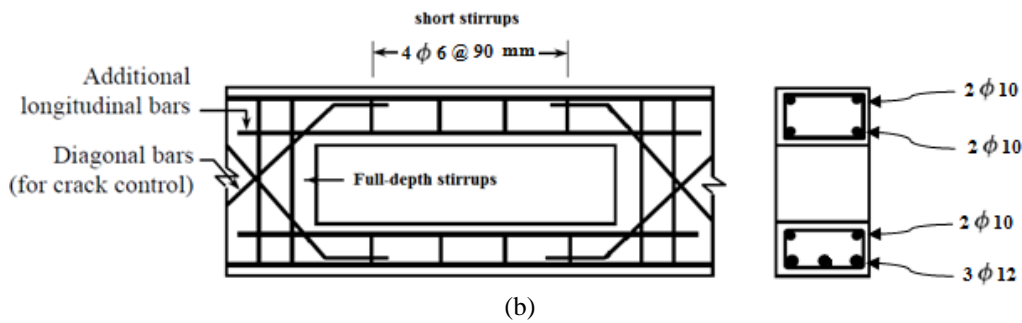
All the RC beams contain a large rectangular opening with a size of 160×400 (depth \times width) mm. The opening was located at the mid of the shear span with a distance of 225 mm away from support and 225 mm away from the concentrated load. The distance between the two concentrated loads is 400 mm and the shear span is 850 mm, as shown in Fig. 3 (a). Beams with an opening were designed according to the plastic hinge method, [17]. The beams were reinforced with three steel bars with a diameter of 12 mm as a major reinforcement in the tension zone and two of a 10 mm diameter at the compression zone. Additional longitudinal bars were provided as two 10 mm diameter steel bars at the top and bottom chords of the opening, and diagonal bars for crack control were also added at the corner of the opening. Steel stirrups of a 6 mm diameter were used at 90 mm spacing along the top and bottom chords.

Fig. 3 Beams description, (a) Opening location, (b) Steel reinforcement at the opening

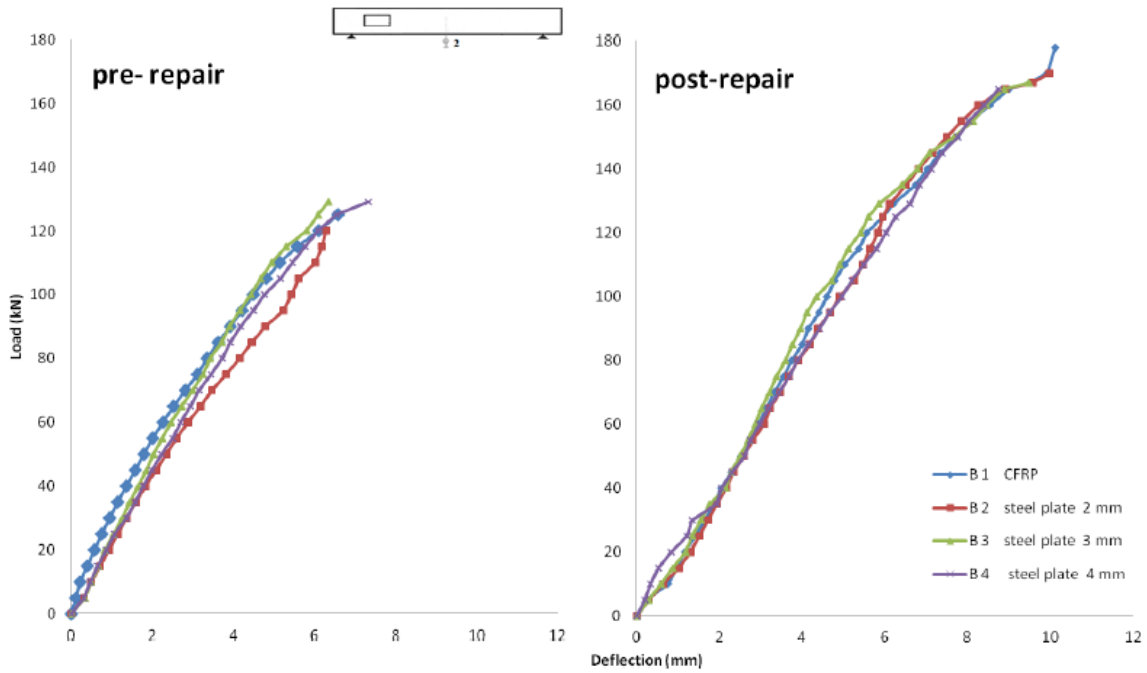
Fig 5. Load against deflection curves at the mid-span at pre and post repair stages

For beam B3, the value of deflection at the pre-repair stage at failure load of 129 kN was 6.35 mm, while at post-repair stage it was 5.85 mm at the same load of 128 kN. The value of deflection for beam B4 at the pre-repair stage was 6.74 mm at a failure load of 129.3 kN, while at the post-repair stage the deflection was 6.14 mm at the same load of 129.3 kN. The result shows that the influence of steel plates on deflection at the edge of the opening increases with the increase in steel plate thickness. The results indicate that the CFRP and steel plates have good effectiveness in reducing the deflection for the repaired beams at the edge of the opening and mid-span of the beam. From Fig. 5, which shows the load against deflection at mid-span curves at pre and post repair stages, it can be seen that curves for repaired beams show

somewhat similar behaviour because both CFRP and steel plates around the opening serve in resisting stress concentration at opening corners. Thus, it is delaying the cracking and controlling width and propagation of cracks. The highest value of deflection was obtained was located at the edge of the opening. The results are in agreement with Tan et al. [20], who found that for beams with an opening, the maximum deflection usually occurs at the high moment end of the opening. The decrease in deflection is smaller for the repaired beams, since the CFRP and steel plates prevent cracks from developing and widening. Furthermore, some contribution to the stiffness of beams was caused by the CFRP and steel plate outside the cracking region. The result shows that increasing steel plate thickness has little effect on reducing the deflection.

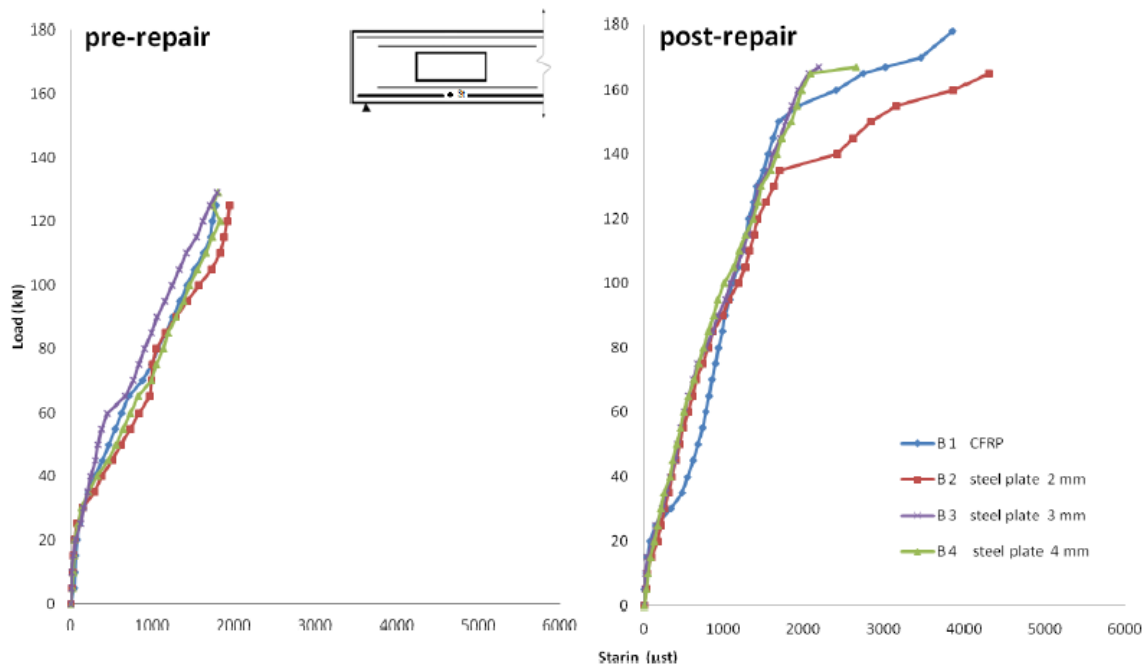
Fig. 6 Load against steel bar strain of (St) at pre and post repair stages

increase in applied load and reaches its yielded strain at the ultimate load. At the post-repair stage, the externally bonded CFRP and steel plate shared the strain with steel bars where the strain gauge (St) reached strain values less than the strain at the pre-repair stage at same load. This was subjected to a different in the decrease of strain values percentage a depending on the material and thickness that were used, as shown in Table 5.

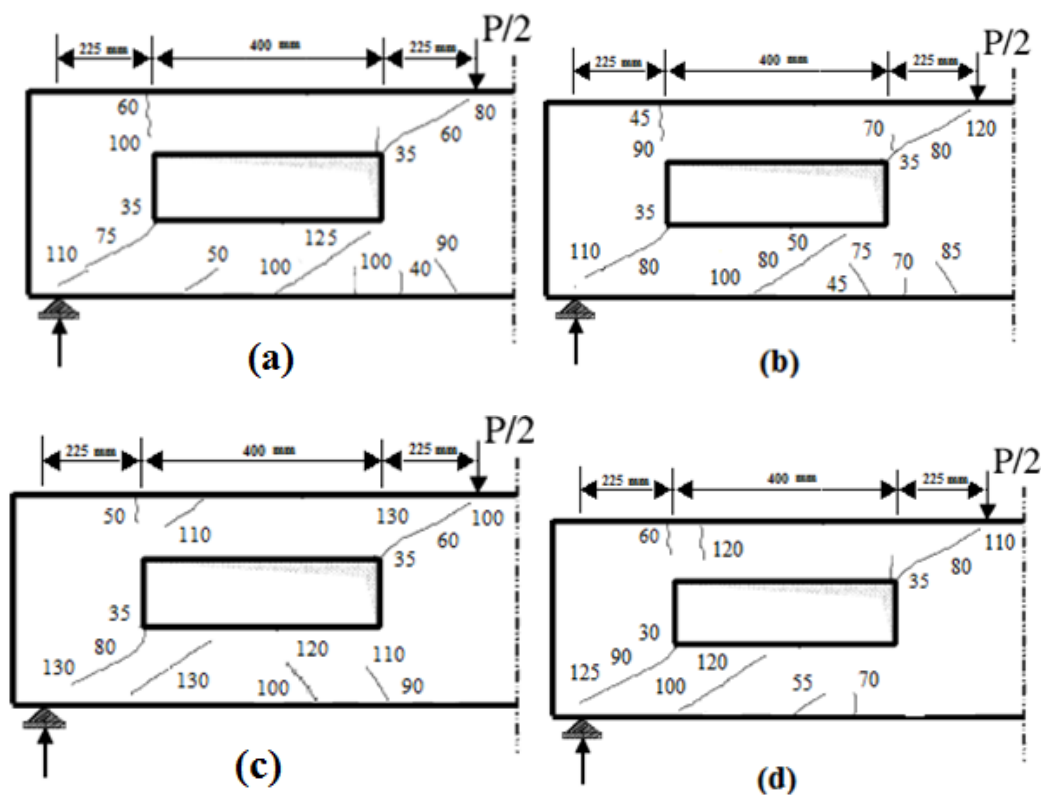
Fig. 11 Crack patterns and failure modes of beams at the pre-repair stage (a) Beam B1, (b) Beam B2, (c) Beam B3, (d) Beam B4

The crack pattern and the failure modes for all beams at pre and post repair stages are presented in this section. Figs. 11 and 12 show the crack pattern and the failure mode for all the beams at the pre and post repair stages, respectively. The failure modes of all the beams are similar because the failure occurs due to failure in concrete as diagonal shear failure before the externally bonded plates reach the ultimate strain. It can be seen from Fig. 11 (b) that the first diagonal crack for beam B2 was observed at the corner of the opening at a load of 35 kN; additional cracks were formed with the increase of the applied load. Failure of the beam occurred when the total applied load reached 128 kN. At the post-repair stage, many cracks were formed at the solid span of the beam, and the failure of the beam occurred at a load of 163.4 kN. At failure, concrete diagonal shear failure was observed around the
