Technical Note

Repair effectiveness of CFRP and steel plates in RC beams with web opening: effect of plate thickness

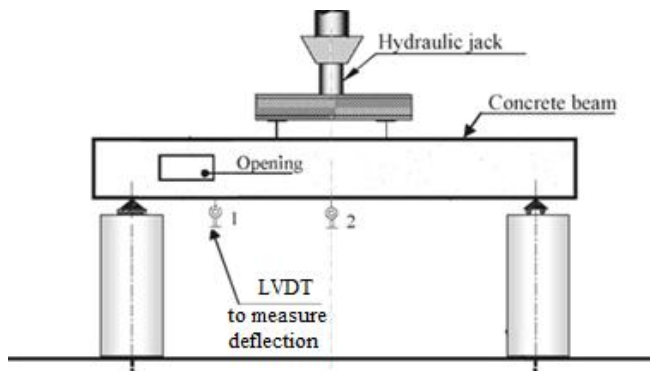
Fig. 1 Test set-up

All beams were tested as simple supported beams subjected to a four-point load, as illustrated in Fig. 1. A universal testing machine with 300 kN capacity was used in order to apply the load on a steel distribution I- beam, which was used to generate the two concentrated loads on the beam. The load was applied gradually with a speed of 4 kN/min and was then released with the same average. Two linear variable differential transformers (LVDT) were used in each test to monitor vertical deflection at two locations, edge of the opening and mid-span of the beam as shown in Fig. 1. For each beam, one strain gauge was attached to the main flexure steel bars below the opening, as shown in Fig. 2 (a). For all the beams, two strain gauges were attached directly to the CFRP and steel plate on the sides of beams to monitor strain variation in CFRP and steel plates, as shown in Fig. 2 (b). All the used electrical devices (load cell, LVDT, and strain gauges) are attached to the data logger in order to monitor the variation in load, deflection and strain values, corresponding to applied loads. The readings were carried out at each 5 kN load step and up to the ultimate applied load. All the beams were subjected to failure load at the pre-repair stages. The beams were then unloaded by bringing back the loading to zero.

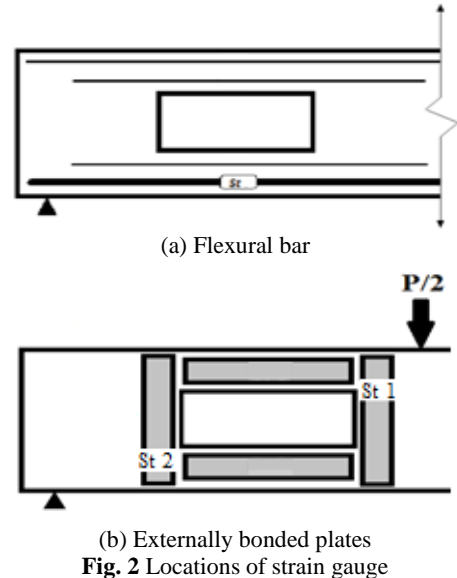
(a)

Fig. 2 Locations of strain gauge

The behaviour of load-strain relationship for externally bonded CFRP and steel plates is presented in this section. Strain gauge are fixed at two locations, one locations is on the opening corner near the support (ST2) and another location is at the opening corner near the point of applied load (ST1), as shown in Fig. 2(b). The load against strain curves for beams B1, B2, B3 and B4 are shown in Figs. 7, 8, 9 and 10, respectively. The recorded strains indicate that the value of strain for all beams did not reach the ultimate

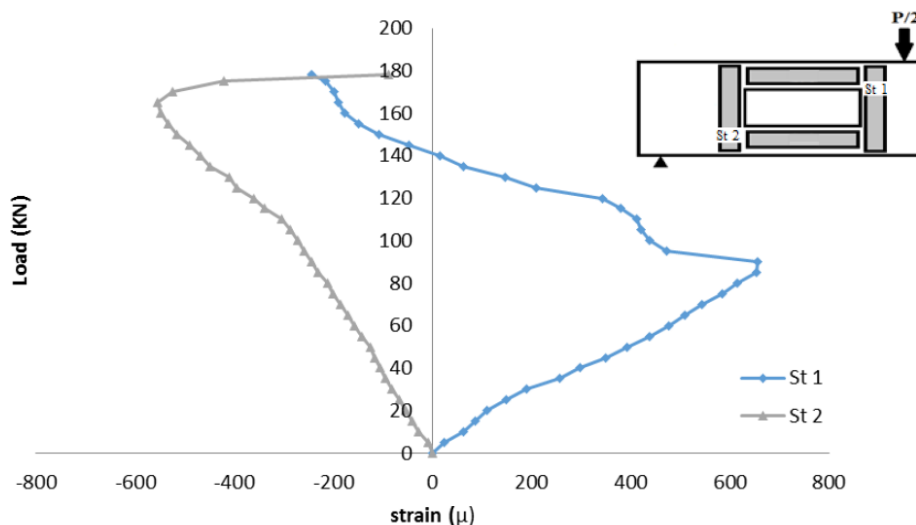
Fig. 7 Load against strain of externally bonded CFRP plates of beam B1

strain of CFRP and steel plates. This is due to the fact that the concrete failed before allowing the repair materials to reach the ultimate strain values. It can be observed from Figs. 7 to 10 that the externally bonded plates start to share the strain in the beam from the start of the applied load. The results are in agreement with Khalifa and Intomio [20], who found that the maximum CFRP vertical strain measured at failure corresponded to 14 % of the reported CFRP ultimate strain. This value is not absolute, because it greatly depends on the location of the strain gauge with respect to a crack.

As can be seen from Fig. 7, for beam B1 the maximum CFRP strain measured at failure was in strain ST1. For beam B3, the steel plate strain measured at failure was deferent at each location, because the value of the strain greatly depends on the location of the strain gauge with respect to a crack, as shown in Fig. 9. It can be observed from Fig. 10 that for beam B4, the maximum CFRP strain measured at failure was in strain ST1, on the bottom chord of the opening. CFRP and steel plates were not fractured or debonded from the concrete surface, and this ultimately indicates that CFRP and steel plates could provide additional strength if the beams did not fail by concrete diagonal shear cracks.

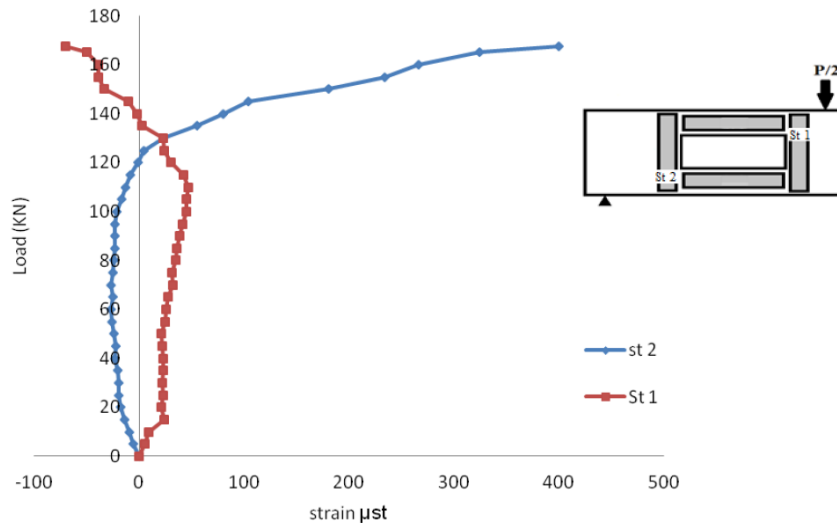
Fig. 9 Load against strain of externally bonded steel plates of beam B3

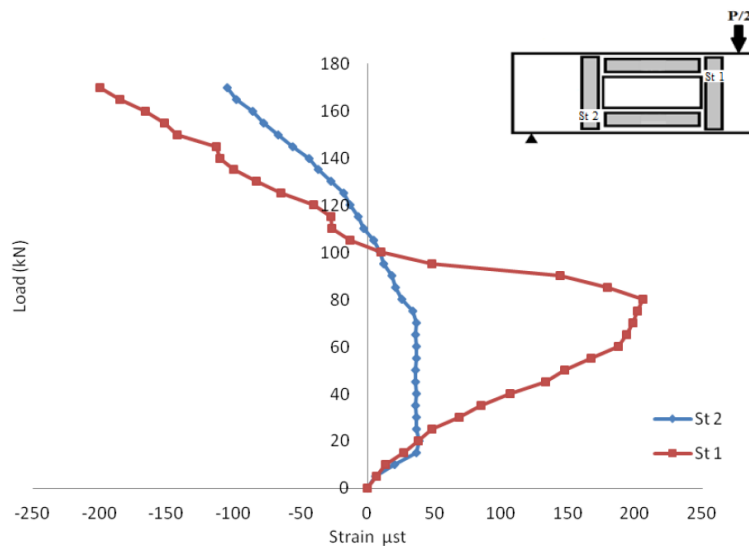
Fig. 10 Load against strain of externally bonded steel plates of beam B4
