Technical Note

Repair effectiveness of CFRP and steel plates in RC beams with web opening: effect of plate thickness

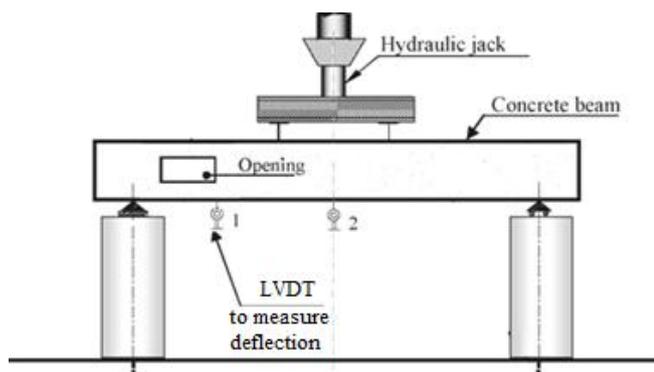
All beams were tested as simple supported beams subjected to a four-point load, as illustrated in Fig. 1. A universal testing machine with 300 kN capacity was used in order to apply the load on a steel distribution I- beam, which was used to generate the two concentrated loads on the beam. The load was applied gradually with a speed of 4 kN/min and was then released with the same average. Two linear variable differential transformers (LVDT) were used in each test to monitor vertical deflection at two locations, edge of the opening and mid-span of the beam as shown in Fig. 1. For each beam, one strain gauge was attached to the main flexure steel bars below the opening, as shown in Fig. 2 (a). For all the beams, two strain gauges were attached directly to the CFRP and steel plate on the sides of beams to monitor strain variation in CFRP and steel plates, as shown in Fig. 2 (b). All the used electrical devices (load cell, LVDT, and strain gauges) are attached to the data logger in order to monitor the variation in load, deflection and strain values, corresponding to applied loads. The readings were carried out at each 5 kN load step and up to the ultimate applied load. All the beams were subjected to failure load at the pre-repair stages. The beams were then unloaded by bringing back the loading to zero.

Fig. 1 Test set-up

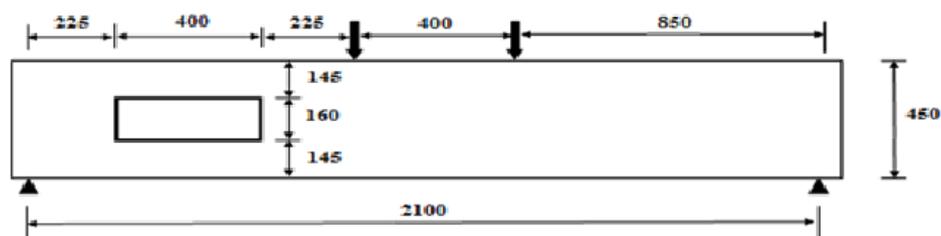
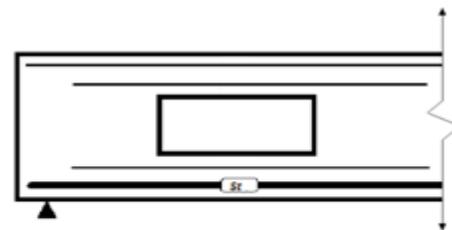
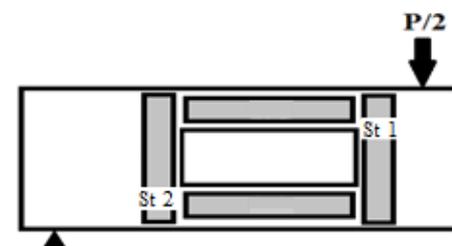
(a) Flexural bar

(b) Externally bonded plates
Fig. 2 Locations of strain gauge

The behaviour of load-strain relationship for externally bonded CFRP and steel plates is presented in this section. Strain gauge are fixed at two locations, one locations is on the opening corner near the support (ST2) and another location is at the opening corner near the point of applied load (ST1), as shown in Fig. 2(b). The load against strain curves for beams B1, B2, B3 and B4 are shown in Figs. 7, 8, 9 and 10, respectively. The recorded strains indicate that the value of strain for all beams did not reach the ultimate

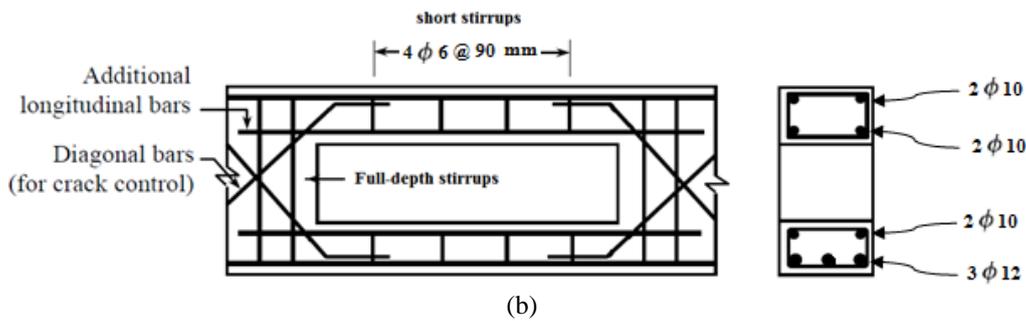
All the RC beams contain a large rectangular opening with a size of 160×400 (depth \times width) mm. The opening was located at the mid of the shear span with a distance of 225 mm away from support and 225 mm away from the concentrated load. The distance between the two concentrated loads is 400 mm and the shear span is 850 mm, as shown in Fig. 3 (a). Beams with an opening were designed according to the plastic hinge method, [17]. The beams were reinforced with three steel bars with a diameter of 12 mm as a major reinforcement in the tension zone and two of a 10 mm diameter at the compression zone. Additional longitudinal bars were provided as two 10 mm diameter steel bars at the top and bottom chords of the opening, and diagonal bars for crack control were also added at the corner of the opening. Steel stirrups of a 6 mm diameter were used at 90 mm spacing along the top and bottom chords.

Fig. 3 Beams description, (a) Opening location, (b) Steel reinforcement at the opening

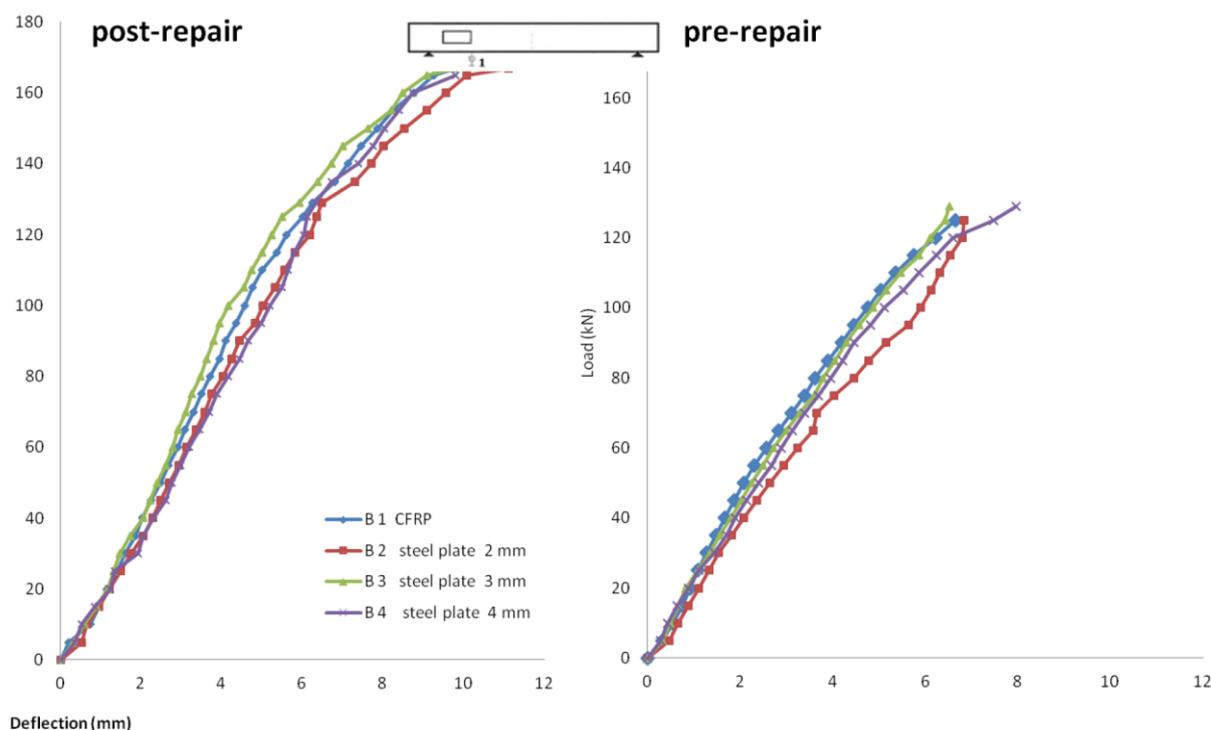
**Fig. 4** Load–deflection curves at the edge of the opening at pre and post repair stages

The load-deflection relationship at the mid span and below the edge of the opening is presented in this section. All the beams showed lower deflection at the mid span as compared to the deflection at the edge of the opening. For deflection at the edge of the opening, the reduction in deflection values found to be 10 % for CFRP, as shown in Table 4. For steel plates, the reductions in deflection were 7 %, 9 %, and 10 % for thicknesses of 2 mm, 3 mm and 4 mm, respectively. Thus, it is clear that the externally bonded plates applied around the web opening are capable of reducing 10 % of the deflection at pre-repair stage.

The beam B2, which was repaired by a steel plate with a thickness of 2mm, shows an effect on deflection at the edge of the opening, where at load of 128 kN the deflection is 6.98 mm and 6.49 mm at pre and post repair stages, respectively. For beam B3, good effect on the load capacity and a good effect on deflection were proved. The highest value of deflection was 6.52 mm obtained at the edge of the opening and it was at the pre-repaired stage at a failure load of 129 kN. However, at the post-repair stage, the deflection for the same load of 129 kN was 5.92 mm. As shown in Fig. 4, which shows the load against deflection at edge of opening curves at pre and post repair stages, the highest effect on deflection was for beams B1 and B4, while the lowest effect on deflection was for beam B2. The value of deflection for beam B1 at the pre-repair stage was 6.58 mm at a failure load of 125.2 kN, while the deflection was 5.95 mm at the post-repair stage at the same load of 125.2 kN.

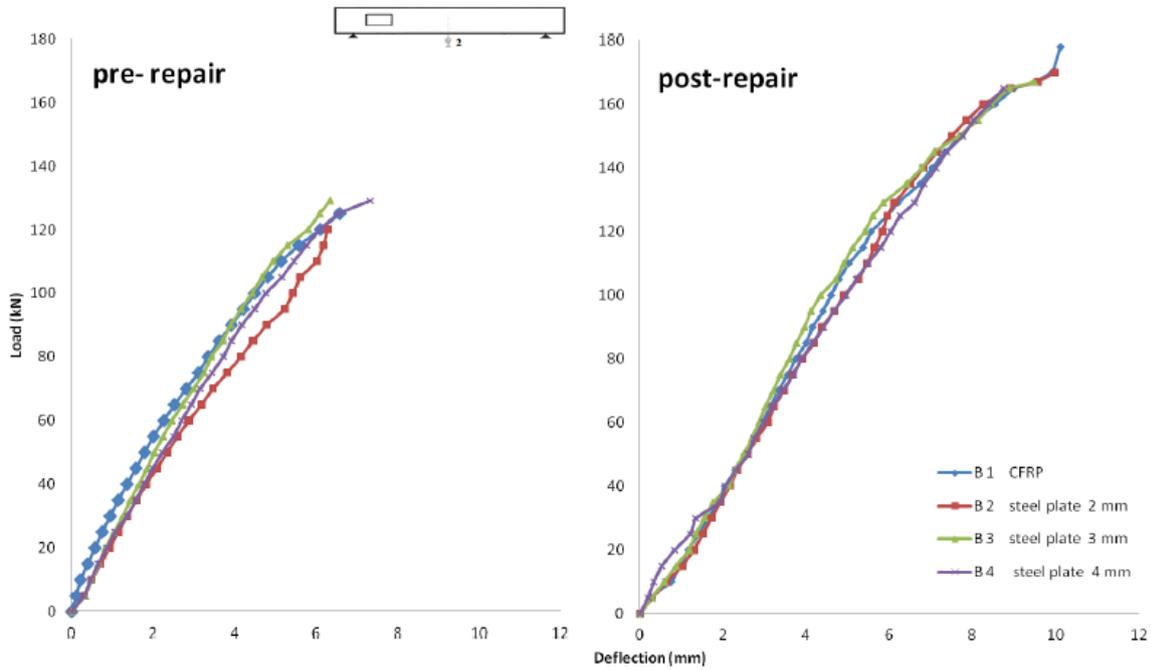
Fig 5. Load against deflection curves at the mid-span at pre and post repair stages

For beam B3, the value of deflection at the pre-repair stage at failure load of 129 kN was 6.35 mm, while at post-repair stage it was 5.85 mm at the same load of 128 kN. The value of deflection for beam B4 at the pre-repair stage was 6.74 mm at a failure load of 129.3 kN, while at the post-repair stage the deflection was 6.14 mm at the same load of 129.3 kN. The result shows that the influence of steel plates on deflection at the edge of the opening increases with the increase in steel plate thickness. The results indicate that the CFRP and steel plates have good effectiveness in reducing the deflection for the repaired beams at the edge of the opening and mid-span of the beam. From Fig. 5, which shows the load against deflection at mid-span curves at pre and post repair stages, it can be seen that curves for repaired beams show

somewhat similar behaviour because both CFRP and steel plates around the opening serve in resisting stress concentration at opening corners. Thus, it is delaying the cracking and controlling width and propagation of cracks. The highest value of deflection was obtained was located at the edge of the opening. The results are in agreement with Tan et al. [20], who found that for beams with an opening, the maximum deflection usually occurs at the high moment end of the opening. The decrease in deflection is smaller for the repaired beams, since the CFRP and steel plates prevent cracks from developing and widening. Furthermore, some contribution to the stiffness of beams was caused by the CFRP and steel plate outside the cracking region. The result shows that increasing steel plate thickness has little effect on reducing the deflection.

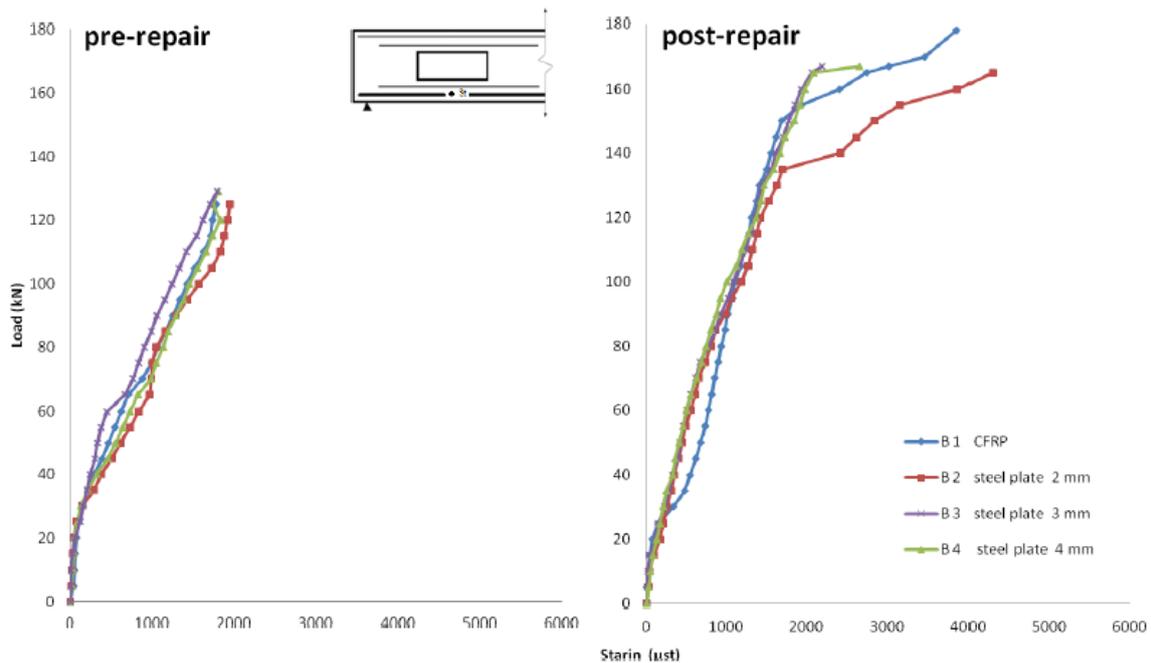
The load-strain relationship of steel reinforcement is presented in this section. The strain gauge (St) was attached onto the main steel reinforcement bar at the middle of the opening in the bottom chord. Fig. 6 shows the load against steel bar strain of the strain gauge (St) at the pre and post repair stages. For all the beams at the pre-repair stage, the strain gauge (St) shows an increase in strain value with the

Fig. 6 Load against steel bar strain of (St) at pre and post repair stages

increase in applied load and reaches its yielded strain at the ultimate load. At the post-repair stage, the externally bonded CFRP and steel plate shared the strain with steel bars where the strain gauge (St) reached strain values less than the strain at the pre-repair stage at same load. This was subjected to a different in the decrease of strain values percentage a depending on the material and thickness that were used, as shown in Table 5.

The strain values in the major steel bar at the bottom chord at the middle of the opening at pre and post repair stages are illustrated in Table 5. The reducing percentage in strain was 24% for beams repaired by CFRP. However, for beams repaired by steel plates, the reducing percentages were found to be 17 %, 19 % and 20 % for thicknesses of 2 mm, 3 mm and 4 mm, respectively. It is clear that the contribution of externally bonded plates on steel bar strain depends on the plate material rather than the thickness of the plates. This is because the strain in steel reinforcement is controlled by the interaction between repair material and concrete surface. The CFRP plates have better interaction with concrete than steel plates and hence are able to share the strain in the reinforcement effectively. Therefore, it is concluded that the CFRP is more effective for repairing of RC beams. The results are in agreement with Hemdan et al. [21], who

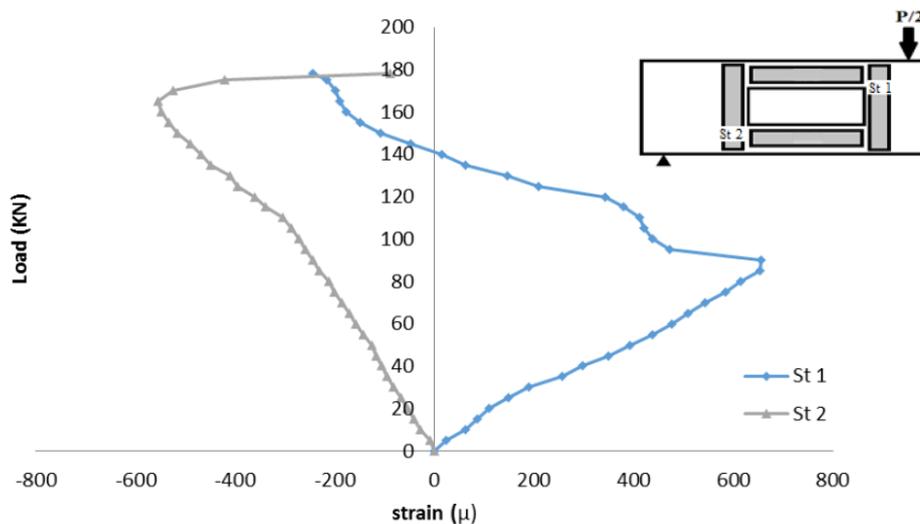
Fig. 7 Load against strain of externally bonded CFRP plates of beam B1

strain of CFRP and steel plates. This is due to the fact that the concrete failed before allowing the repair materials to reach the ultimate strain values. It can be observed from Figs. 7 to 10 that the externally bonded plates start to share the strain in the beam from the start of the applied load. The results are in agreement with Khalifa and Intomio [20], who found that the maximum CFRP vertical strain measured at failure corresponded to 14 % of the reported CFRP ultimate strain. This value is not absolute, because it greatly depends on the location of the strain gauge with respect to a crack.

As can be seen from Fig. 7, for beam B1 the maximum CFRP strain measured at failure was in strain ST1. For beam B3, the steel plate strain measured at failure was deferent at each location, because the value of the strain greatly depends on the location of the strain gauge with respect to a crack, as shown in Fig. 9. It can be observed from Fig. 10 that for beam B4, the maximum CFRP strain measured at failure was in strain ST1, on the bottom chord of the opening. CFRP and steel plates were not fractured or debonded from the concrete surface, and this ultimately indicates that CFRP and steel plates could provide additional strength if the beams did not fail by concrete diagonal shear cracks.

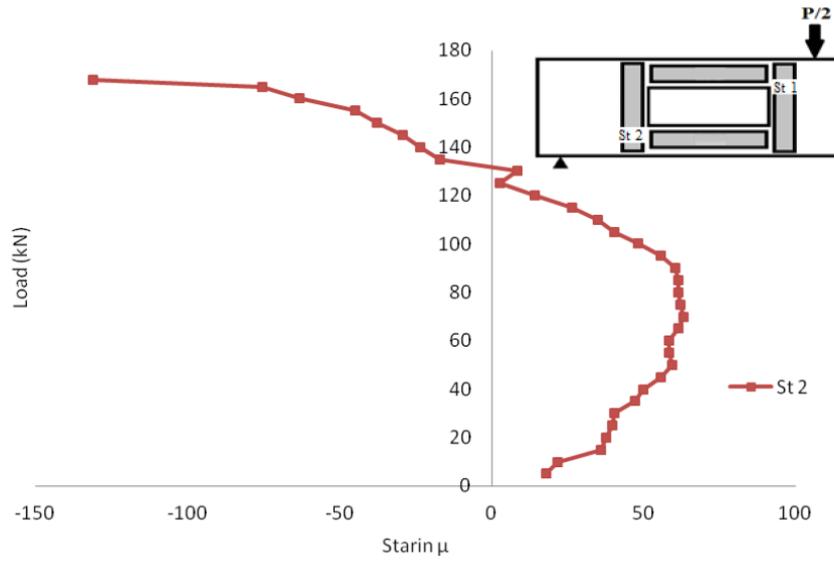
Fig. 8 Load against strain of externally bonded steel plate of beam B2

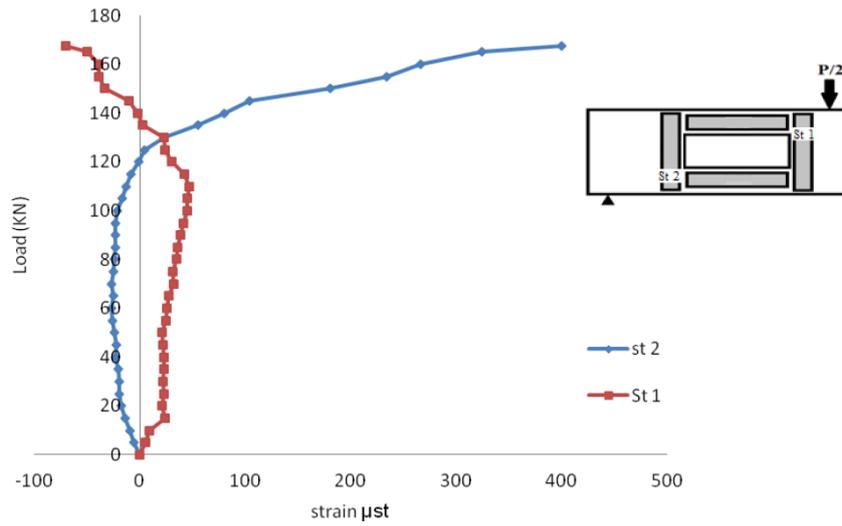
Fig. 9 Load against strain of externally bonded steel plates of beam B3

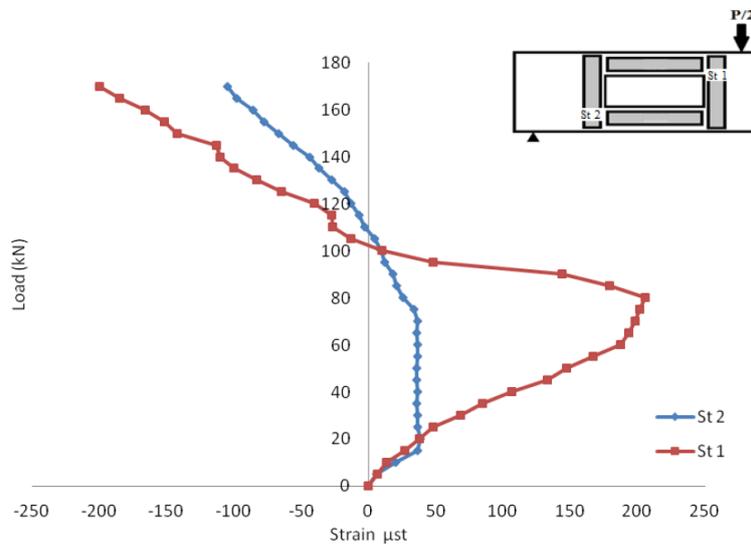
Fig. 10 Load against strain of externally bonded steel plates of beam B4

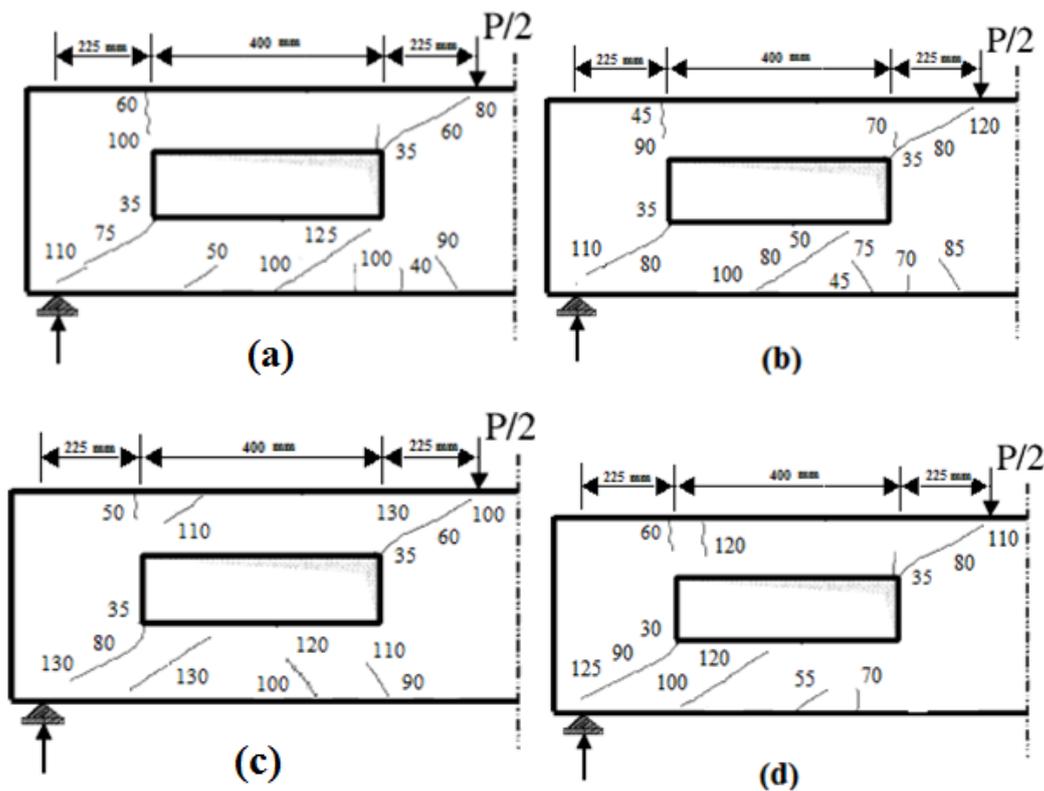
The crack pattern and the failure modes for all beams at pre and post repair stages are presented in this section. Figs. 11 and 12 show the crack pattern and the failure mode for all the beams at the pre and post repair stages, respectively. The failure modes of all the beams are similar because the failure occurs due to failure in concrete as diagonal shear failure before the externally bonded plates reach the ultimate strain. It can be seen from Fig. 11 (b) that the first diagonal crack for beam B2 was observed at the corner of the opening at a load of 35 kN; additional cracks were formed with the increase of the applied load. Failure of the beam occurred when the total applied load reached 128 kN. At the post-repair stage, many cracks were formed at the solid span of the beam, and the failure of the beam occurred at a load of 163.4 kN. At failure, concrete diagonal shear failure was observed around the

Fig. 11 Crack patterns and failure modes of beams at the pre-repair stage (a) Beam B1, (b) Beam B2, (c) Beam B3, (d) Beam B4

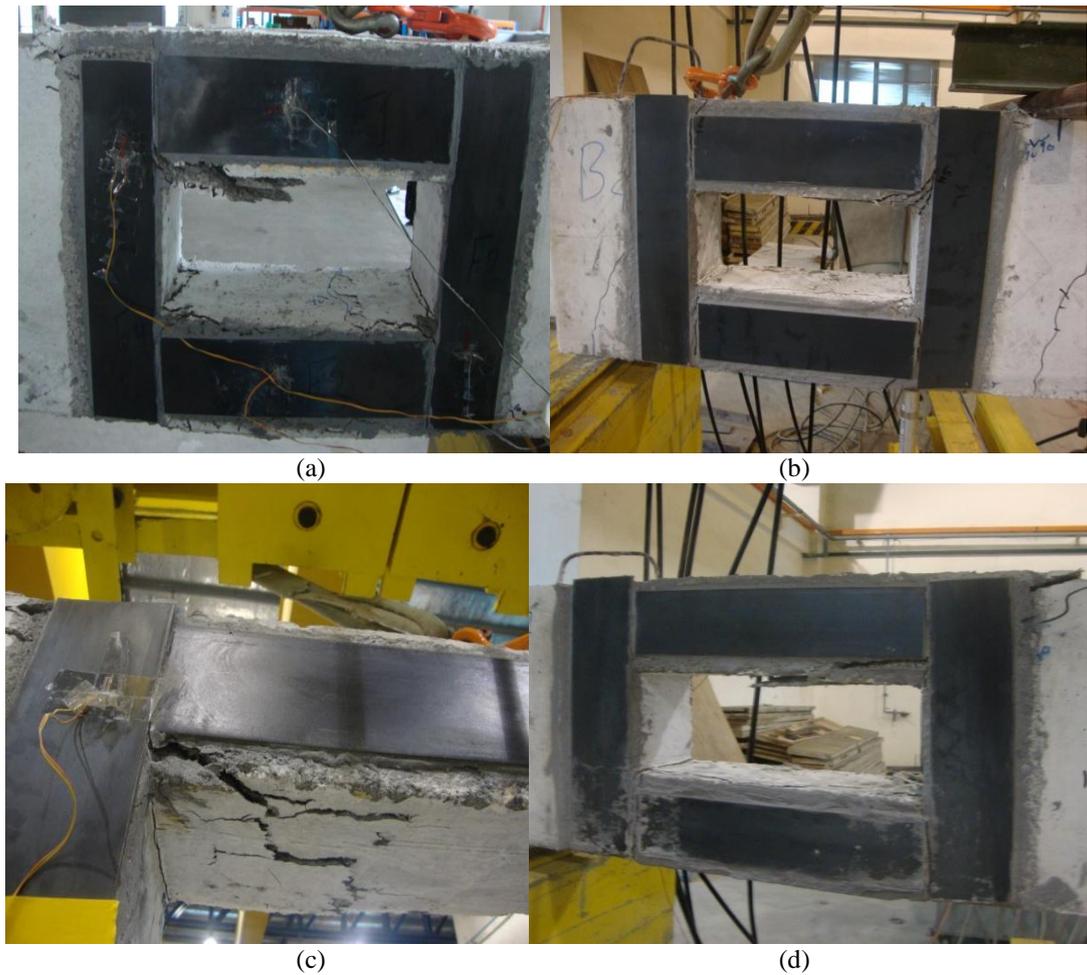
opening, as shown in Fig. 12 (b).

Fig. 12 Failure modes of beams at the post-repair stage (a) Beam B1, (b) Beam B2, (c) Beam B3, (d) Beam B4

This mode of failure is called splitting failure, which is due to relatively high longitudinal compressive stress developed at the top of the chords, which created transverse tension, and led to splitting failure, as according to Khalifa and Nanni [22]. The CFRP sheet did not fracture or debond from the concrete surface at the ultimate load. As can be seen from Fig. 11 (d), the first diagonal crack for beam B4 was observed at the corner of the opening at a load of 35 kN, additional cracks were formed with the increase of the applied load. Failure of the beam occurred when the total applied load reached 129.3 kN. As shown in Fig. 12 (d) for beam B4 at the post-repair stage, many cracks were formed at the solid span of the beam and the failure of the beam occurred at a load of 170 kN. At failure, crushing of the concrete was observed on the top and bottom face of the chord members, due to high compressive stress in concrete before the externally bonded plates reach the maximum strain.
