**Technical Note****Repair effectiveness of CFRP and steel plates in RC beams with web opening: effect of plate thickness**A. Ahmed A¹, S. Naganathan^{1,*}, K. Nasharuddin¹, M.M. Fayyadh²

Keywords: Web opening, CFRP plate, Steel plate, Repair.

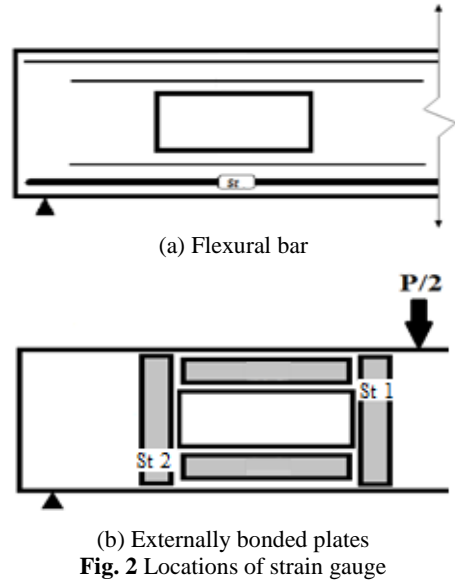
Fig. 2 Locations of strain gauge

The behaviour of load-strain relationship for externally bonded CFRP and steel plates is presented in this section. Strain gauge are fixed at two locations, one locations is on the opening corner near the support (ST2) and another location is at the opening corner near the point of applied load (ST1), as shown in Fig. 2(b). The load against strain curves for beams B1, B2, B3 and B4 are shown in Figs. 7, 8, 9 and 10, respectively. The recorded strains indicate that the value of strain for all beams did not reach the ultimate

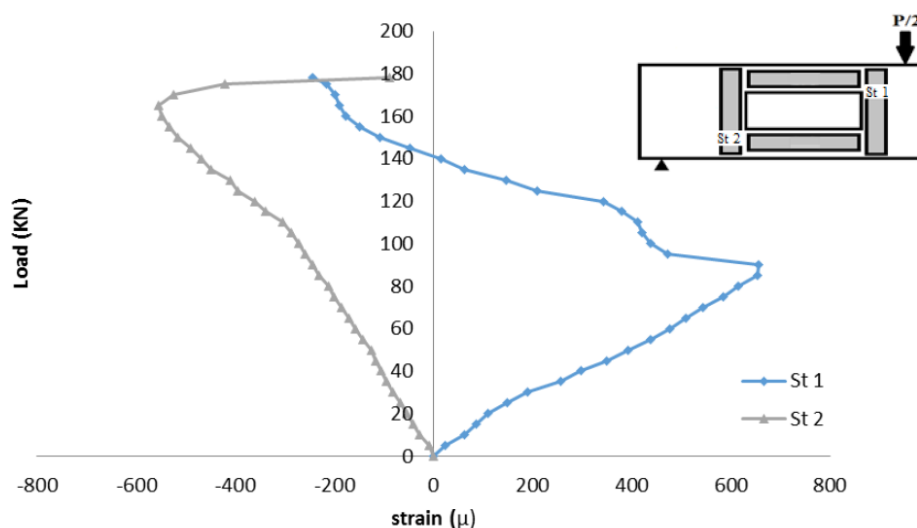
Fig. 7 Load against strain of externally bonded CFRP plates of beam B1

As can be seen from Fig. 7, for beam B1 the maximum CFRP strain measured at failure was in strain ST1. For beam B3, the steel plate strain measured at failure was deferent at each location, because the value of the strain greatly depends on the location of the strain gauge with respect to a crack, as shown in Fig. 9. It can be observed from Fig. 10 that for beam B4, the maximum CFRP strain measured at failure was in strain ST1, on the bottom chord of the opening. CFRP and steel plates were not fractured or debonded from the concrete surface, and this ultimately indicates that CFRP and steel plates could provide additional strength if the beams did not fail by concrete diagonal shear cracks.

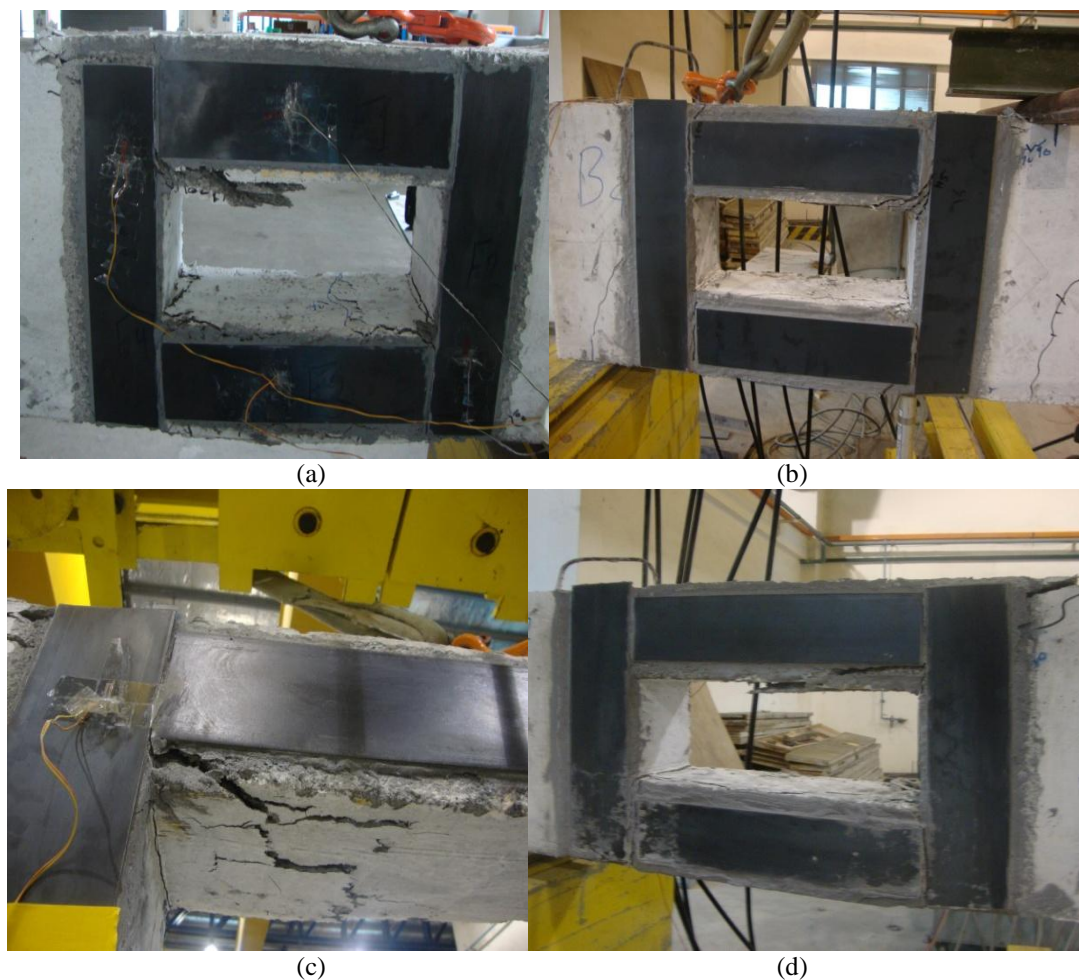
Fig. 12 Failure modes of beams at the post-repair stage (a) Beam B1, (b) Beam B2, (c) Beam B3, (d) Beam B4

The crack pattern and the failure modes for all beams at pre and post repair stages are presented in this section. Figs. 11 and 12 show the crack pattern and the failure mode for all the beams at the pre and post repair stages, respectively. The failure modes of all the beams are similar because the failure occurs due to failure in concrete as diagonal shear failure before the externally bonded plates reach the ultimate strain. It can be seen from Fig. 11 (b) that the first diagonal crack for beam B2 was observed at the corner of the opening at a load of 35 kN; additional cracks were formed with the increase of the applied load. Failure of the beam occurred when the total applied load reached 128 kN. At the post-repair stage, many cracks were formed at the solid span of the beam, and the failure of the beam occurred at a load of 163.4 kN. At failure, concrete diagonal shear failure was observed around the

opening, as shown in Fig. 12 (b).

This mode of failure is called splitting failure, which is due to relatively high longitudinal compressive stress developed at the top of the chords, which created transverse tension, and led to splitting failure, as according to Khalifa and Nanni [22]. The CFRP sheet did not fracture or debond from the concrete surface at the ultimate load. As can be seen from Fig. 11 (d), the first diagonal crack for beam B4 was observed at the corner of the opening at a load of 35 kN, additional cracks were formed with the increase of the applied load. Failure of the beam occurred when the total applied load reached 129.3 kN. As shown in Fig. 12 (d) for beam B4 at the post-repair stage, many cracks were formed at the solid span of the beam and the failure of the beam occurred at a load of 170 kN. At failure, crushing of the concrete was observed on the top and bottom face of the chord members, due to high compressive stress in concrete before the externally bonded plates reach the maximum strain.
