Technical Note

Repair effectiveness of CFRP and steel plates in RC beams with web opening: effect of plate thickness

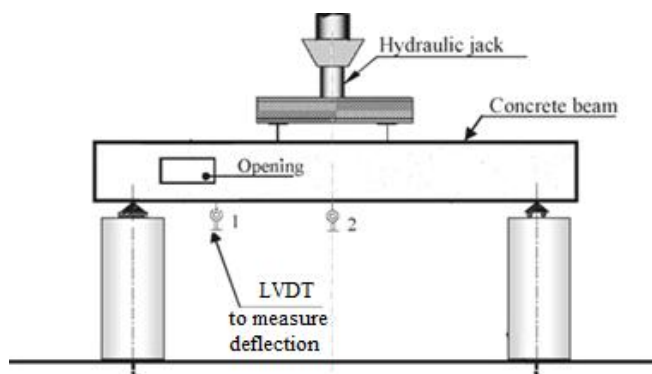
Fig. 1 Test set-up

All beams were tested as simple supported beams subjected to a four-point load, as illustrated in Fig. 1. A universal testing machine with 300 kN capacity was used in order to apply the load on a steel distribution I- beam, which was used to generate the two concentrated loads on the beam. The load was applied gradually with a speed of 4 kN/min and was then released with the same average. Two linear variable differential transformers (LVDT) were used in each test to monitor vertical deflection at two locations, edge of the opening and mid-span of the beam as shown in Fig. 1. For each beam, one strain gauge was attached to the main flexure steel bars below the opening, as shown in Fig. 2 (a). For all the beams, two strain gauges were attached directly to the CFRP and steel plate on the sides of beams to monitor strain variation in CFRP and steel plates, as shown in Fig. 2 (b). All the used electrical devices (load cell, LVDT, and strain gauges) are attached to the data logger in order to monitor the variation in load, deflection and train values, corresponding to applied loads. The readings were carried out at each 5 kN load step and up to the ultimate applied load. All the beams were subjected to failure load at the pre-repair stages. The beams were then unloaded by bringing back the loading to zero.

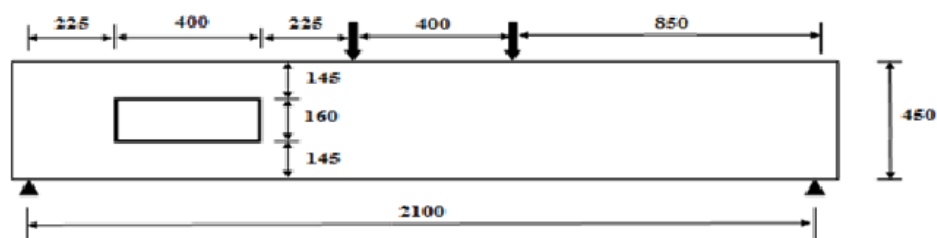
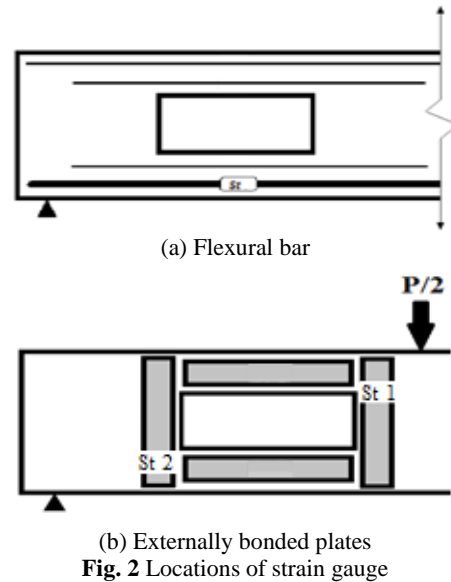
(a)

Fig. 2 Locations of strain gauge

The behaviour of load-strain relationship for externally bonded CFRP and steel plates is presented in this section. Strain gauge are fixed at two locations, one locations is on the opening corner near the support (ST2) and another location is at the opening corner near the point of applied load (ST1), as shown in Fig. 2(b). The load against strain curves for beams B1, B2, B3 and B4 are shown in Figs. 7, 8, 9 and 10, respectively. The recorded strains indicate that the value of strain for all beams did not reach the ultimate

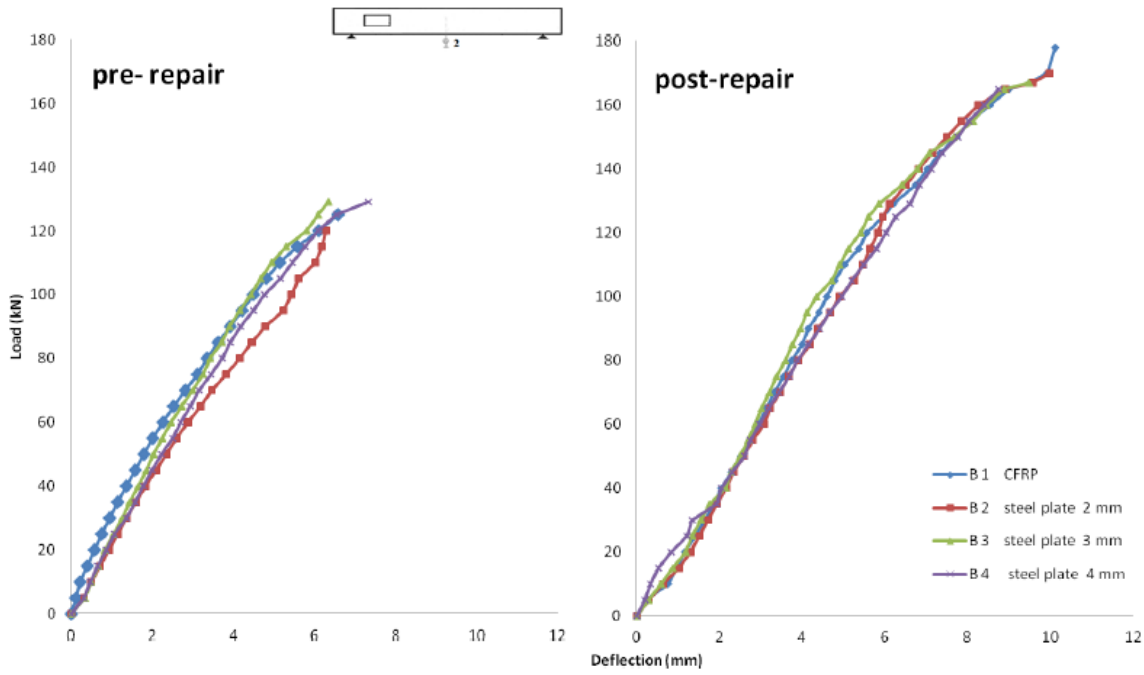
Fig 5. Load against deflection curves at the mid-span at pre and post repair stages

For beam B3, the value of deflection at the pre-repair stage at failure load of 129 kN was 6.35 mm, while at post-repair stage it was 5.85 mm at the same load of 128 kN. The value of deflection for beam B4 at the pre-repair stage was 6.74 mm at a failure load of 129.3 kN, while at the post-repair stage the deflection was 6.14 mm at the same load of 129.3 kN. The result shows that the influence of steel plates on deflection at the edge of the opening increases with the increase in steel plate thickness. The results indicate that the CFRP and steel plates have good effectiveness in reducing the deflection for the repaired beams at the edge of the opening and mid-span of the beam. From Fig. 5, which shows the load against deflection at mid-span curves at pre and post repair stages, it can be seen that curves for repaired beams show

somewhat similar behaviour because both CFRP and steel plates around the opening serve in resisting stress concentration at opening corners. Thus, it is delaying the cracking and controlling width and propagation of cracks. The highest value of deflection was obtained was located at the edge of the opening. The results are in agreement with Tan et al. [20], who found that for beams with an opening, the maximum deflection usually occurs at the high moment end of the opening. The decrease in deflection is smaller for the repaired beams, since the CFRP and steel plates prevent cracks from developing and widening. Furthermore, some contribution to the stiffness of beams was caused by the CFRP and steel plate outside the cracking region. The result shows that increasing steel plate thickness has little effect on reducing the deflection.

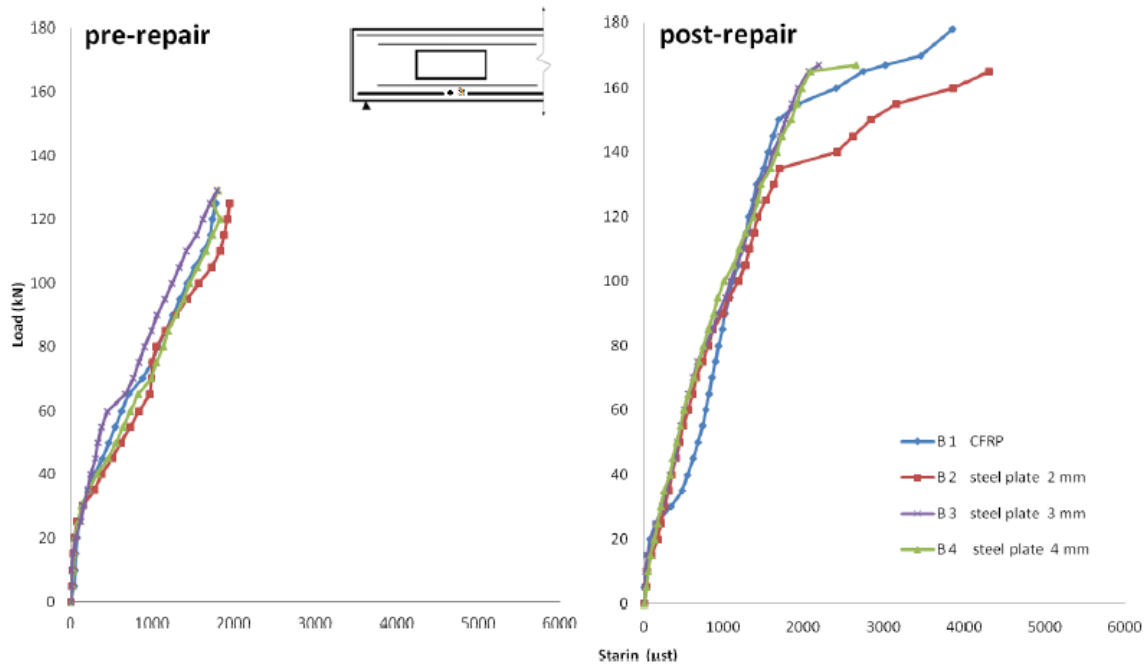
Fig. 6 Load against steel bar strain of (St) at pre and post repair stages

The load-strain relationship of steel reinforcement is presented in this section. The strain gauge (St) was attached onto the main steel reinforcement bar at the middle of the opening in the bottom chord. Fig. 6 shows the load against steel bar strain of the strain gauge (St) at the pre and post repair stages. For all the beams at the pre-repair stage, the strain gauge (St) shows an increase in strain value with the

increase in applied load and reaches its yielded strain at the ultimate load. At the post-repair stage, the externally bonded CFRP and steel plate shared the strain with steel bars where the strain gauge (St) reached strain values less than the strain at the pre-repair stage at same load. This was subjected to a different in the decrease of strain values percentage a depending on the material and thickness that were used, as shown in Table 5.
