## Technical Note

# Repair effectiveness of CFRP and steel plates in RC beams with web opening: effect of plate thickness

A. Ahmed A<sup>1</sup>, S. Naganathan<sup>1,\*</sup>, K. Nasharuddin<sup>1</sup>, M.M. Fayyadh<sup>2</sup>

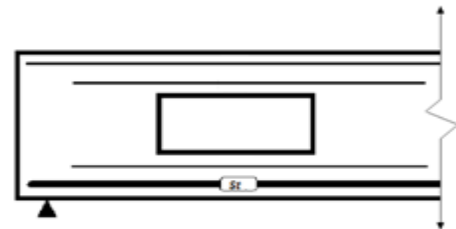
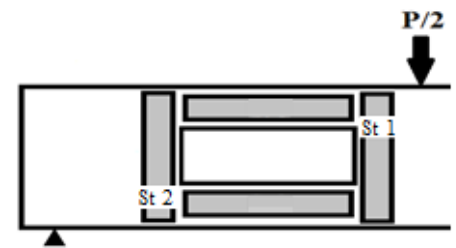
(b) Externally bonded plates  
Fig. 2 Locations of strain gauge

The load-strain relationship of steel reinforcement is presented in this section. The strain gauge (St) was attached onto the main steel reinforcement bar at the middle of the opening in the bottom chord. Fig. 6 shows the load against steel bar strain of the strain gauge (St) at the pre and post repair stages. For all the beams at the pre-repair stage, the strain gauge (St) shows an increase in strain value with the

The behaviour of load-strain relationship for externally bonded CFRP and steel plates is presented in this section. Strain gauge are fixed at two locations, one locations is on the opening corner near the support (ST2) and another location is at the opening corner near the point of applied load (ST1), as shown in Fig. 2(b). The load against strain curves for beams B1, B2, B3 and B4 are shown in Figs. 7, 8, 9 and 10, respectively. The recorded strains indicate that the value of strain for all beams did not reach the ultimate

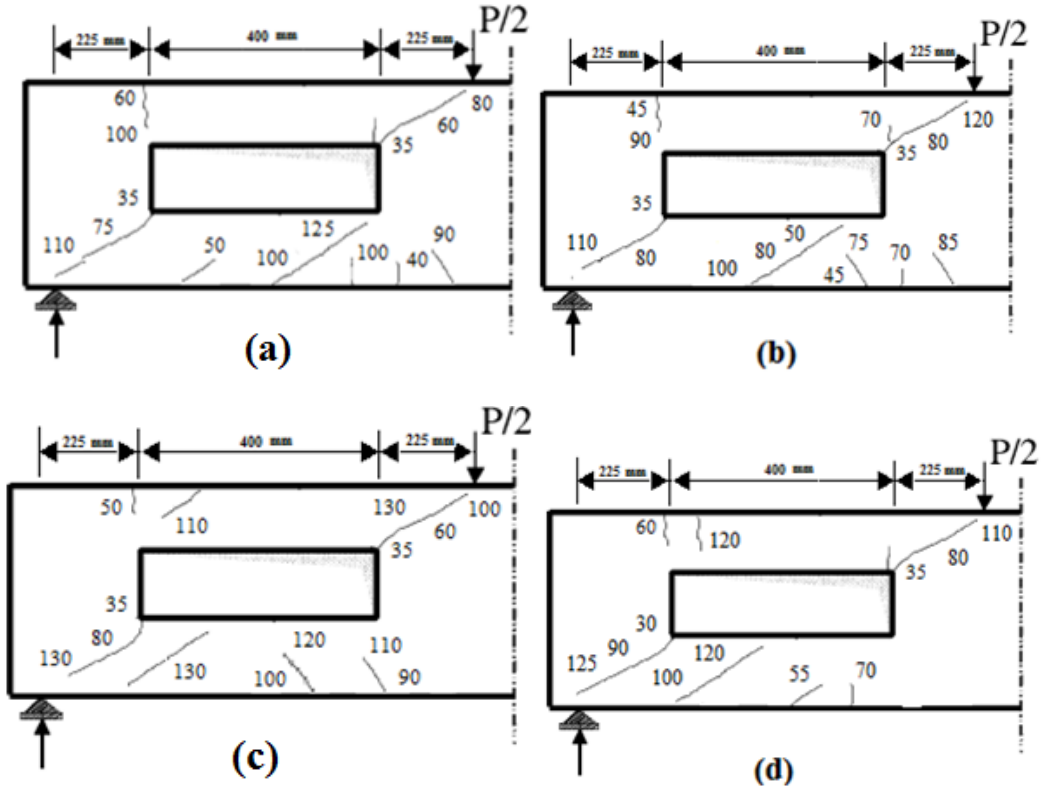
**Fig. 11** Crack patterns and failure modes of beams at the pre-repair stage (a) Beam B1, (b) Beam B2, (c) Beam B3, (d) Beam B4

The crack pattern and the failure modes for all beams at pre and post repair stages are presented in this section. Figs. 11 and 12 show the crack pattern and the failure mode for all the beams at the pre and post repair stages, respectively. The failure modes of all the beams are similar because the failure occurs due to failure in concrete as diagonal shear failure before the externally bonded plates reach the ultimate strain. It can be seen from Fig. 11 (b) that the first diagonal crack for beam B2 was observed at the corner of the opening at a load of 35 kN; additional cracks were formed with the increase of the applied load. Failure of the beam occurred when the total applied load reached 128 kN. At the post-repair stage, many cracks were formed at the solid span of the beam, and the failure of the beam occurred at a load of 163.4 kN. At failure, concrete diagonal shear failure was observed around the

This mode of failure is called splitting failure, which is due to relatively high longitudinal compressive stress developed at the top of the chords, which created transverse tension, and led to splitting failure, as according to Khalifa and Nanni [22]. The CFRP sheet did not fracture or debond from the concrete surface at the ultimate load. As can be seen from Fig. 11 (d), the first diagonal crack for beam B4 was observed at the corner of the opening at a load of 35 kN, additional cracks were formed with the increase of the applied load. Failure of the beam occurred when the total applied load reached 129.3 kN. As shown in Fig. 12 (d) for beam B4 at the post-repair stage, many cracks were formed at the solid span of the beam and the failure of the beam occurred at a load of 170 kN. At failure, crushing of the concrete was observed on the top and bottom face of the chord members, due to high compressive stress in concrete before the externally bonded plates reach the maximum strain.
