Technical Note

Repair effectiveness of CFRP and steel plates in RC beams with web opening: effect of plate thickness

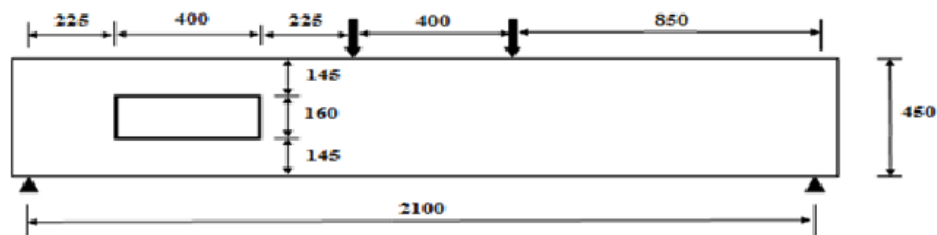
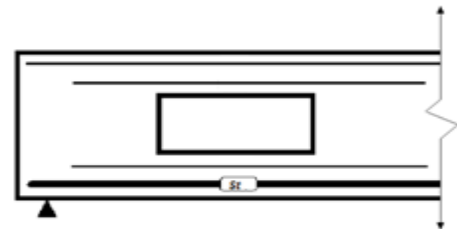
(b) Externally bonded plates
Fig. 2 Locations of strain gauge

The behaviour of load-strain relationship for externally bonded CFRP and steel plates is presented in this section. Strain gauge are fixed at two locations, one locations is on the opening corner near the support (ST2) and another location is at the opening corner near the point of applied load (ST1), as shown in Fig. 2(b). The load against strain curves for beams B1, B2, B3 and B4 are shown in Figs. 7, 8, 9 and 10, respectively. The recorded strains indicate that the value of strain for all beams did not reach the ultimate

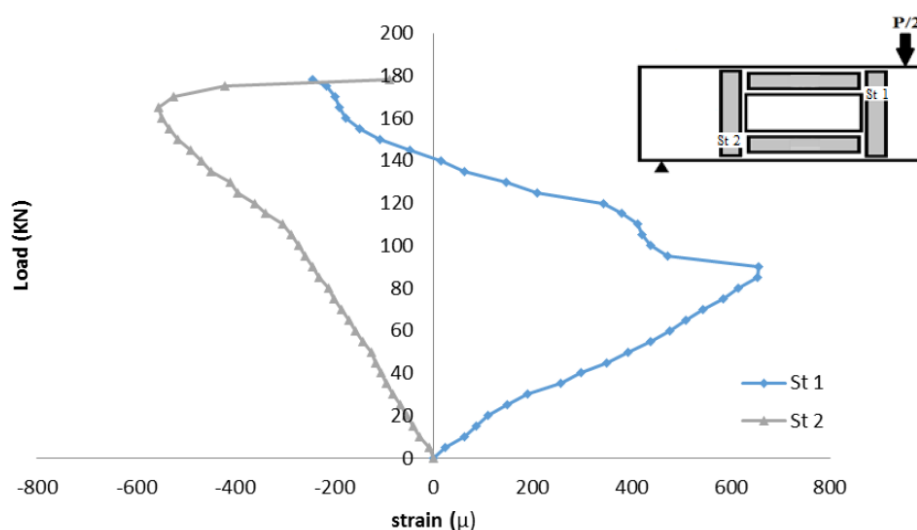
Fig. 7 Load against strain of externally bonded CFRP plates of beam B1

strain of CFRP and steel plates. This is due to the fact that the concrete failed before allowing the repair materials to reach the ultimate strain values. It can be observed from Figs. 7 to 10 that the externally bonded plates start to share the strain in the beam from the start of the applied load. The results are in agreement with Khalifa and Intomio [20], who found that the maximum CFRP vertical strain measured at failure corresponded to 14 % of the reported CFRP ultimate strain. This value is not absolute, because it greatly depends on the location of the strain gauge with respect to a crack.

As can be seen from Fig. 7, for beam B1 the maximum CFRP strain measured at failure was in strain ST1. For beam B3, the steel plate strain measured at failure was deferent at each location, because the value of the strain greatly depends on the location of the strain gauge with respect to a crack, as shown in Fig. 9. It can be observed from Fig. 10 that for beam B4, the maximum CFRP strain measured at failure was in strain ST1, on the bottom chord of the opening. CFRP and steel plates were not fractured or debonded from the concrete surface, and this ultimately indicates that CFRP and steel plates could provide additional strength if the beams did not fail by concrete diagonal shear cracks.
