Investigation of long term coupled effect of high temperature and constant high humidity on corrosion rehabilitated patches of reinforced concrete structures

Abstract

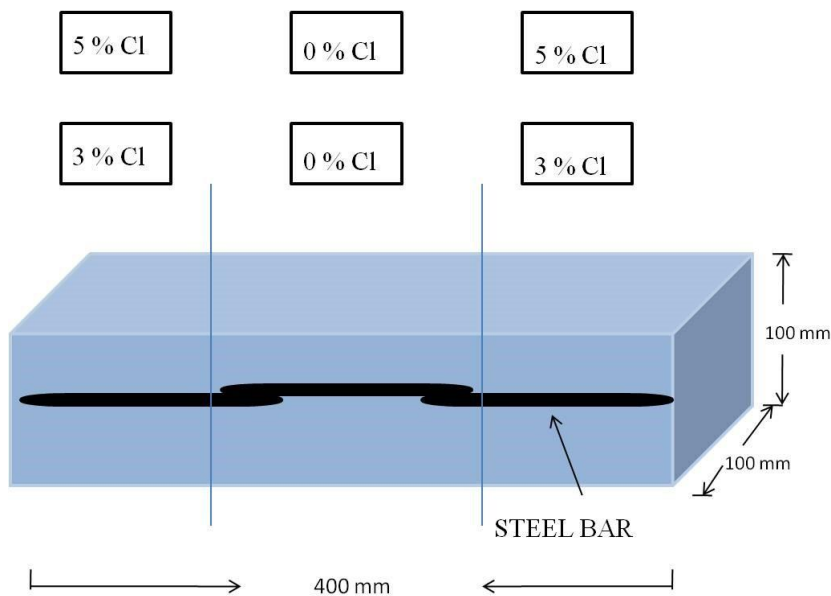
Fig. 2 Schematic representation of the identical test specimen

elsewhere [10]. The schematic diagram of these specimens is shown in Fig. 2 and the complete mixing procedure is shown in Fig. 3. Since the objective of this research is to find the long term coupled effect of varying temperature and high humidity on macro-cell corrosion phenomenon, these specimens were kept at 50°C, 40°C and 30°C temperature conditions and 85% relative humidity in environment control chambers for 2 years.

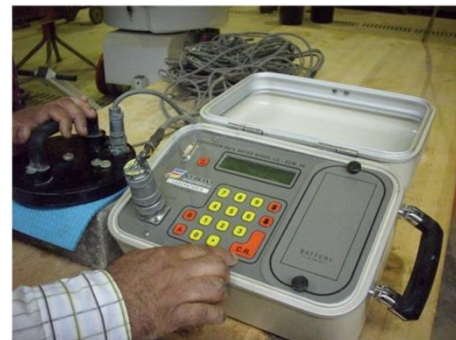
Figure 4 GECOR-8 (Corrosion Measurement device)

The steel rebar corrosion current (I_{corr}) and corrosion potential (E_{corr}) were measured for all specimens using a GECOR device [11] and ASTM C-876 [12]. The GECOR measures the corrosion rate as reflected by the corrosion current density and the half-cell corrosion potential. A true measure of the corrosion rate is possible by the polarization resistance technique. It has been well established by Stern and Geary that the corrosion current is linearly related to the polarization resistance, which gives a direct quantitative measurement of the amount of steel turning into oxide at the time of measurement. By Faraday's equation, this can be extrapolated to direct metal sectional loss. The corrosion current values in GECOR (GECOR-8, 2012) are calculated from the polarization resistance R_p using the relation $I_{corr} = B/R_p$, where I_{corr} is given in $\mu A/cm^2$ when R_p is given in $k\Omega/cm^2$ and $B = 26$ mV. The I_{corr} is directly proportional to corrosion rate through the relation, corrosion rate ($\mu m/year$) = $11.6 \times I_{corr}$. This gives a tool for quantifying the average reduction of rebar diameter over time. The measurement of corrosion rate usually involves applying electrical signal through a connection to the steel bar. In GECOR this signal is confined to the steel rebar in a circle with a diameter of 110 mm. There is evidence that this technique gives a more accurate measurement of the corrosion rate [13]. The GECOR device is quite valuable and versatile for the corrosion measurement of steel in concrete. See Fig. 4 for further illustration.

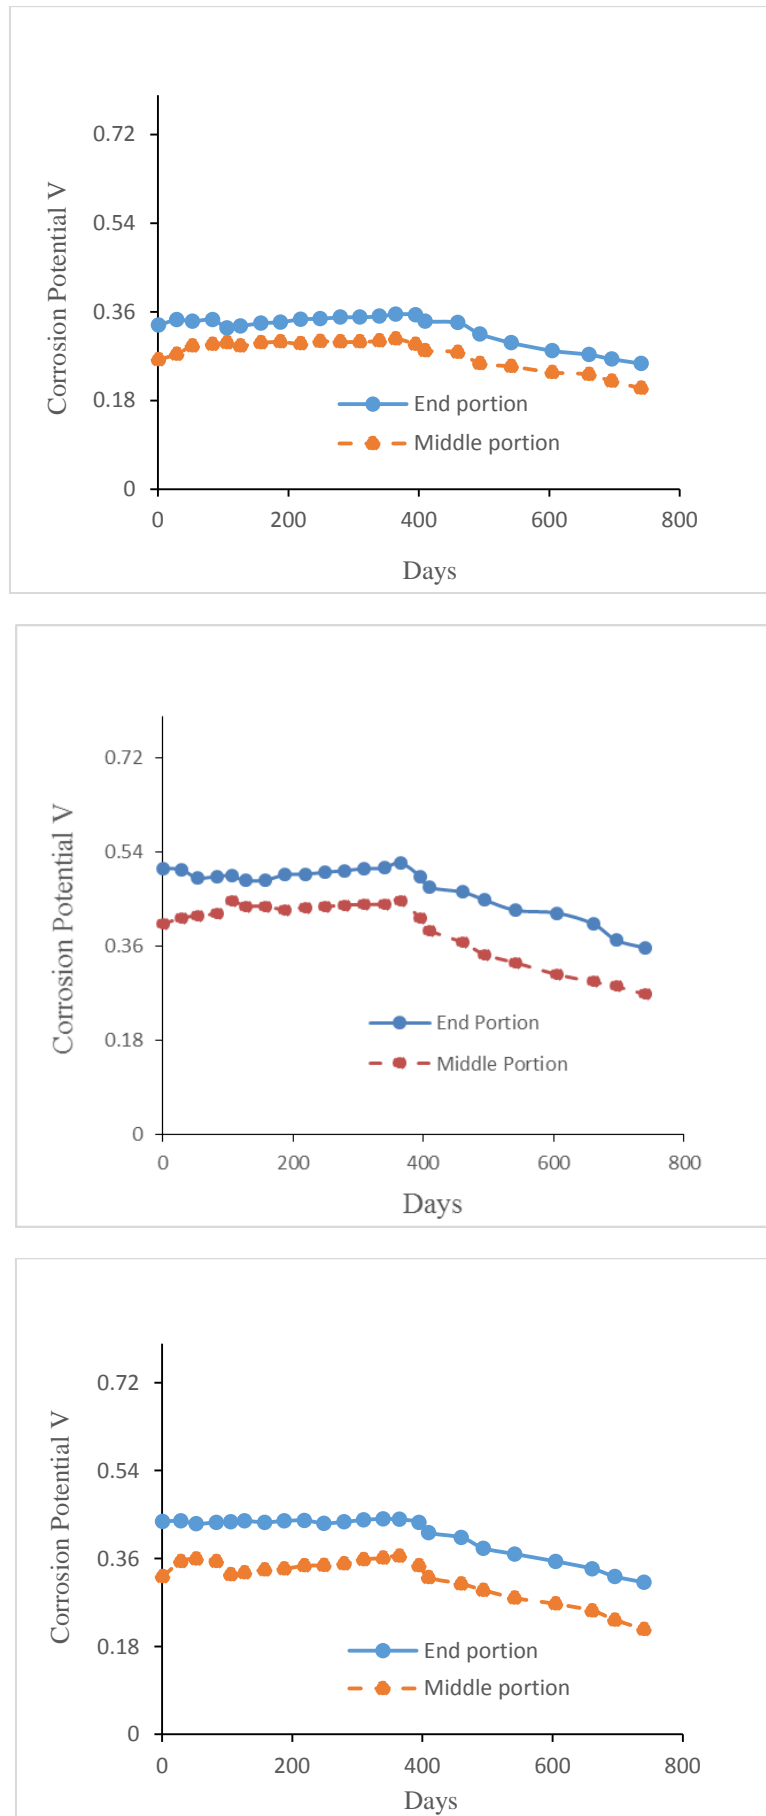
Fig. 6 (a-c) Corrosion potential measurement for 3% chloride contaminated specimen at the end kept at 30°C, 40°C and 50°C

1) At the middle non contaminated portion of the specimen having 5% chloride at the end portions and kept at 50°C (#1 and #2), the maximum corrosion of **-0.235** Volts was found after 2 years as compared to **-0.285** Volts at 30°C in the middle zero chloride portion of the same specimens (#5 and #6). However previously, much higher readings of these specimens were obtained on completion of one year observations [10]. The reason of this phenomenon could be the long term coupled effect of temperature and constant high humidity due to which the decline in corrosion potential after two years was significant. The results are shown in Figs. 5 and 6.

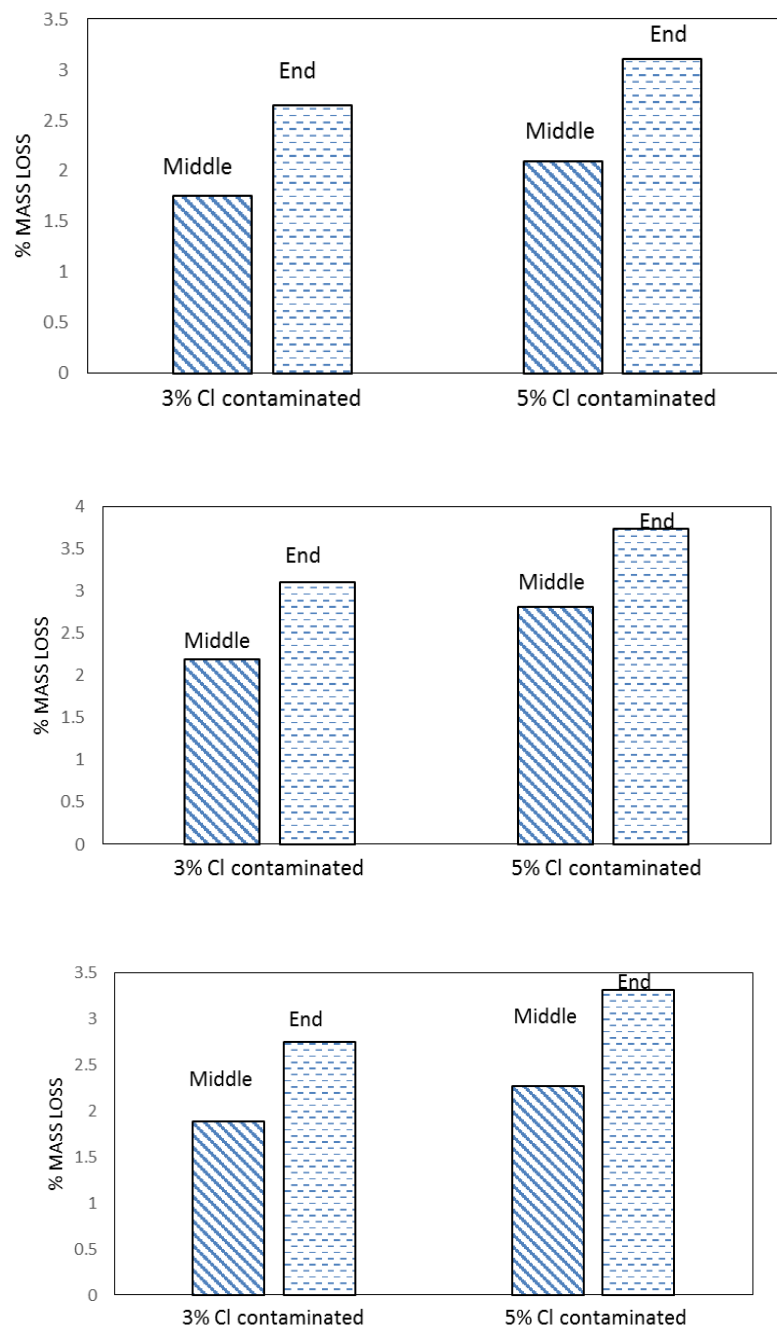
Fig. 7 % Mass loss for 3% and 5% chloride contaminated specimen at the end kept at 30°C, 40°C and 50°C

steel of the end portion of the same specimen kept at 50°C gave the highest % mass loss of 3.31 and middle steel gave 2.27 % mass losses which was lower than the mass losses at 40°C. The results are shown in Fig. 7.

2) The steel from the end portions of 3 % chloride contaminated concrete specimens kept at 30°C, 40°C and 50°C gave 2.65, 3.11 and 2.75 % mass loss respectively. While the middle steels from the uncontaminated portion of these specimens gave 1.75, 2.19 and 1.88 % mass losses respectively as shown in figure 7. Similarly in the 3% chloride contaminated specimens reduced % mass losses at 50°C obtained as compared to the mass loss at 40°C, confirming the authenticity of the results of this research.

As it can be seen from gravimetric mass loss results of various specimens put in varying temperatures, shown in figure 7(a-c), the steels from the middle portion of all the specimens simulating the actual patch repair in field, were corroded and gave approximately 70% of the mass loss obtained in their respective contaminated end portions, indicating the chloride transfer and vulnerability of repaired portion against corrosion.
