Investigation of long term coupled effect of high temperature and constant high humidity on corrosion rehabilitated patches of reinforced concrete structures

Abstract

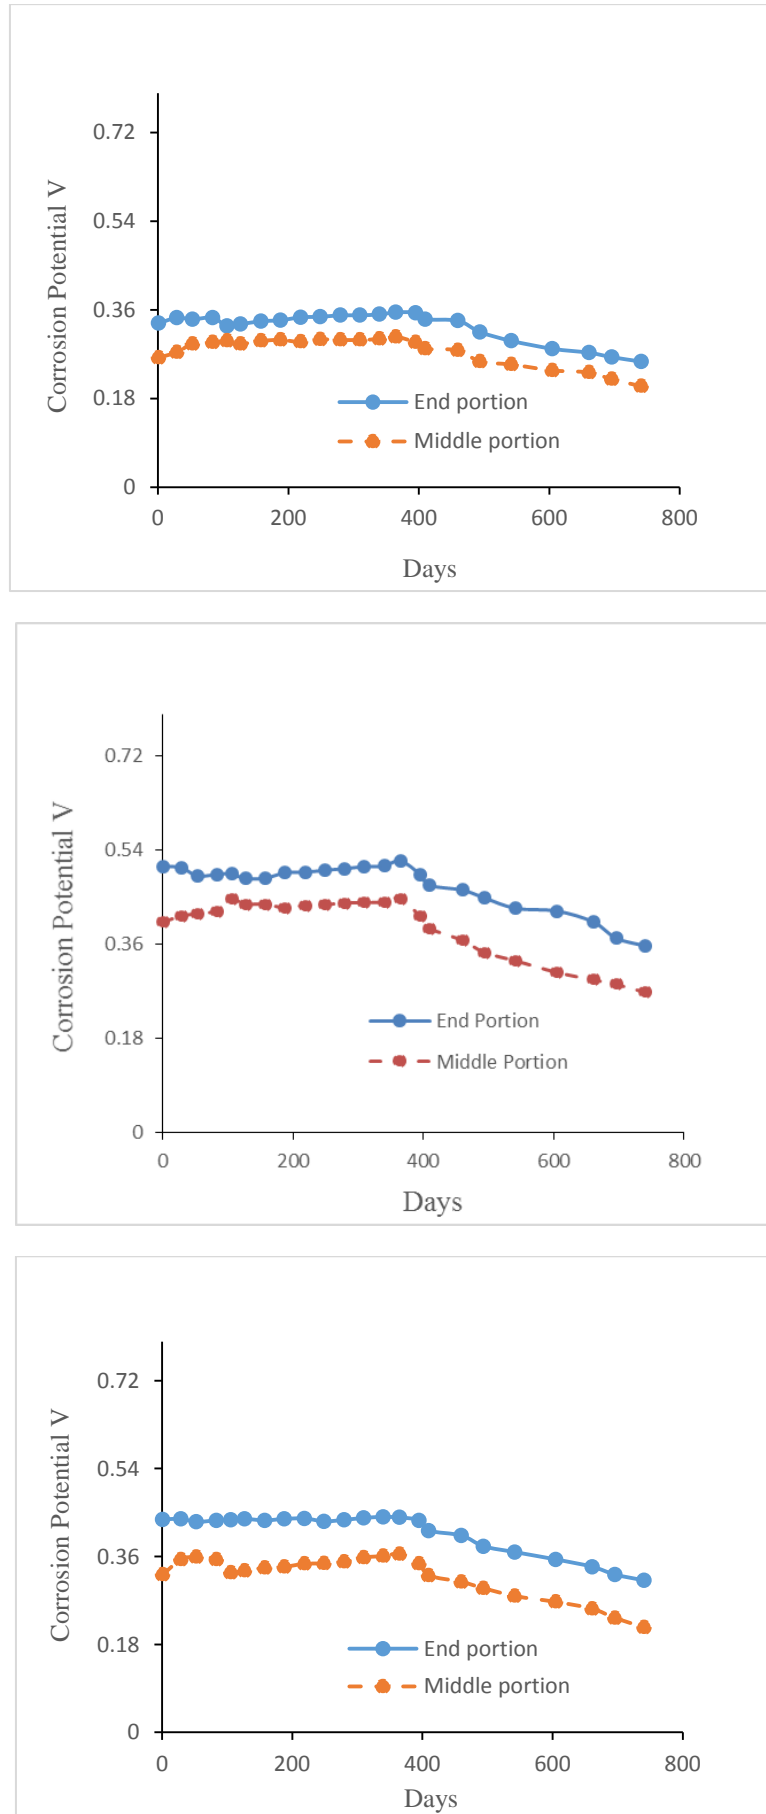
Fig. 6 (a-c) Corrosion potential measurement for 3% chloride contaminated specimen at the end kept at 30°C, 40°C and 50°C

1) At the middle non contaminated portion of the specimen having 5% chloride at the end portions and kept at 50°C (#1 and #2), the maximum corrosion of **-0.235** Volts was found after 2 years as compared to **-0.285** Volts at 30°C in the middle zero chloride portion of the same specimens (#5 and #6). However previously, much higher readings of these specimens were obtained on completion of one year observations [10]. The reason of this phenomenon could be the long term coupled effect of temperature and constant high humidity due to which the decline in corrosion potential after two years was significant. The results are shown in Figs. 5 and 6.
