Investigation of long term coupled effect of high temperature and constant high humidity on corrosion rehabilitated patches of reinforced concrete structures

Abstract

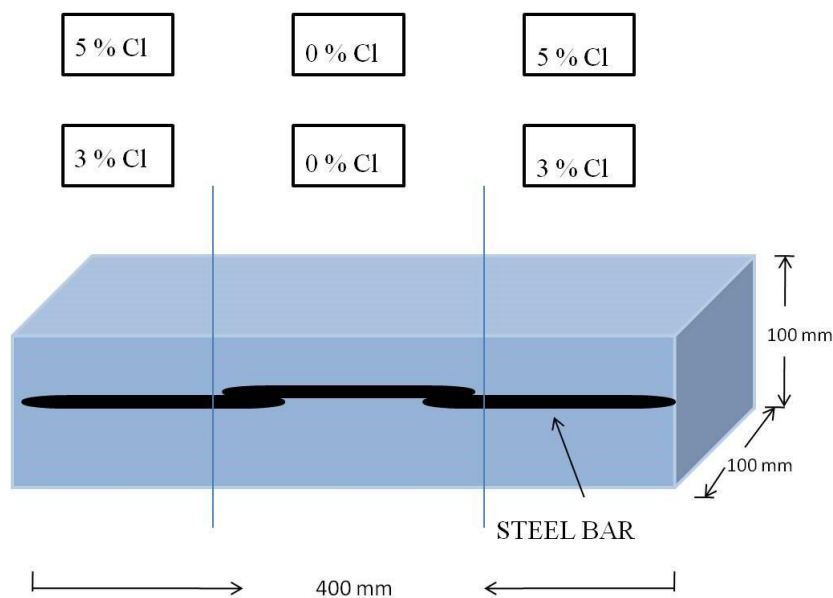
Fig. 2 Schematic representation of the identical test specimen

elsewhere [10]. The schematic diagram of these specimens is shown in Fig. 2 and the complete mixing procedure is shown in Fig. 3. Since the objective of this research is to find the long term coupled effect of varying temperature and high humidity on macro-cell corrosion phenomenon, these specimens were kept at 50°C, 40°C and 30°C temperature conditions and 85% relative humidity in environment control chambers for 2 years.

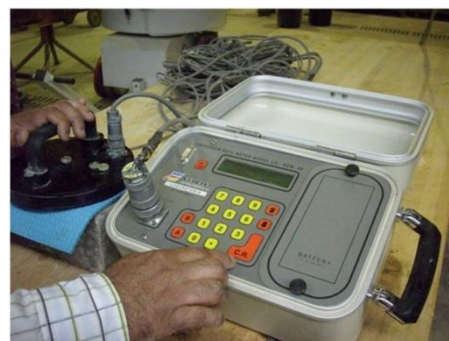
Figure 4 GECOR-8 (Corrosion Measurement device)

The steel rebar corrosion current (I_{corr}) and corrosion potential (E_{corr}) were measured for all specimens using a GECOR device [11] and ASTM C-876 [12]. The GECOR measures the corrosion rate as reflected by the corrosion current density and the half-cell corrosion potential. A true measure of the corrosion rate is possible by the polarization resistance technique. It has been well established by Stern and Geary that the corrosion current is linearly related to the polarization resistance, which gives a direct quantitative measurement of the amount of steel turning into oxide at the time of measurement. By Faraday's equation, this can be extrapolated to direct metal sectional loss. The corrosion current values in GECOR (GECOR-8, 2012) are calculated from the polarization resistance R_p using the relation $I_{corr} = B/R_p$, where I_{corr} is given in $\mu A/cm^2$ when R_p is given in $k\Omega/cm^2$ and $B = 26$ mV. The I_{corr} is directly proportional to corrosion rate through the relation, corrosion rate ($\mu m/year$) = $11.6 \times I_{corr}$. This gives a tool for quantifying the average reduction of rebar diameter over time. The measurement of corrosion rate usually involves applying electrical signal through a connection to the steel bar. In GECOR this signal is confined to the steel rebar in a circle with a diameter of 110 mm. There is evidence that this technique gives a more accurate measurement of the corrosion rate [13]. The GECOR device is quite valuable and versatile for the corrosion measurement of steel in concrete. See Fig. 4 for further illustration.

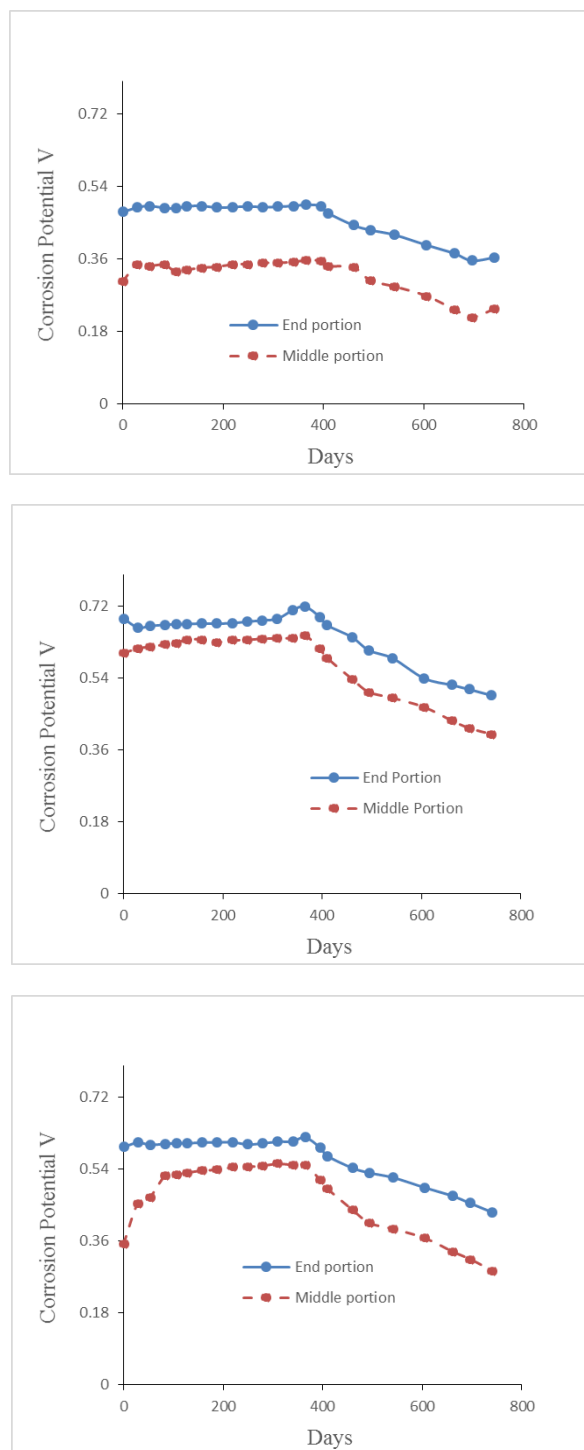
Fig. 5 (a-c) Corrosion potential measurement for 5% contaminated chloride specimen at the end kept at 30°C, 40°C and 50°C

1) At the middle non contaminated portion of the specimen having 5% chloride at the end portions and kept at 50°C (#1 and #2), the maximum corrosion of **-0.235** Volts was found after 2 years as compared to **-0.285** Volts at 30°C in the middle zero chloride portion of the same specimens (#5 and #6). However previously, much higher readings of these specimens were obtained on completion of one year observations [10]. The reason of this phenomenon could be the long term coupled effect of temperature and constant high humidity due to which the decline in corrosion potential after two years was significant. The results are shown in Figs. 5 and 6.

2) The maximum corrosion potential reading of the specimens #1 and #2 was found **-0.363** Volts as compared to high chloride induced potentials of **-0.432** Volts (figure 5) of the same specimens #5 and #6 at 30°C (figure 4)
