Investigation of long term coupled effect of high temperature and constant high humidity on corrosion rehabilitated patches of reinforced concrete structures

Abstract

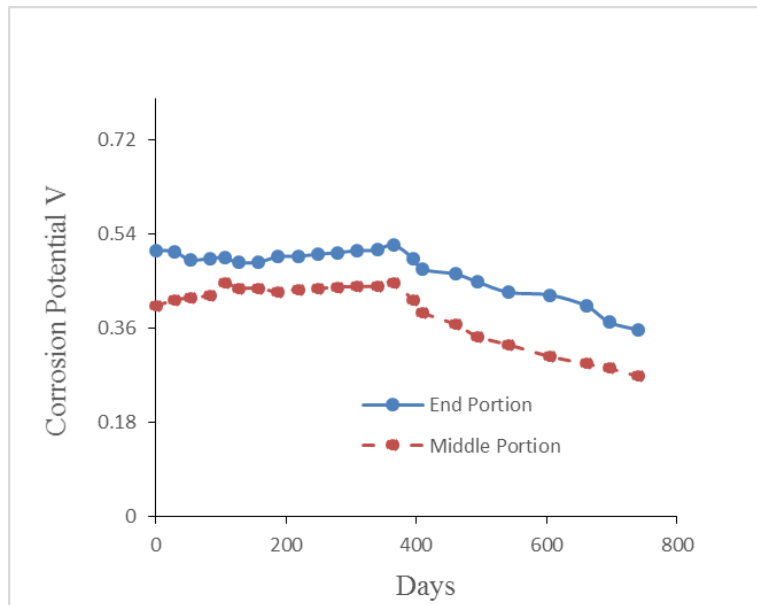
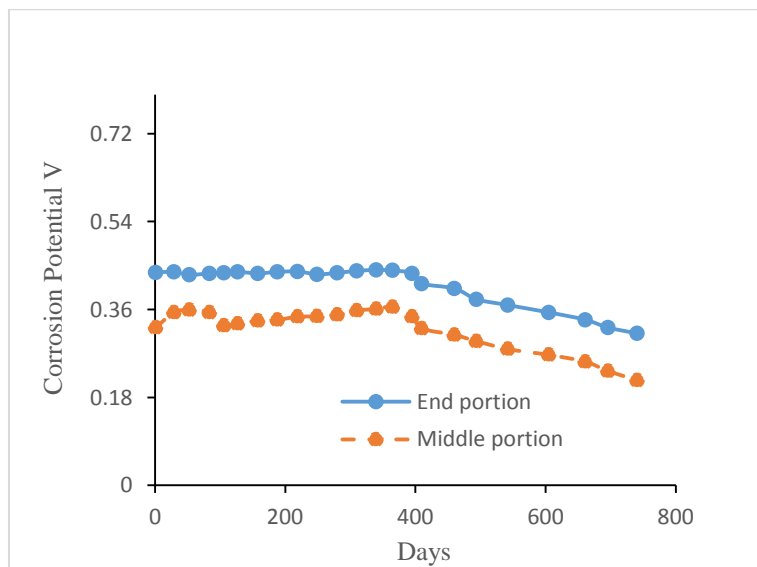
Fig. 6 (a-c) Corrosion potential measurement for 3% chloride contaminated specimen at the end kept at 30°C, 40°C and 50°C

1) At the middle non contaminated portion of the specimen having 5% chloride at the end portions and kept at $50^\circ C$ (#1 and #2), the maximum corrosion of **-0.235** Volts was found after 2 years as compared to **-0.285** Volts at $30^\circ C$ in the middle zero chloride portion of the same specimens (#5 and #6). However previously, much higher readings of these specimens were obtained on completion of one year observations [10]. The reason of this phenomenon could be the long term coupled effect of temperature and constant high humidity due to which the decline in corrosion potential after two years was significant. The results are shown in Figs. 5 and 6.

5) In the 3 % chloride contaminated specimens (#7 and #8) at the end, the corrosion potential of **-0.255** Volts was obtained as compared to high **-0.311** Volts of same specimens (#11 and #12) which were kept at 30 °C.

6) In specimen #7 and #8, the corrosion potential of **-0.205** volts at the middle non contaminated portion was obtained as compared to **-0.215** Volt at 30°C.
