## Investigation of long term coupled effect of high temperature and constant high humidity on corrosion rehabilitated patches of reinforced concrete structures

M. Wasim<sup>1</sup>, Raja Rizwan Hussain<sup>2,\*</sup>, M. A. Baloch<sup>3</sup>

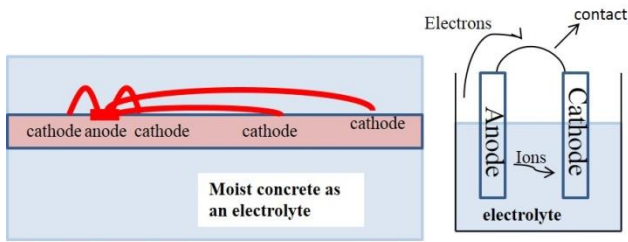
Figure 1 Separation of cathode and anode

The authors of this research paper, previously investigated and established the phenomenon of macro-cell formation in the repaired reinforced concrete patches due to the separation of anode and cathode [9], which is illustrated in Fig. 1. They also corroborated that the presence of high chloride content aided by the severe environmental conditions i.e. varying temperature and high constant humidity, not only break the passive film which protects steel from further corrosion but also accelerate the corrosion of reinforcement steel bars even in repaired reinforced concrete patches [10]. However, what would be the effect of long term coupled effect of varying temperature and constant high humidity on macro-cell corrosion of such repaired RC patches remained a question and leads to the objectives of this research paper.

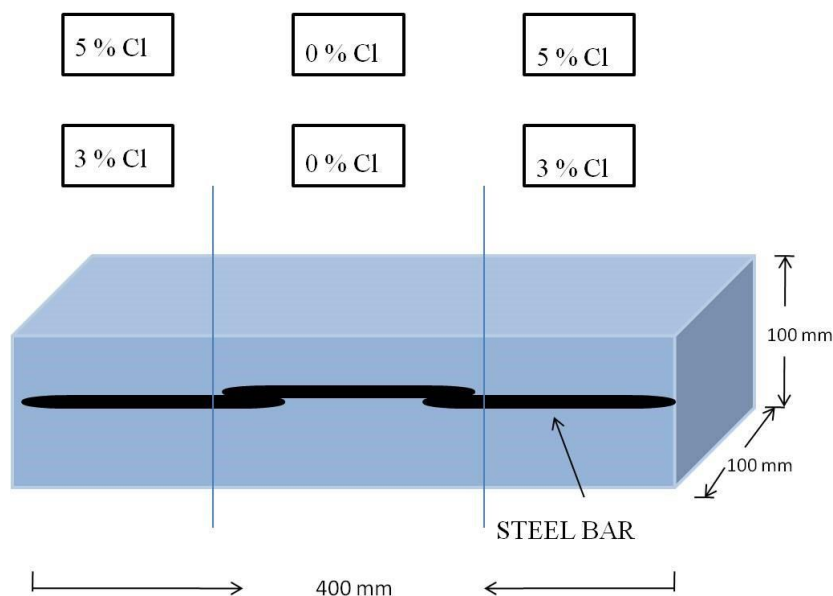
**Fig. 2** Schematic representation of the identical test specimen

elsewhere [10]. The schematic diagram of these specimens is shown in Fig. 2 and the complete mixing procedure is shown in Fig. 3. Since the objective of this research is to find the long term coupled effect of varying temperature and high humidity on macro-cell corrosion phenomenon, these specimens were kept at 50°C, 40°C and 30°C temperature conditions and 85% relative humidity in environment control chambers for 2 years.

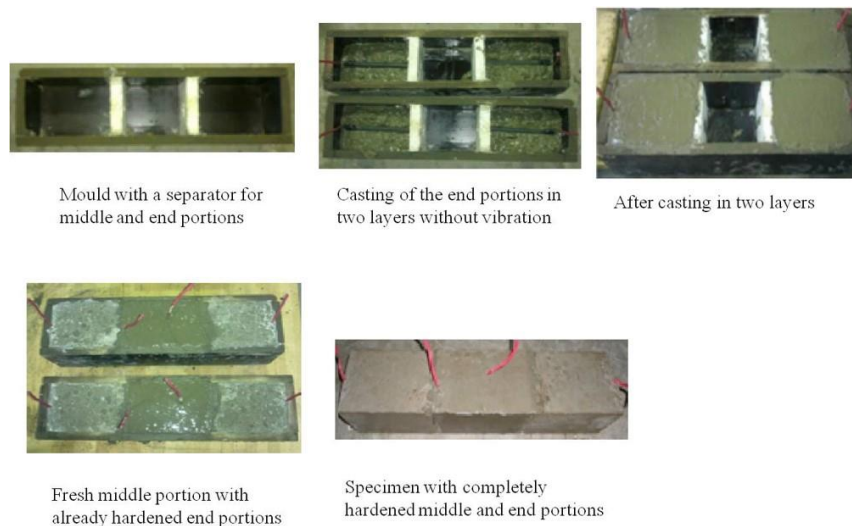
Figure 3 Specimens preparation

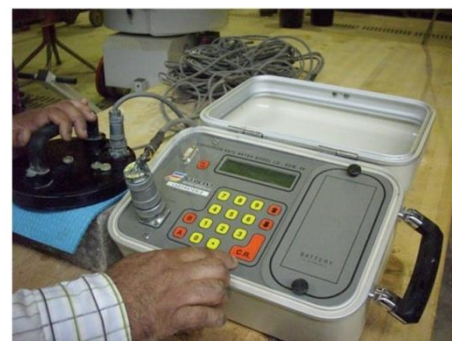
Figure 4 GECOR-8 (Corrosion Measurement device)

The steel rebar corrosion current ( $I_{corr}$ ) and corrosion potential ( $E_{corr}$ ) were measured for all specimens using a GECOR device [11] and ASTM C-876 [12]. The GECOR measures the corrosion rate as reflected by the corrosion current density and the half-cell corrosion potential. A true measure of the corrosion rate is possible by the polarization resistance technique. It has been well established by Stern and Geary that the corrosion current is linearly related to the polarization resistance, which gives a direct quantitative measurement of the amount of steel turning into oxide at the time of measurement. By Faraday's equation, this can be extrapolated to direct metal sectional loss. The corrosion current values in GECOR (GECOR-8, 2012) are calculated from the polarization resistance  $R_p$  using the relation  $I_{corr} = B/R_p$ , where  $I_{corr}$  is given in  $\mu A/cm^2$  when  $R_p$  is given in  $k\Omega/cm^2$  and  $B = 26$  mV. The  $I_{corr}$  is directly proportional to corrosion rate through the relation, corrosion rate ( $\mu m/year$ ) =  $11.6 \times I_{corr}$ . This gives a tool for quantifying the average reduction of rebar diameter over time. The measurement of corrosion rate usually involves applying electrical signal through a connection to the steel bar. In GECOR this signal is confined to the steel rebar in a circle with a diameter of 110 mm. There is evidence that this technique gives a more accurate measurement of the corrosion rate [13]. The GECOR device is quite valuable and versatile for the corrosion measurement of steel in concrete. See Fig. 4 for further illustration.

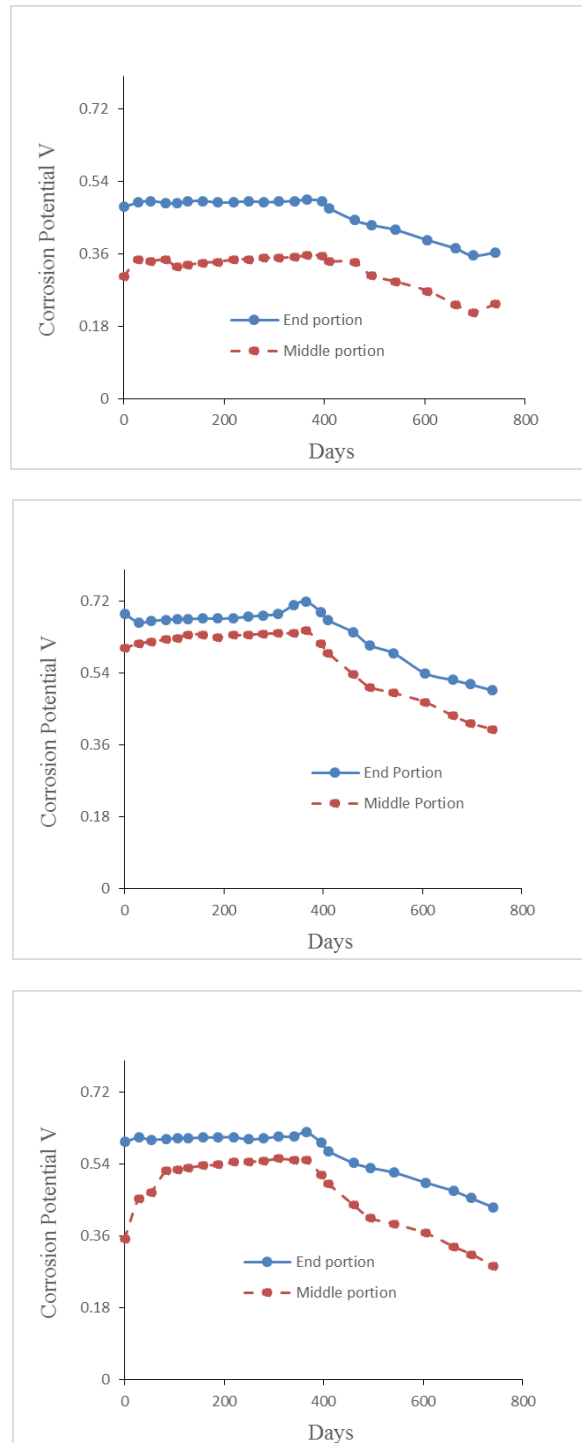
**Fig. 5** (a-c) Corrosion potential measurement for 5% contaminated chloride specimen at the end kept at 30°C, 40°C and 50°C

1) At the middle non contaminated portion of the specimen having 5% chloride at the end portions and kept at 50°C (#1 and #2), the maximum corrosion of **-0.235** Volts was found after 2 years as compared to **-0.285** Volts at 30°C in the middle zero chloride portion of the same specimens (#5 and #6). However previously, much higher readings of these specimens were obtained on completion of one year observations [10]. The reason of this phenomenon could be the long term coupled effect of temperature and constant high humidity due to which the decline in corrosion potential after two years was significant. The results are shown in Figs. 5 and 6.

2) The maximum corrosion potential reading of the specimens #1 and #2 was found **-0.363** Volts as compared to high chloride induced potentials of **-0.432** Volts (figure 5) of the same specimens #5 and #6 at 30°C (figure 4)

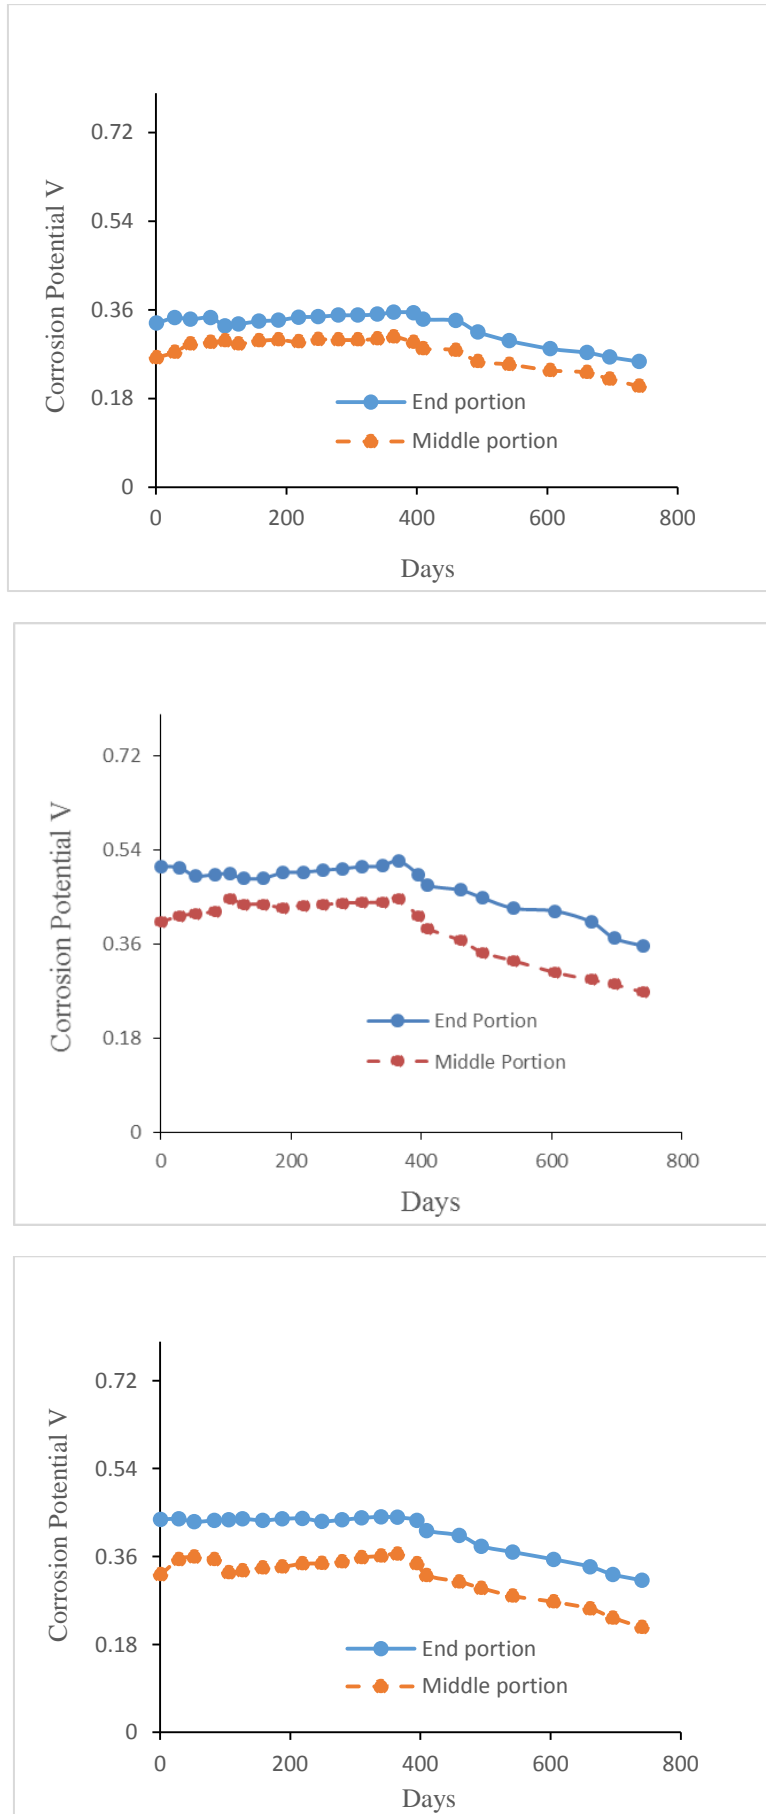
Fig. 6 (a-c) Corrosion potential measurement for 3% chloride contaminated specimen at the end kept at 30°C, 40°C and 50°C

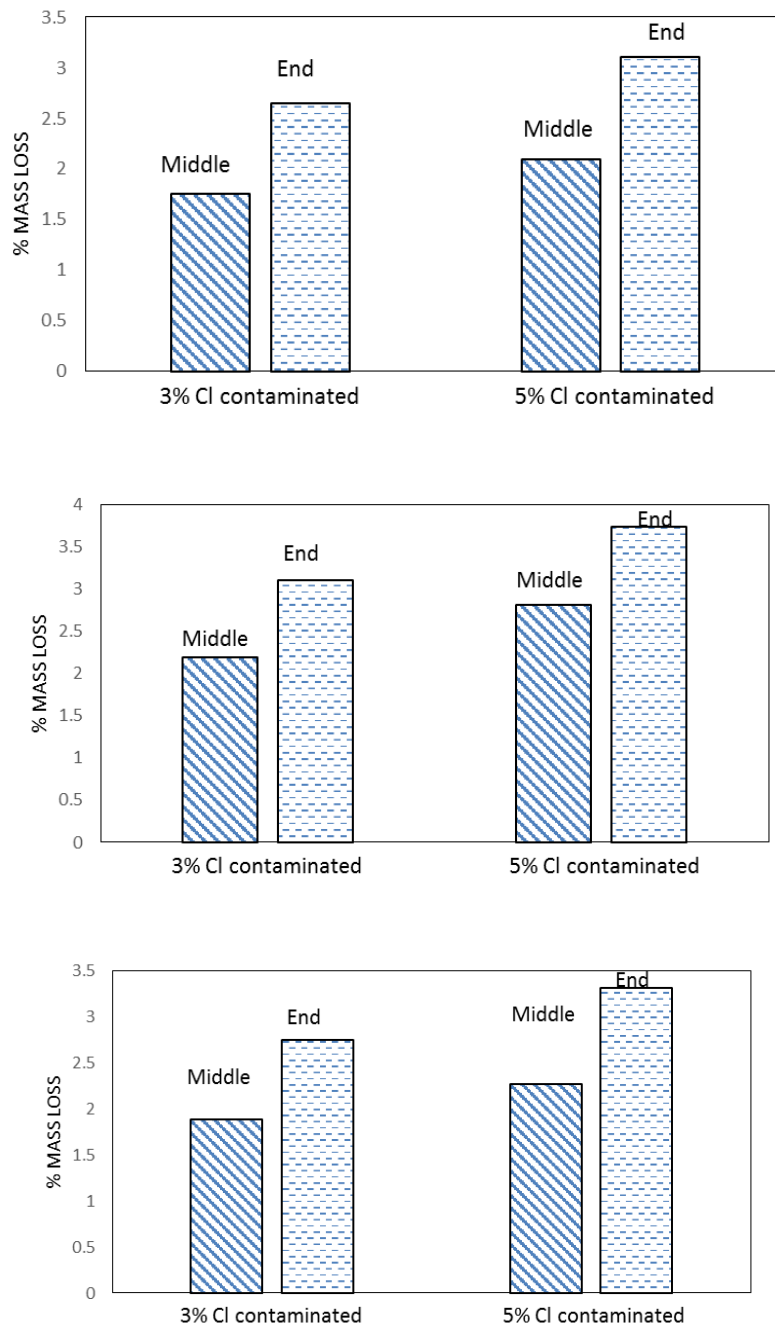
**Fig. 7** % Mass loss for 3% and 5% chloride contaminated specimen at the end kept at 30°C, 40°C and 50°C

1) The steel bar from the end portion of 5% chloride contaminated concrete gave the highest % mass loss of 3.73 at 40°C while the steel bar from its middle portion gave 2.81 % mass loss. When the steel taken from the end portion of the same specimen kept at 30°C gave the highest % mass loss of 3.11 and 2.09 % obtained from its middle steel. However interestingly even after exposure of two years observation, the

steel of the end portion of the same specimen kept at 50°C gave the highest % mass loss of 3.31 and middle steel gave 2.27 % mass losses which was lower than the mass losses at 40°C. The results are shown in Fig. 7.

2) The steel from the end portions of 3 % chloride contaminated concrete specimens kept at 30°C, 40°C and 50°C gave 2.65, 3.11 and 2.75 % mass loss respectively. While the middle steels from the uncontaminated portion of these specimens gave 1.75, 2.19 and 1.88 % mass losses respectively as shown in figure 7. Similarly in the 3% chloride contaminated specimens reduced % mass losses at 50°C obtained as compared to the mass loss at 40°C, confirming the authenticity of the results of this research.

As it can be seen from gravimetric mass loss results of various specimens put in varying temperatures, shown in figure 7(a-c), the steels from the middle portion of all the specimens simulating the actual patch repair in field, were corroded and gave approximately 70% of the mass loss obtained in their respective contaminated end portions, indicating the chloride transfer and vulnerability of repaired portion against corrosion.
