## Investigation of long term coupled effect of high temperature and constant high humidity on corrosion rehabilitated patches of reinforced concrete structures

### Abstract

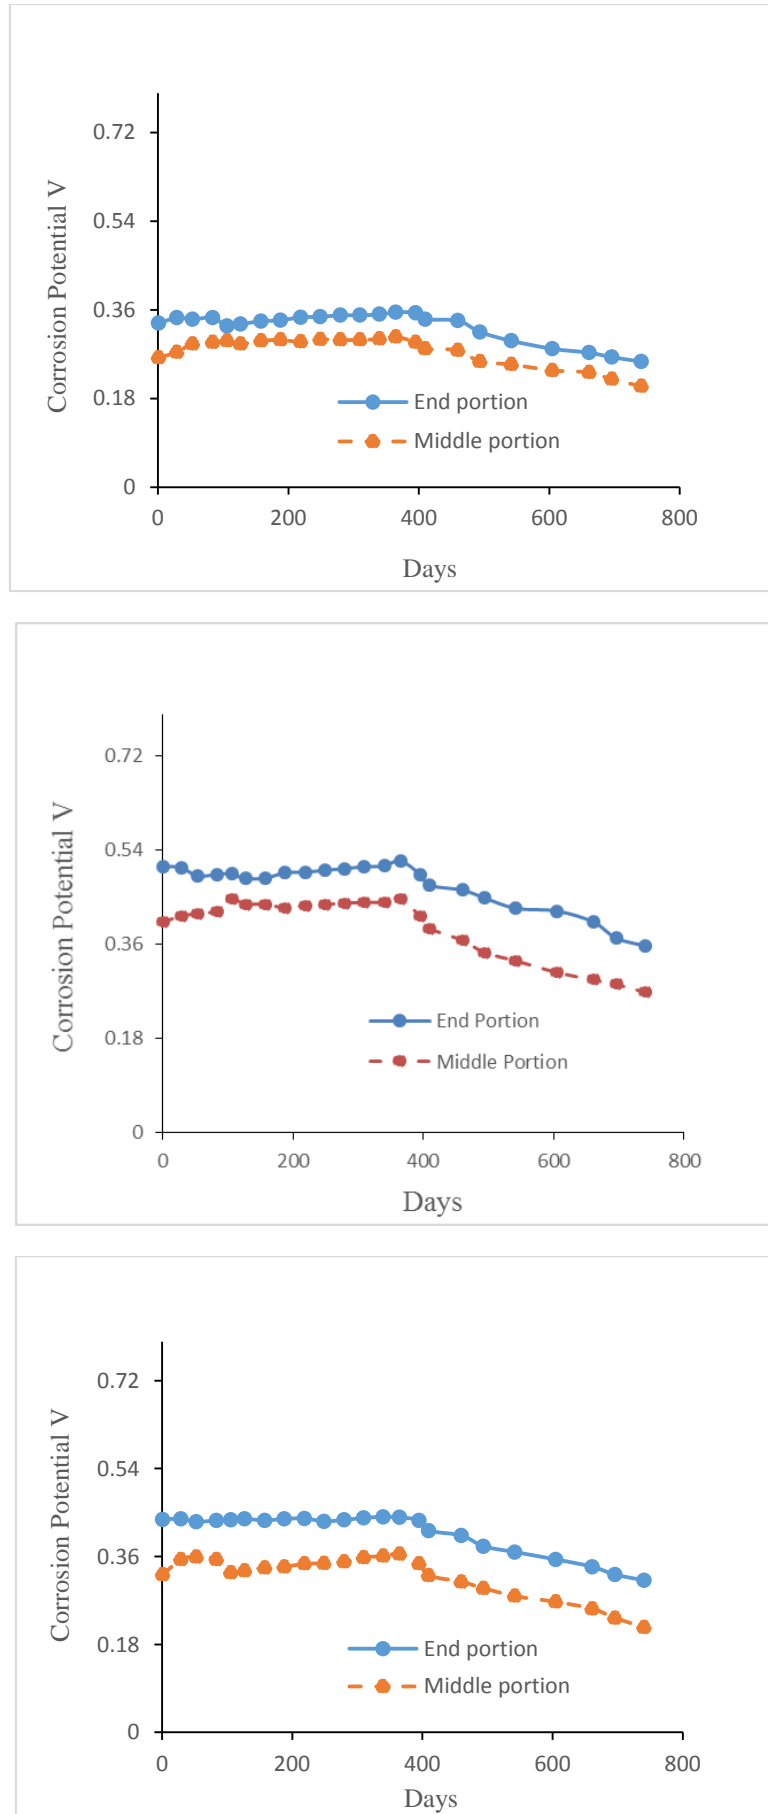
**Fig. 6** (a-c) Corrosion potential measurement for 3% chloride contaminated specimen at the end kept at 30°C, 40°C and 50°C

1) At the middle non contaminated portion of the specimen having 5% chloride at the end portions and kept at 50°C (#1 and #2), the maximum corrosion of **-0.235** Volts was found after 2 years as compared to **-0.285** Volts at 30°C in the middle zero chloride portion of the same specimens (#5 and #6). However previously, much higher readings of these specimens were obtained on completion of one year observations [10]. The reason of this phenomenon could be the long term coupled effect of temperature and constant high humidity due to which the decline in corrosion potential after two years was significant. The results are shown in Figs. 5 and 6.
