Investigation of long term coupled effect of high temperature and constant high humidity on corrosion rehabilitated patches of reinforced concrete structures

Abstract

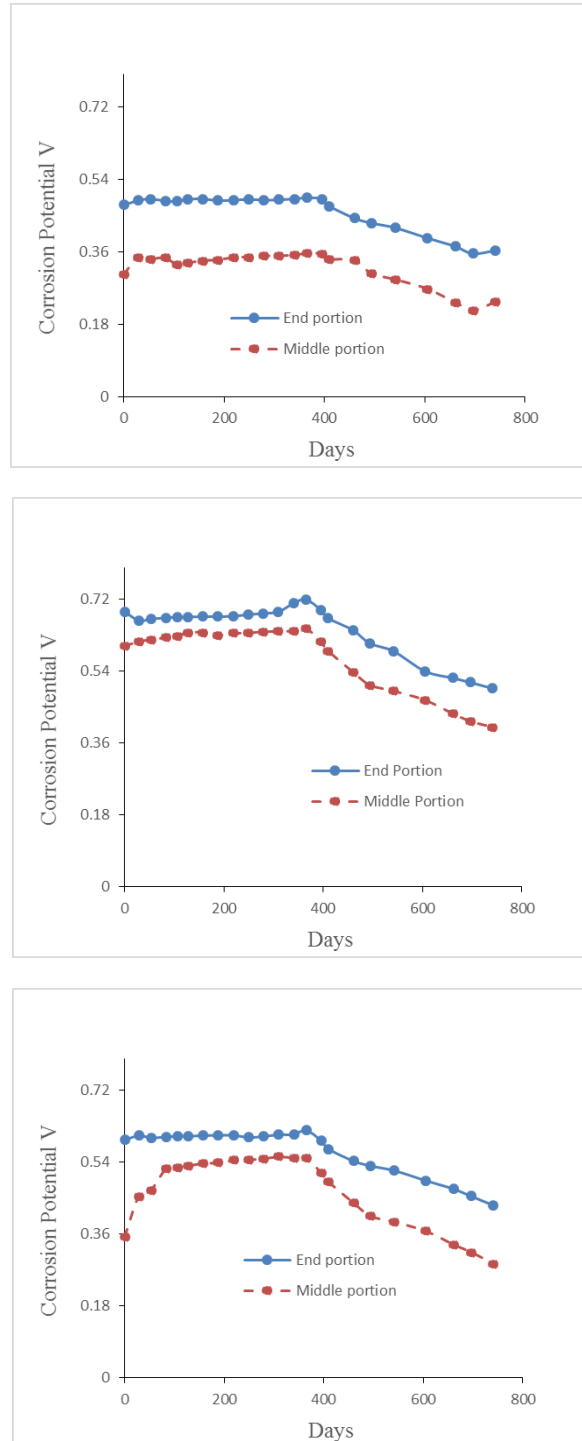
Fig. 5 (a-c) Corrosion potential measurement for 5% contaminated chloride specimen at the end kept at 30°C, 40°C and 50°C

1) At the middle non contaminated portion of the specimen having 5% chloride at the end portions and kept at 50°C (#1 and #2), the maximum corrosion of **-0.235** Volts was found after 2 years as compared to **-0.285** Volts at 30°C in the middle zero chloride portion of the same specimens (#5 and #6). However previously, much higher readings of these specimens were obtained on completion of one year observations [10]. The reason of this phenomenon could be the long term coupled effect of temperature and constant high humidity due to which the decline in corrosion potential after two years was significant. The results are shown in Figs. 5 and 6.

2) The maximum corrosion potential reading of the specimens #1 and #2 was found **-0.363** Volts as compared to high chloride induced potentials of **-0.432** Volts (figure 5) of the same specimens #5 and #6 at 30°C (figure 4)
