Experimental Studies on GFRP Repaired Hollow-Block Concrete Sections

Abstract: This study evaluates two different types of techniques for concrete hollow-block sections reinforced with traditional steel rebars and wire meshes, and compares their structural behaviour to that of an ordinary reinforced concrete beam section. The comparisons are based on the responses both before and after they were repaired with glass fibre reinforced polymers (GFRP). The specimens were subjected to concentrated loading up to initial failure. After failure, the specimens were repaired and loaded once again until ultimate failure. It was shown that the success of the repair by GFRP depended on the mode of failure of the hollow-block concrete beams.

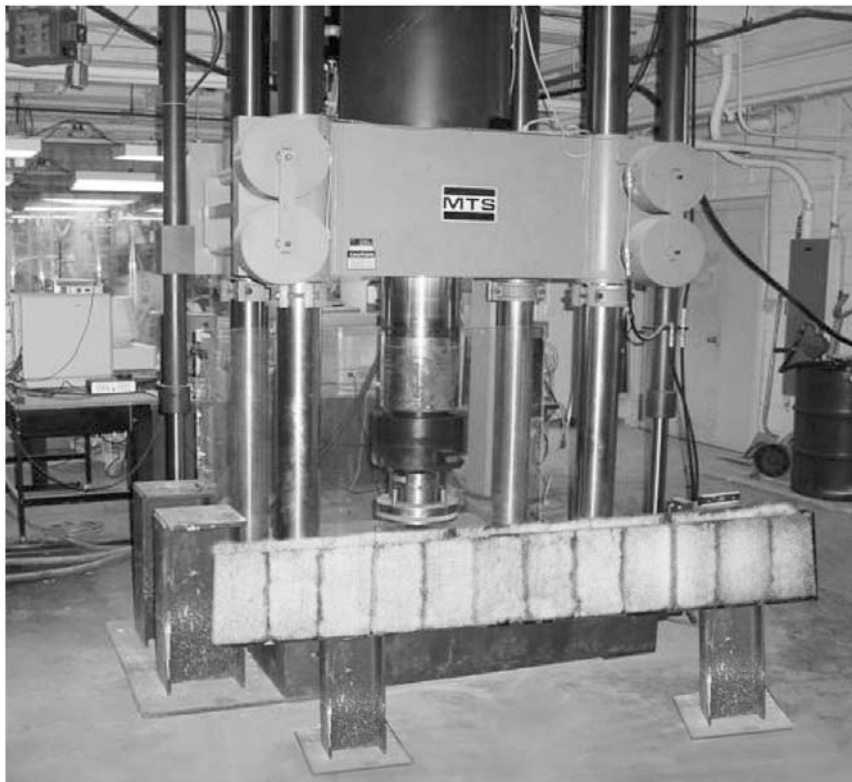
Fig.1 Test Set-up

concentrated load acting at mid-span, as shown in Fig 1.

The specimens were tested using a 980 kN Universal testing Machine; a dial gauge having a travel of 25 mm was used to record the vertical deflection at the bottom of the mid-span of the beam.

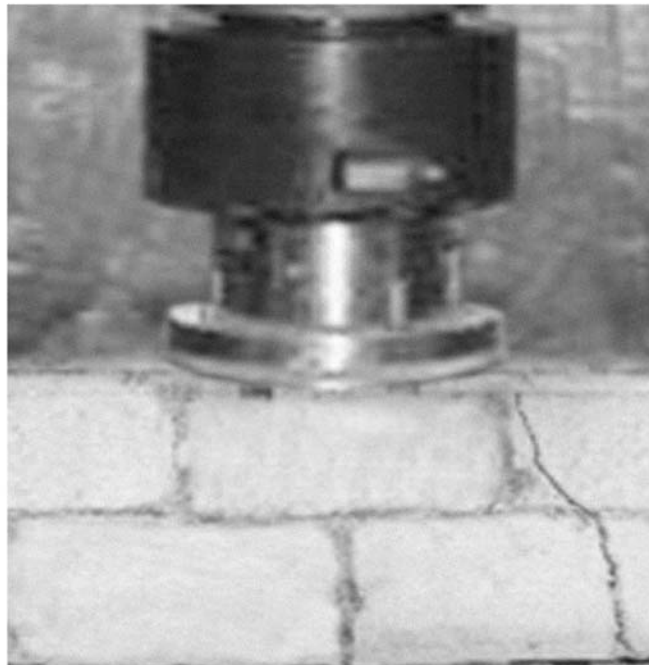
After the initial fracture, the cracks for both groups (small and long beams) opened relatively rapidly. In all cases of the beams failing in shear, the complete collapse of the specimens was prevented due to the dowel action of the reinforcing bars, as shown in Fig. 3.

Fig. 3 Shear Failure for Beam Tests

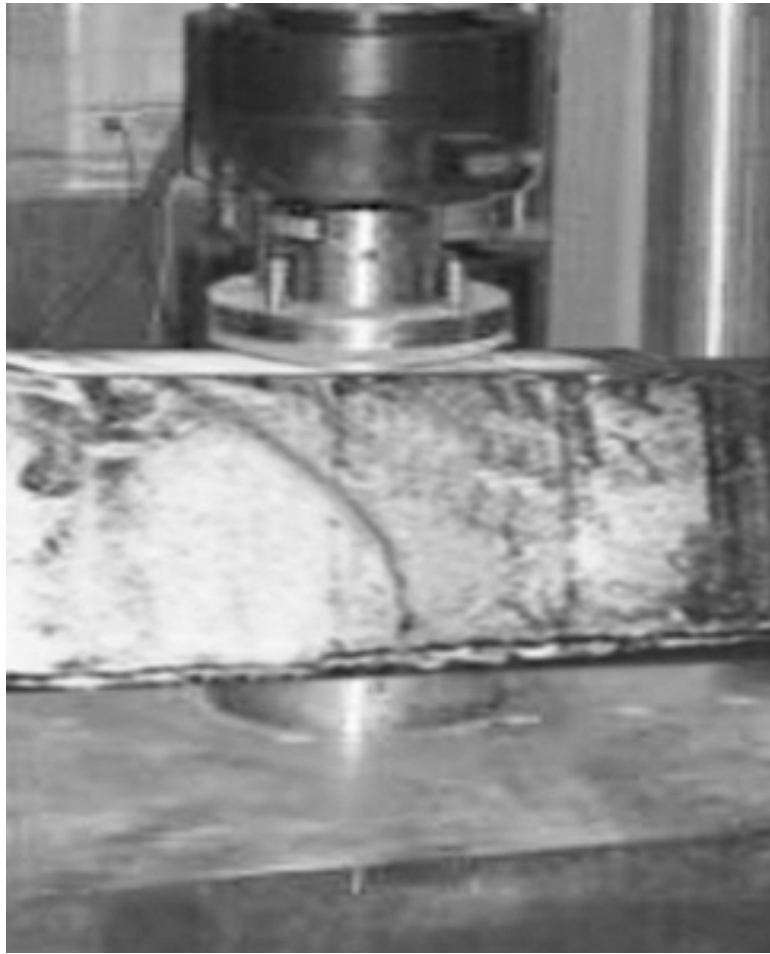
Fig. 4 Shear Failure of Beam with GFRP

For all the beam specimens repaired by GFRP sheets, it was observed that most of the crack patterns recorded was similar to those of the original beams. These cracks either resulted in fracture of the GFRP layer or resulted in its delamination from the two vertical sides of the beams, as shown in Fig. 4.

The ratios of the load carrying capacities of the beams after repair to their load carrying capacities before repair (P_{rep}/P_{vir}) are presented in column 7 of Table 1. It is seen that the ratio of restored load carrying capacities for the CB(S) and HBS(S) were 47% and 76%, respectively. The load carrying capacities of all the remaining beams were restored. CB(S) and HBS(S) failed at lower loads and higher deformations without having increased toughness. These beams failed in shear. This implies that the repair of shear damaged beams was not efficient.
