Experimental Studies on GFRP Repaired Hollow-Block Concrete Sections

Abstract: This study evaluates two different types of techniques for concrete hollow-block sections reinforced with traditional steel rebars and wire meshes, and compares their structural behaviour to that of an ordinary reinforced concrete beam section. The comparisons are based on the responses both before and after they were repaired with glass fibre reinforced polymers (GFRP). The specimens were subjected to concentrated loading up to initial failure. After failure, the specimens were repaired and loaded once again until ultimate failure. It was shown that the success of the repair by GFRP depended on the mode of failure of the hollow-block concrete beams.

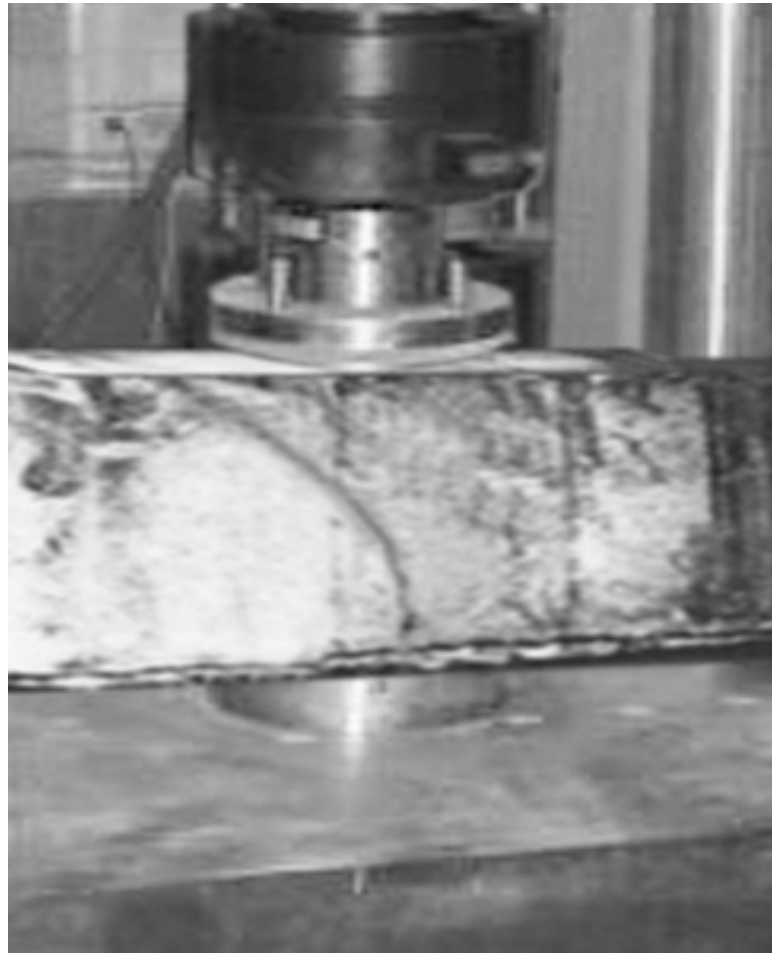
Fig. 4 Shear Failure of Beam with GFRP

For all the beam specimens repaired by GFRP sheets, it was observed that most of the crack patterns recorded was similar to those of the original beams. These cracks either resulted in fracture of the GFRP layer or resulted in its delamination from the two vertical sides of the beams, as shown in Fig. 4.

The ratios of the load carrying capacities of the beams after repair to their load carrying capacities before repair (P_{rep}/P_{vir}) are presented in column 7 of Table 1. It is seen that the ratio of restored load carrying capacities for the CB(S) and HBS(S) were 47% and 76%, respectively. The load carrying capacities of all the remaining beams were restored. CB(S) and HBS(S) failed at lower loads and higher deformations without having increased toughness. These beams failed in shear. This implies that the repair of shear damaged beams was not efficient.
