Experimental Studies on GFRP Repaired Hollow-Block Concrete Sections

Abstract: This study evaluates two different types of techniques for concrete hollow-block sections reinforced with traditional steel rebars and wire meshes, and compares their structural behaviour to that of an ordinary reinforced concrete beam section. The comparisons are based on the responses both before and after they were repaired with glass fibre reinforced polymers (GFRP). The specimens were subjected to concentrated loading up to initial failure. After failure, the specimens were repaired and loaded once again until ultimate failure. It was shown that the success of the repair by GFRP depended on the mode of failure of the hollow-block concrete beams.

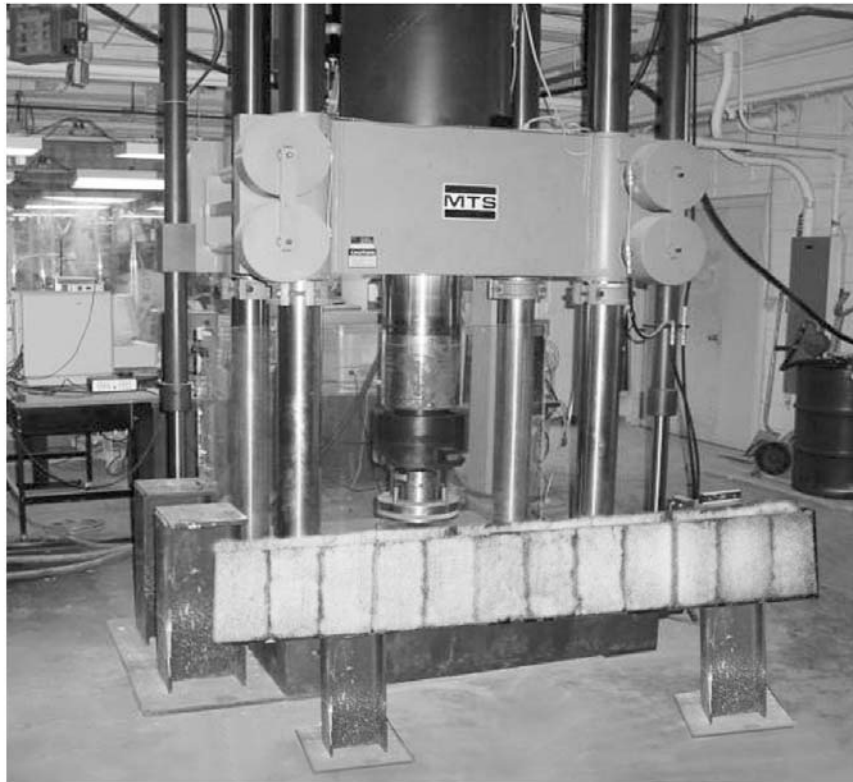
Fig.1 Test Set-up

concentrated load acting at mid-span, as shown in Fig 1.

The specimens were tested using a 980 kN Universal testing Machine; a dial gauge having a travel of 25 mm was used to record the vertical deflection at the bottom of the mid-span of the beam.

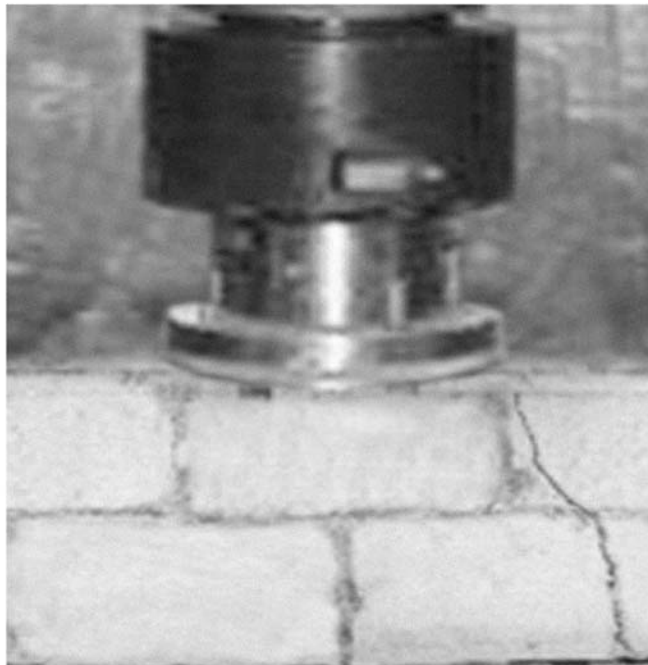
Fig. 3 Shear Failure for Beam Tests

After the initial fracture, the cracks for both groups (small and long beams) opened relatively rapidly. In all cases of the beams failing in shear, the complete collapse of the specimens was prevented due to the dowel action of the reinforcing bars, as shown in Fig. 3.

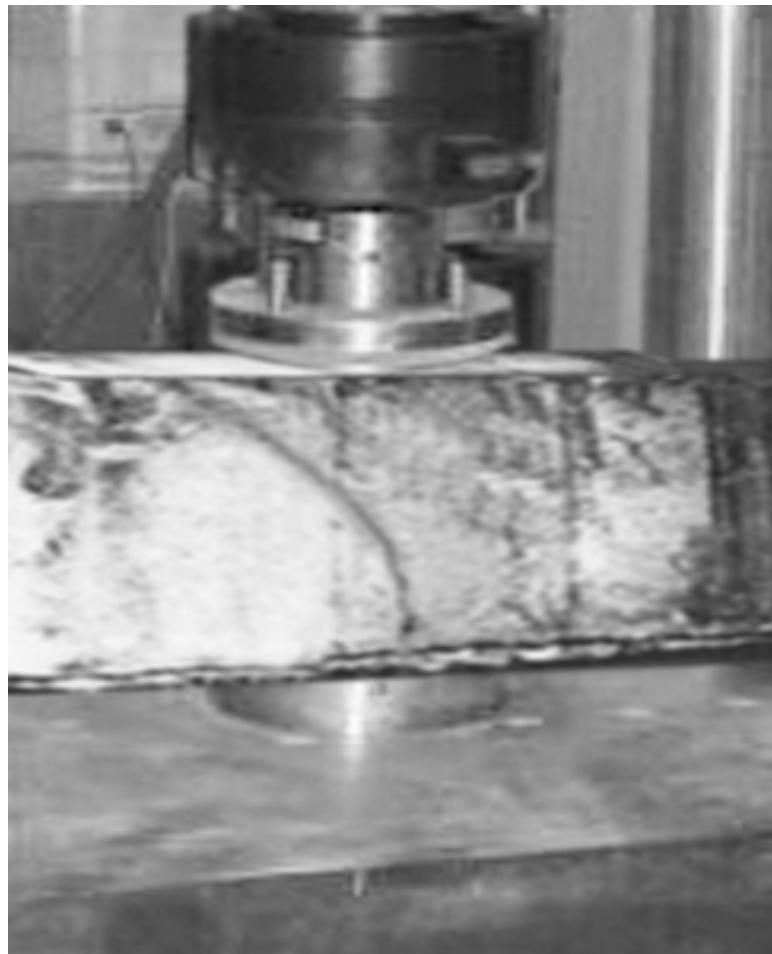
Fig. 4 Shear Failure of Beam with GFRP

For all the beam specimens repaired by GFRP sheets, it was observed that most of the crack patterns recorded was similar to those of the original beams. These cracks either resulted in fracture of the GFRP layer or resulted in its delamination from the two vertical sides of the beams, as shown in Fig. 4.

The ratios of the load carrying capacities of the beams after repair to their load carrying capacities before repair (P_{rep}/P_{vir}) are presented in column 7 of Table 1. It is seen that the ratio of restored load carrying capacities for the CB(S) and HBS(S) were 47% and 76%, respectively. The load carrying capacities of all the remaining beams were restored. CB(S) and HBS(S) failed at lower loads and higher deformations without having increased toughness. These beams failed in shear. This implies that the repair of shear damaged beams was not efficient.
