Technical Note

Repair effectiveness of CFRP and steel plates in RC beams with web opening: effect of plate thickness

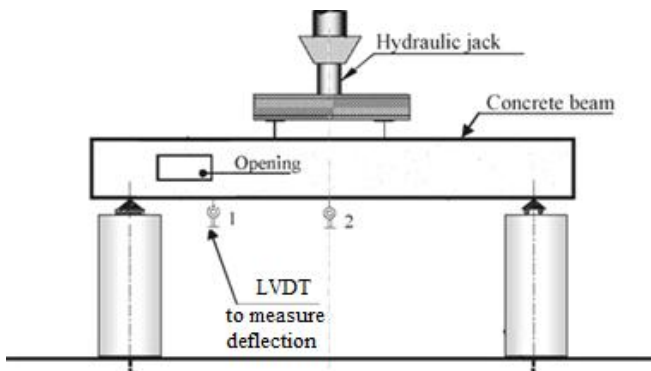
Fig. 1 Test set-up

All beams were tested as simple supported beams subjected to a four-point load, as illustrated in Fig. 1. A universal testing machine with 300 kN capacity was used in order to apply the load on a steel distribution I- beam, which was used to generate the two concentrated loads on the beam. The load was applied gradually with a speed of 4 kN/min and was then released with the same average. Two linear variable differential transformers (LVDT) were used in each test to monitor vertical deflection at two locations, edge of the opening and mid-span of the beam as shown in Fig. 1. For each beam, one strain gauge was attached to the main flexure steel bars below the opening, as shown in Fig. 2 (a). For all the beams, two strain gauges were attached directly to the CFRP and steel plate on the sides of beams to monitor strain variation in CFRP and steel plates, as shown in Fig. 2 (b). All the used electrical devices (load cell, LVDT, and strain gauges) are attached to the data logger in order to monitor the variation in load, deflection and train values, corresponding to applied loads. The readings were carried out at each 5 kN load step and up to the ultimate applied load. All the beams were subjected to failure load at the pre-repair stages. The beams were then unloaded by bringing back the loading to zero.

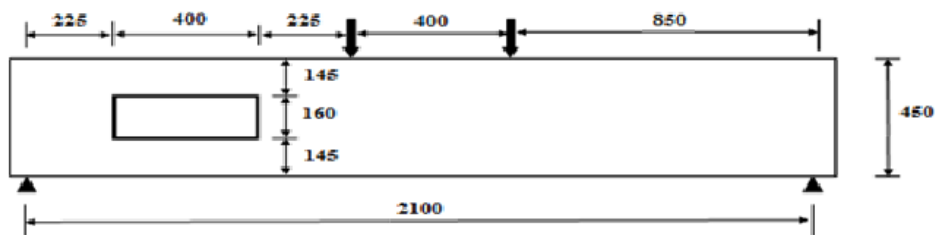
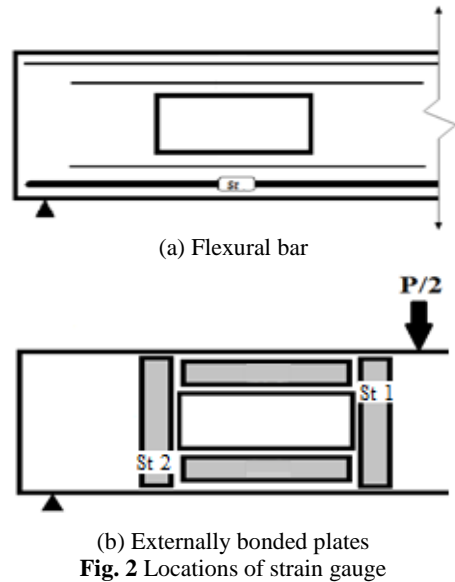
Fig. 2 Locations of strain gauge

The behaviour of load-strain relationship for externally bonded CFRP and steel plates is presented in this section. Strain gauge are fixed at two locations, one locations is on the opening corner near the support (ST2) and another location is at the opening corner near the point of applied load (ST1), as shown in Fig. 2(b). The load against strain curves for beams B1, B2, B3 and B4 are shown in Figs. 7, 8, 9 and 10, respectively. The recorded strains indicate that the value of strain for all beams did not reach the ultimate

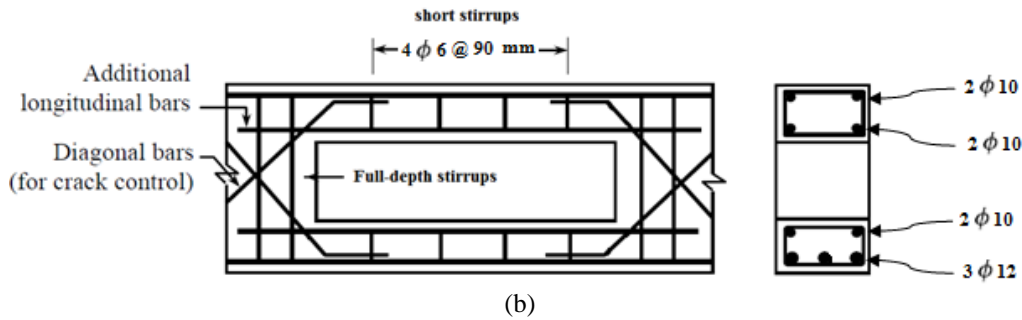
Fig. 3 Beams description, (a) Opening location, (b) Steel reinforcement at the opening

All the RC beams contain a large rectangular opening with a size of 160 × 400 (depth × width) mm. The opening was located at the mid of the shear span with a distance of 225 mm away from support and 225 mm away from the concentrated load. The distance between the two concentrated loads is 400 mm and the shear span is 850 mm, as shown in Fig. 3 (a). Beams with an opening were designed according to the plastic hinge method, [17]. The beams were reinforced with three steel bars with a diameter of 12 mm as a major reinforcement in the tension zone and two of a 10 mm diameter at the compression zone. Additional longitudinal bars were provided as two 10 mm diameter steel bars at the top and bottom chords of the opening, and diagonal bars for crack control were also added at the corner of the opening. Steel stirrups of a 6 mm diameter were used at 90 mm spacing along the top and bottom chords.

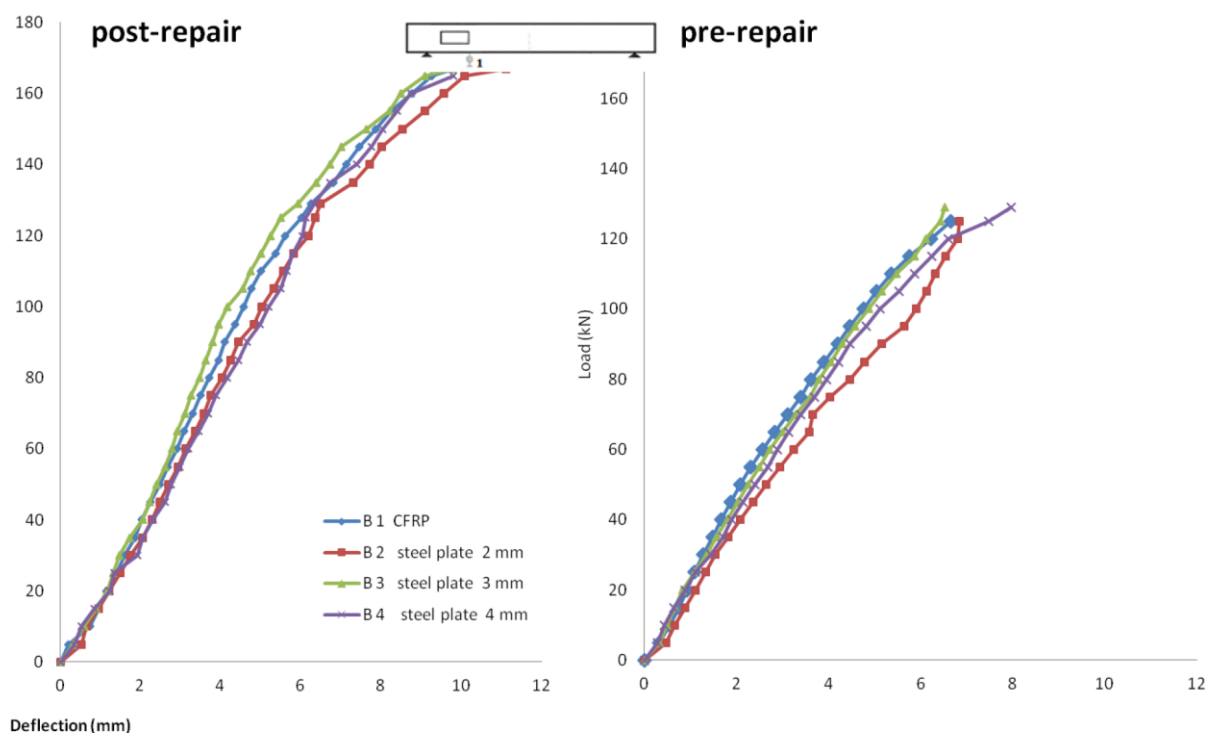
**Fig. 4** Load–deflection curves at the edge of the opening at pre and post repair stages

The beam B2, which was repaired by a steel plate with a thickness of 2mm, shows an effect on deflection at the edge of the opening, where at load of 128 kN the deflection is 6.98 mm and 6.49 mm at pre and post repair stages, respectively. For beam B3, good effect on the load capacity and a good effect on deflection were proved. The highest value of deflection was 6.52 mm obtained at the edge of the opening and it was at the pre-repaired stage at a failure load of 129 kN. However, at the post-repair stage, the deflection for the same load of 129 kN was 5.92 mm. As shown in Fig. 4, which shows the load against deflection at edge of opening curves at pre and post repair stages, the highest effect on deflection was for beams B1 and B4, while the lowest effect on deflection was for beam B2. The value of deflection for beam B1 at the pre-repair stage was 6.58 mm at a failure load of 125.2 kN, while the deflection was 5.95 mm at the post-repair stage at the same load of 125.2 kN.

For beam B3, the value of deflection at the pre-repair stage at failure load of 129 kN was 6.35 mm, while at post-repair stage it was 5.85 mm at the same load of 128 kN. The value of deflection for beam B4 at the pre-repair stage was 6.74 mm at a failure load of 129.3 kN, while at the post-repair stage the deflection was 6.14 mm at the same load of 129.3 kN. The result shows that the influence of steel plates on deflection at the edge of the opening increases with the increase in steel plate thickness. The results indicate that the CFRP and steel plates have good effectiveness in reducing the deflection for the repaired beams at the edge of the opening and mid-span of the beam. From Fig. 5, which shows the load against deflection at mid-span curves at pre and post repair stages, it can be seen that curves for repaired beams show

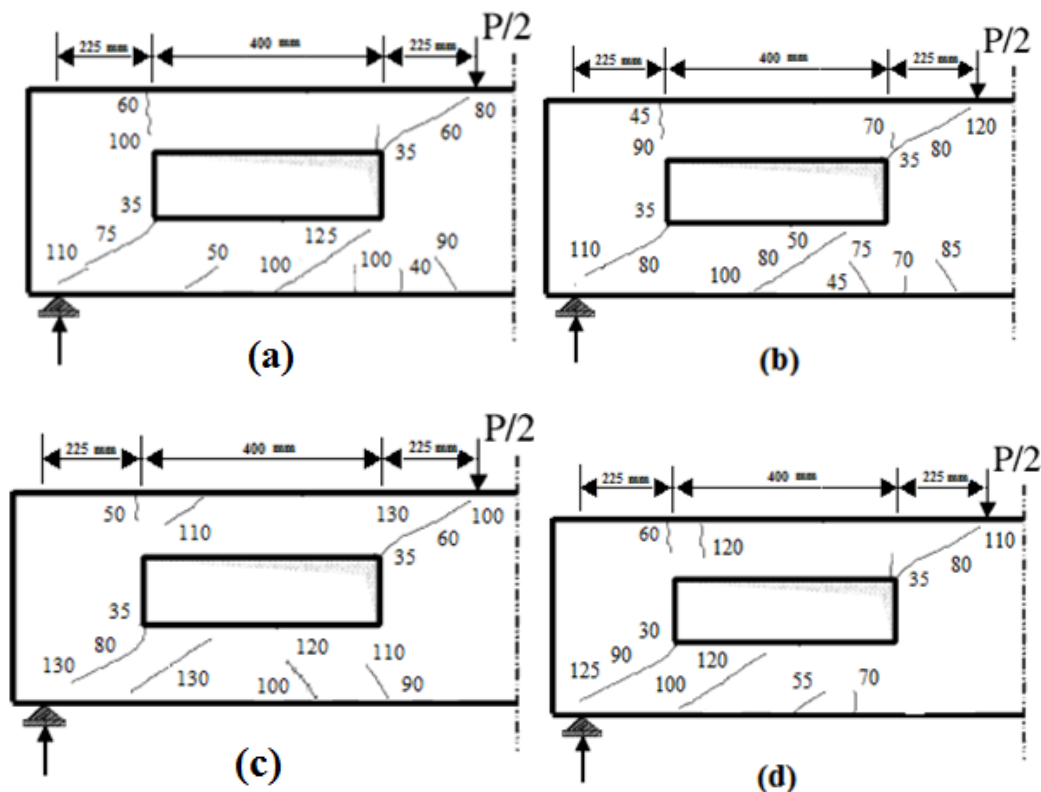
Fig. 11 Crack patterns and failure modes of beams at the pre-repair stage (a) Beam B1, (b) Beam B2, (c) Beam B3, (d) Beam B4

The crack pattern and the failure modes for all beams at pre and post repair stages are presented in this section. Figs. 11 and 12 show the crack pattern and the failure mode for all the beams at the pre and post repair stages, respectively. The failure modes of all the beams are similar because the failure occurs due to failure in concrete as diagonal shear failure before the externally bonded plates reach the ultimate strain. It can be seen from Fig. 11 (b) that the first diagonal crack for beam B2 was observed at the corner of the opening at a load of 35 kN; additional cracks were formed with the increase of the applied load. Failure of the beam occurred when the total applied load reached 128 kN. At the post-repair stage, many cracks were formed at the solid span of the beam, and the failure of the beam occurred at a load of 163.4 kN. At failure, concrete diagonal shear failure was observed around the

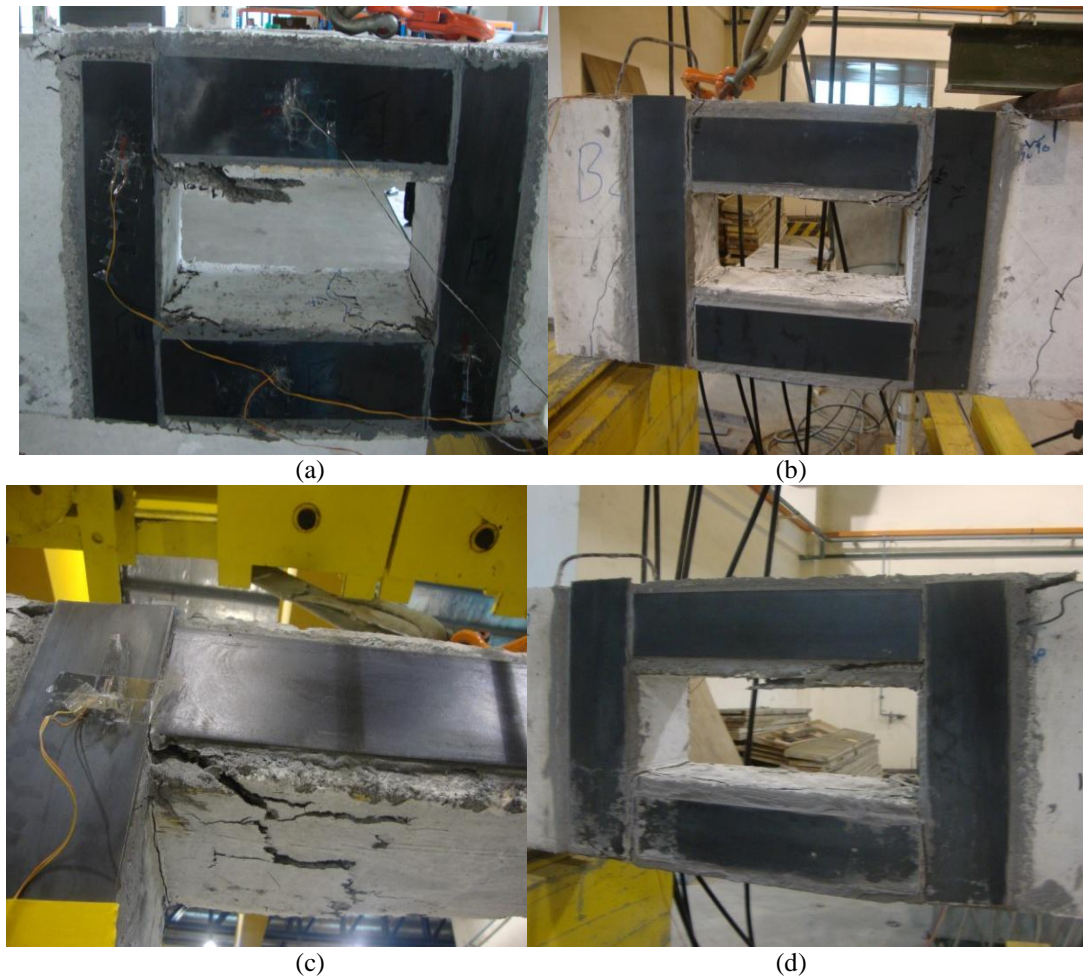
Fig. 12 Failure modes of beams at the post-repair stage (a) Beam B1, (b) Beam B2, (c) Beam B3, (d) Beam B4

opening, as shown in Fig. 12 (b).

This mode of failure is called splitting failure, which is due to relatively high longitudinal compressive stress developed at the top of the chords, which created transverse tension, and led to splitting failure, as according to Khalifa and Nanni [22]. The CFRP sheet did not fracture or debond from the concrete surface at the ultimate load. As can be seen from Fig. 11 (d), the first diagonal crack for beam B4 was observed at the corner of the opening at a load of 35 kN, additional cracks were formed with the increase of the applied load. Failure of the beam occurred when the total applied load reached 129.3 kN. As shown in Fig. 12 (d) for beam B4 at the post-repair stage, many cracks were formed at the solid span of the beam and the failure of the beam occurred at a load of 170 kN. At failure, crushing of the concrete was observed on the top and bottom face of the chord members, due to high compressive stress in concrete before the externally bonded plates reach the maximum strain.
