Technical Note

Repair effectiveness of CFRP and steel plates in RC beams with web opening: effect of plate thickness

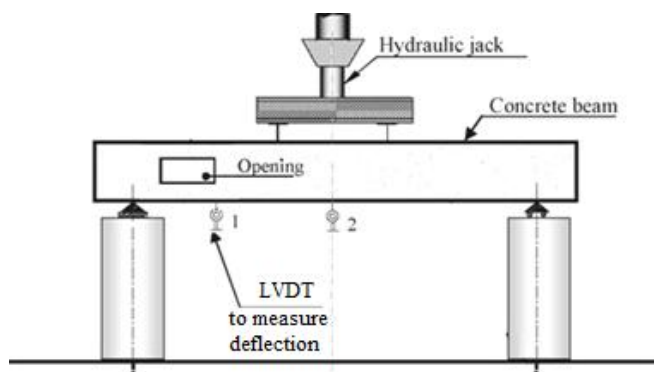
Fig. 1 Test set-up

All beams were tested as simple supported beams subjected to a four-point load, as illustrated in Fig. 1. A universal testing machine with 300 kN capacity was used in order to apply the load on a steel distribution I- beam, which was used to generate the two concentrated loads on the beam. The load was applied gradually with a speed of 4 kN/min and was then released with the same average. Two linear variable differential transformers (LVDT) were used in each test to monitor vertical deflection at two locations, edge of the opening and mid-span of the beam as shown in Fig. 1. For each beam, one strain gauge was attached to the main flexure steel bars below the opening, as shown in Fig. 2 (a). For all the beams, two strain gauges were attached directly to the CFRP and steel plate on the sides of beams to monitor strain variation in CFRP and steel plates, as shown in Fig. 2 (b). All the used electrical devices (load cell, LVDT, and strain gauges) are attached to the data logger in order to monitor the variation in load, deflection and strain values, corresponding to applied loads. The readings were carried out at each 5 kN load step and up to the ultimate applied load. All the beams were subjected to failure load at the pre-repair stages. The beams were then unloaded by bringing back the loading to zero.

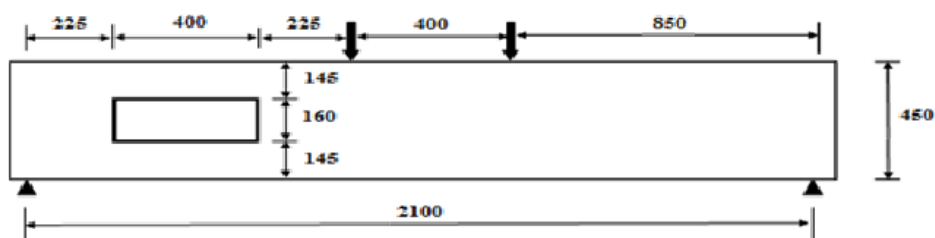
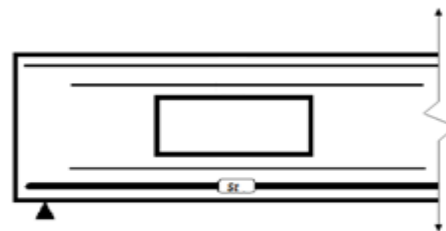
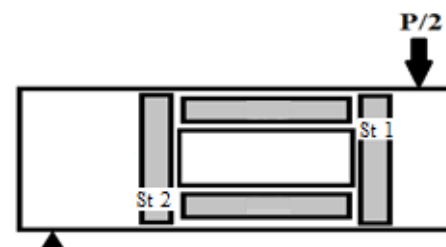
(b) Externally bonded plates
Fig. 2 Locations of strain gauge

The load-strain relationship of steel reinforcement is presented in this section. The strain gauge (St) was attached onto the main steel reinforcement bar at the middle of the opening in the bottom chord. Fig. 6 shows the load against steel bar strain of the strain gauge (St) at the pre and post repair stages. For all the beams at the pre-repair stage, the strain gauge (St) shows an increase in strain value with the

The behaviour of load-strain relationship for externally bonded CFRP and steel plates is presented in this section. Strain gauge are fixed at two locations, one locations is on the opening corner near the support (ST2) and another location is at the opening corner near the point of applied load (ST1), as shown in Fig. 2(b). The load against strain curves for beams B1, B2, B3 and B4 are shown in Figs. 7, 8, 9 and 10, respectively. The recorded strains indicate that the value of strain for all beams did not reach the ultimate

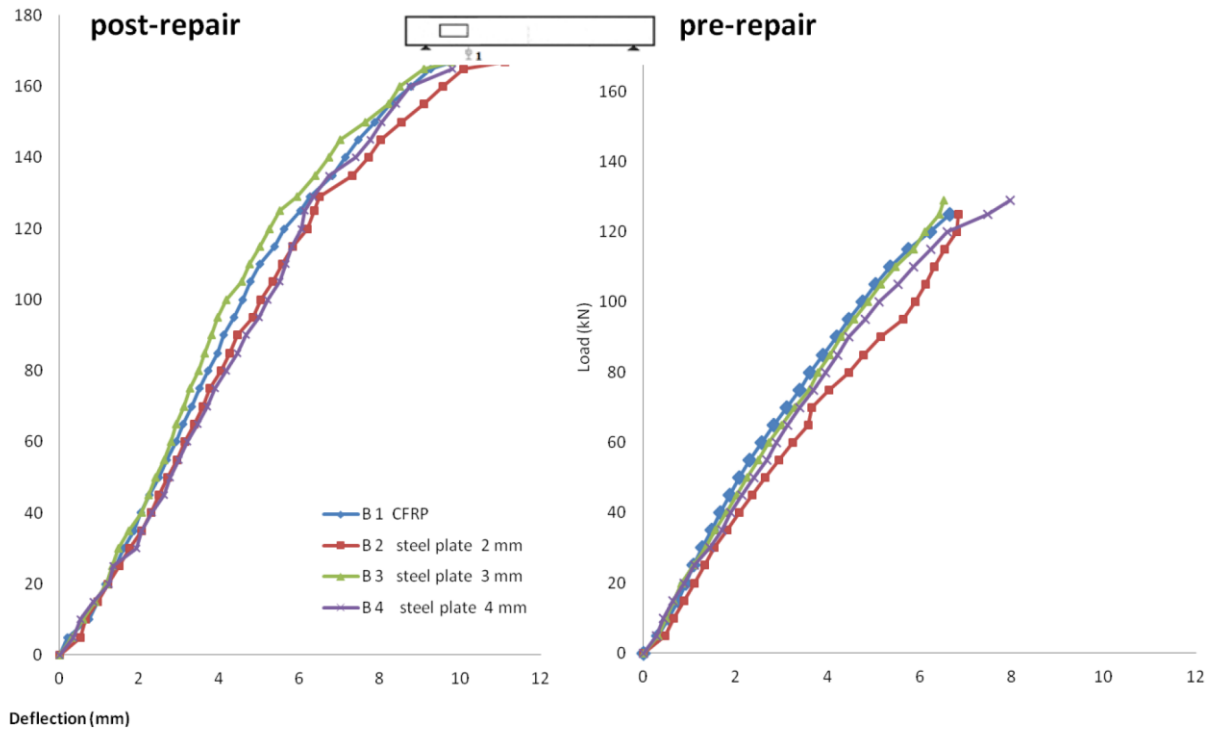
Fig. 4 Load–deflection curves at the edge of the opening at pre and post repair stages

The load-deflection relationship at the mid span and below the edge of the opening is presented in this section. All the beams showed lower deflection at the mid span as compared to the deflection at the edge of the opening. For deflection at the edge of the opening, the reduction in deflection values found to be 10 % for CFRP, as shown in Table 4. For steel plates, the reductions in deflection were 7 %, 9 %, and 10 % for thicknesses of 2 mm, 3 mm and 4 mm, respectively. Thus, it is clear that the externally bonded plates applied around the web opening are capable of reducing 10 % of the deflection at pre-repair stage.

The beam B2, which was repaired by a steel plate with a thickness of 2mm, shows an effect on deflection at the edge of the opening, where at load of 128 kN the deflection is 6.98 mm and 6.49 mm at pre and post repair stages, respectively. For beam B3, good effect on the load capacity and a good effect on deflection were proved. The highest value of deflection was 6.52 mm obtained at the edge of the opening and it was at the pre-repaired stage at a failure load of 129 kN. However, at the post-repair stage, the deflection for the same load of 129 kN was 5.92 mm. As shown in Fig. 4, which shows the load against deflection at edge of opening curves at pre and post repair stages, the highest effect on deflection was for beams B1 and B4, while the lowest effect on deflection was for beam B2. The value of deflection for beam B1 at the pre-repair stage was 6.58 mm at a failure load of 125.2 kN, while the deflection was 5.95 mm at the post-repair stage at the same load of 125.2 kN.

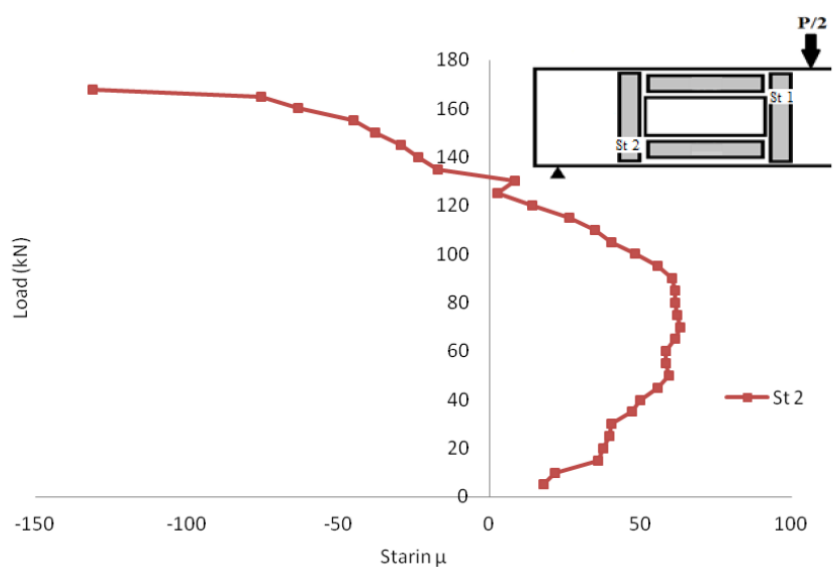
Fig. 8 Load against strain of externally bonded steel plate of beam B2

strain of CFRP and steel plates. This is due to the fact that the concrete failed before allowing the repair materials to reach the ultimate strain values. It can be observed from Figs. 7 to 10 that the externally bonded plates start to share the strain in the beam from the start of the applied load. The results are in agreement with Khalifa and Intomio [20], who found that the maximum CFRP vertical strain measured at failure corresponded to 14 % of the reported CFRP ultimate strain. This value is not absolute, because it greatly depends on the location of the strain gauge with respect to a crack.

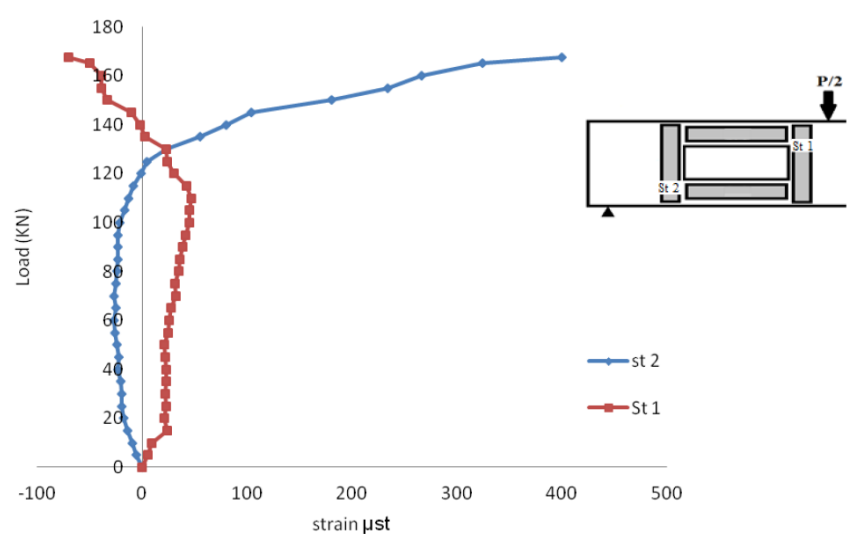
Fig. 9 Load against strain of externally bonded steel plates of beam B3

As can be seen from Fig. 7, for beam B1 the maximum CFRP strain measured at failure was in strain ST1. For beam B3, the steel plate strain measured at failure was deferent at each location, because the value of the strain greatly depends on the location of the strain gauge with respect to a crack, as shown in Fig. 9. It can be observed from Fig. 10 that for beam B4, the maximum CFRP strain measured at failure was in strain ST1, on the bottom chord of the opening. CFRP and steel plates were not fractured or debonded from the concrete surface, and this ultimately indicates that CFRP and steel plates could provide additional strength if the beams did not fail by concrete diagonal shear cracks.

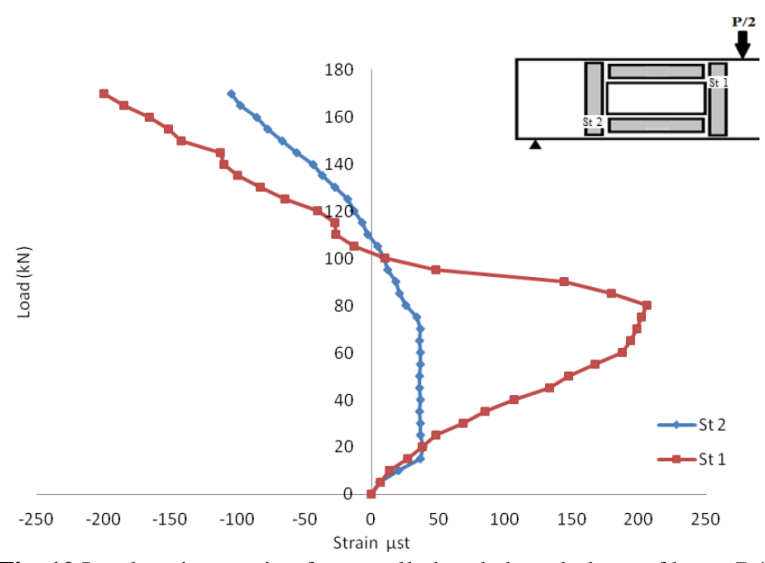
Fig. 10 Load against strain of externally bonded steel plates of beam B4

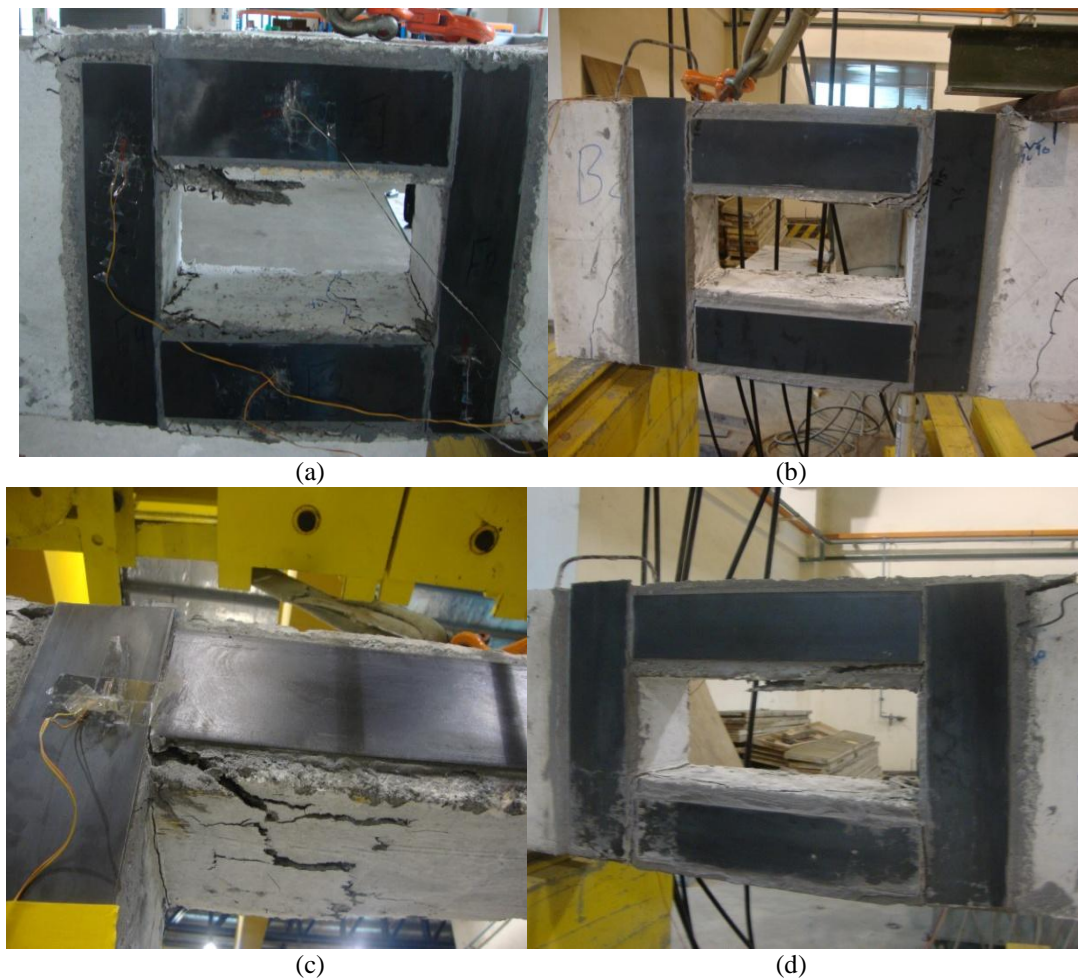
Fig. 12 Failure modes of beams at the post-repair stage (a) Beam B1, (b) Beam B2, (c) Beam B3, (d) Beam B4

The crack pattern and the failure modes for all beams at pre and post repair stages are presented in this section. Figs. 11 and 12 show the crack pattern and the failure mode for all the beams at the pre and post repair stages, respectively. The failure modes of all the beams are similar because the failure occurs due to failure in concrete as diagonal shear failure before the externally bonded plates reach the ultimate strain. It can be seen from Fig. 11 (b) that the first diagonal crack for beam B2 was observed at the corner of the opening at a load of 35 kN; additional cracks were formed with the increase of the applied load. Failure of the beam occurred when the total applied load reached 128 kN. At the post-repair stage, many cracks were formed at the solid span of the beam, and the failure of the beam occurred at a load of 163.4 kN. At failure, concrete diagonal shear failure was observed around the

opening, as shown in Fig. 12 (b).

This mode of failure is called splitting failure, which is due to relatively high longitudinal compressive stress developed at the top of the chords, which created transverse tension, and led to splitting failure, as according to Khalifa and Nanni [22]. The CFRP sheet did not fracture or debond from the concrete surface at the ultimate load. As can be seen from Fig. 11 (d), the first diagonal crack for beam B4 was observed at the corner of the opening at a load of 35 kN, additional cracks were formed with the increase of the applied load. Failure of the beam occurred when the total applied load reached 129.3 kN. As shown in Fig. 12 (d) for beam B4 at the post-repair stage, many cracks were formed at the solid span of the beam and the failure of the beam occurred at a load of 170 kN. At failure, crushing of the concrete was observed on the top and bottom face of the chord members, due to high compressive stress in concrete before the externally bonded plates reach the maximum strain.
