Technical Note

Repair effectiveness of CFRP and steel plates in RC beams with web opening: effect of plate thickness

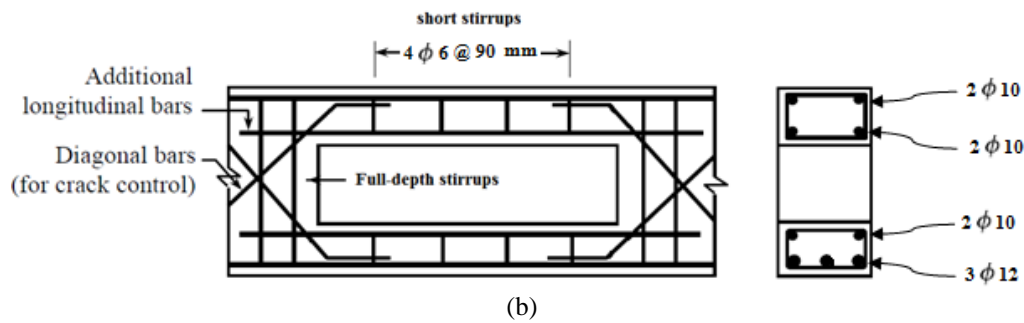
Fig. 3 Beams description, (a) Opening location, (b) Steel reinforcement at the opening

All the RC beams contain a large rectangular opening with a size of 160 × 400 (depth × width) mm. The opening was located at the mid of the shear span with a distance of 225 mm away from support and 225 mm away from the concentrated load. The distance between the two concentrated loads is 400 mm and the shear span is 850 mm, as shown in Fig. 3 (a). Beams with an opening were designed according to the plastic hinge method, [17]. The beams were reinforced with three steel bars with a diameter of 12 mm as a major reinforcement in the tension zone and two of a 10 mm diameter at the compression zone. Additional longitudinal bars were provided as two 10 mm diameter steel bars at the top and bottom chords of the opening, and diagonal bars for crack control were also added at the corner of the opening. Steel stirrups of a 6 mm diameter were used at 90 mm spacing along the top and bottom chords.

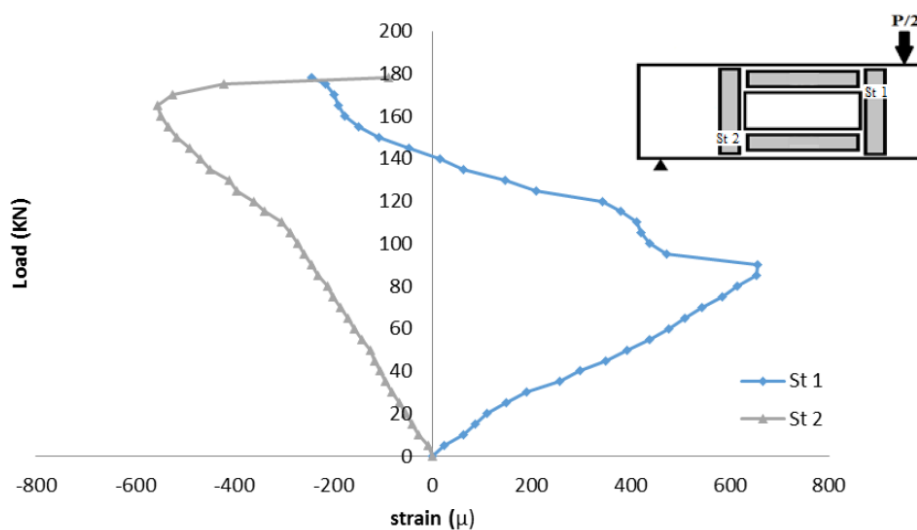
Fig. 7 Load against strain of externally bonded CFRP plates of beam B1

As can be seen from Fig. 7, for beam B1 the maximum CFRP strain measured at failure was in strain ST1. For beam B3, the steel plate strain measured at failure was deferent at each location, because the value of the strain greatly depends on the location of the strain gauge with respect to a crack, as shown in Fig. 9. It can be observed from Fig. 10 that for beam B4, the maximum CFRP strain measured at failure was in strain ST1, on the bottom chord of the opening. CFRP and steel plates were not fractured or debonded from the concrete surface, and this ultimately indicates that CFRP and steel plates could provide additional strength if the beams did not fail by concrete diagonal shear cracks.

The behaviour of load-strain relationship for externally bonded CFRP and steel plates is presented in this section. Strain gauge are fixed at two locations , one locations is on the opening corner near the support (ST2) and another location is at the opening corner near the point of applied load (ST1), as shown in Fig. 2(b). The load against strain curves for beams B1, B2, B3 and B4 are shown in Figs. 7, 8, 9 and 10, respectively. The recorded strains indicate that the value of strain for all beams did not reach the ultimate

strain of CFRP and steel plates. This is due to the fact that the concrete failed before allowing the repair materials to reach the ultimate strain values. It can be observed from Figs. 7 to 10 that the externally bonded plates start to share the strain in the beam from the start of the applied load. The results are in agreement with Khalifa and Intomio [20], who found that the maximum CFRP vertical strain measured at failure corresponded to 14 % of the reported CFRP ultimate strain. This value is not absolute, because it greatly depends on the location of the strain gauge with respect to a crack.
