Technical Note

Repair effectiveness of CFRP and steel plates in RC beams with web opening: effect of plate thickness

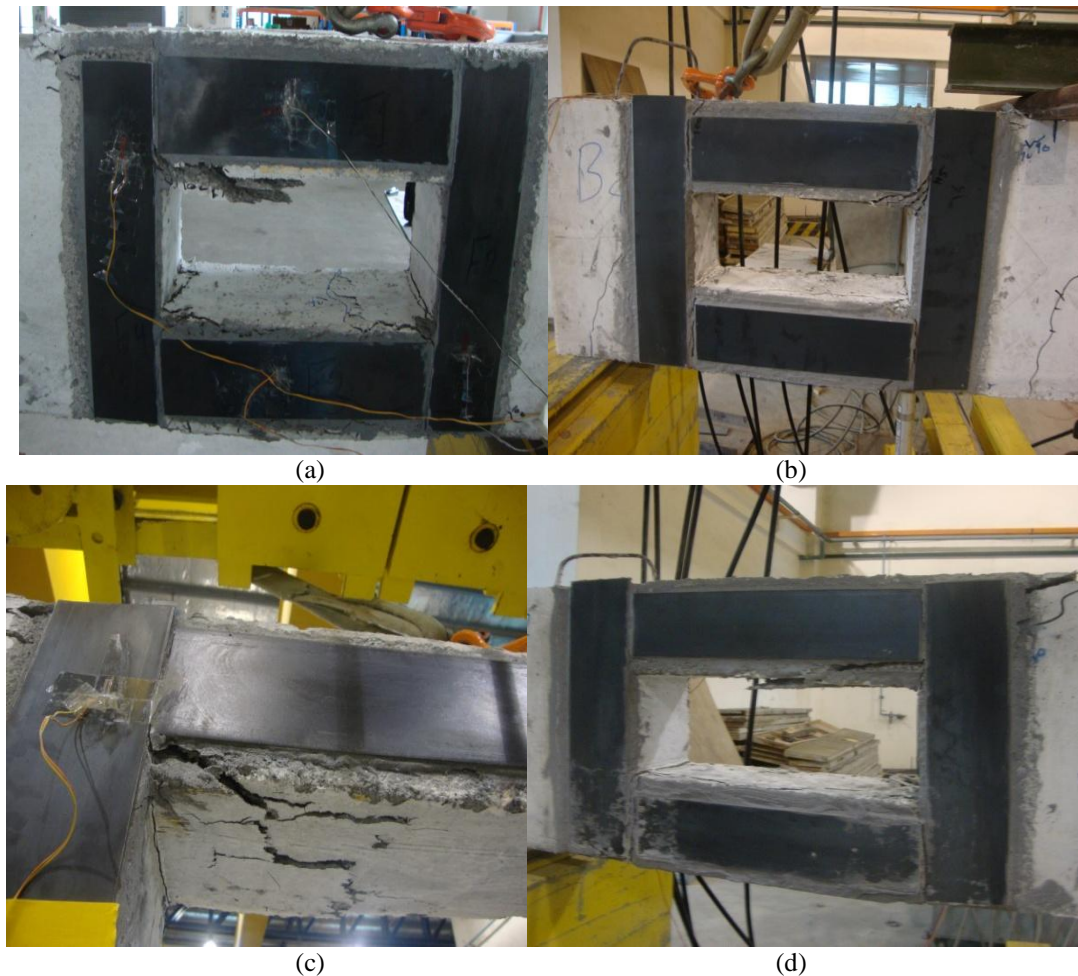
Fig. 12 Failure modes of beams at the post-repair stage (a) Beam B1, (b) Beam B2, (c) Beam B3, (d) Beam B4

The crack pattern and the failure modes for all beams at pre and post repair stages are presented in this section. Figs. 11 and 12 show the crack pattern and the failure mode for all the beams at the pre and post repair stages, respectively. The failure modes of all the beams are similar because the failure occurs due to failure in concrete as diagonal shear failure before the externally bonded plates reach the ultimate strain. It can be seen from Fig. 11 (b) that the first diagonal crack for beam B2 was observed at the corner of the opening at a load of 35 kN; additional cracks were formed with the increase of the applied load. Failure of the beam occurred when the total applied load reached 128 kN. At the post-repair stage, many cracks were formed at the solid span of the beam, and the failure of the beam occurred at a load of 163.4 kN. At failure, concrete diagonal shear failure was observed around the

opening, as shown in Fig. 12 (b).

This mode of failure is called splitting failure, which is due to relatively high longitudinal compressive stress developed at the top of the chords, which created transverse tension, and led to splitting failure, as according to Khalifa and Nanni [22]. The CFRP sheet did not fracture or debond from the concrete surface at the ultimate load. As can be seen from Fig. 11 (d), the first diagonal crack for beam B4 was observed at the corner of the opening at a load of 35 kN, additional cracks were formed with the increase of the applied load. Failure of the beam occurred when the total applied load reached 129.3 kN. As shown in Fig. 12 (d) for beam B4 at the post-repair stage, many cracks were formed at the solid span of the beam and the failure of the beam occurred at a load of 170 kN. At failure, crushing of the concrete was observed on the top and bottom face of the chord members, due to high compressive stress in concrete before the externally bonded plates reach the maximum strain.
