Technical Note

Repair effectiveness of CFRP and steel plates in RC beams with web opening: effect of plate thickness

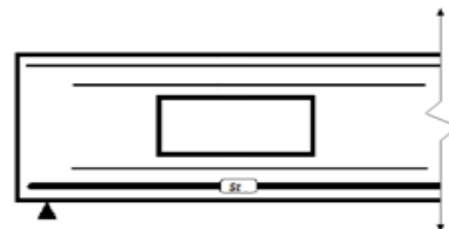
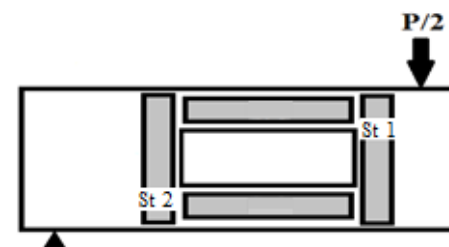
(a) Flexural bar

(b) Externally bonded plates
Fig. 2 Locations of strain gauge

The load-strain relationship of steel reinforcement is presented in this section. The strain gauge (St) was attached onto the main steel reinforcement bar at the middle of the opening in the bottom chord. Fig. 6 shows the load against steel bar strain of the strain gauge (St) at the pre and post repair stages. For all the beams at the pre-repair stage, the strain gauge (St) shows an increase in strain value with the

The behaviour of load-strain relationship for externally bonded CFRP and steel plates is presented in this section. Strain gauge are fixed at two locations , one locations is on the opening corner near the support (ST2) and another location is at the opening corner near the point of applied load (ST1), as shown in Fig. 2(b). The load against strain curves for beams B1, B2, B3 and B4 are shown in Figs. 7, 8, 9 and 10, respectively. The recorded strains indicate that the value of strain for all beams did not reach the ultimate

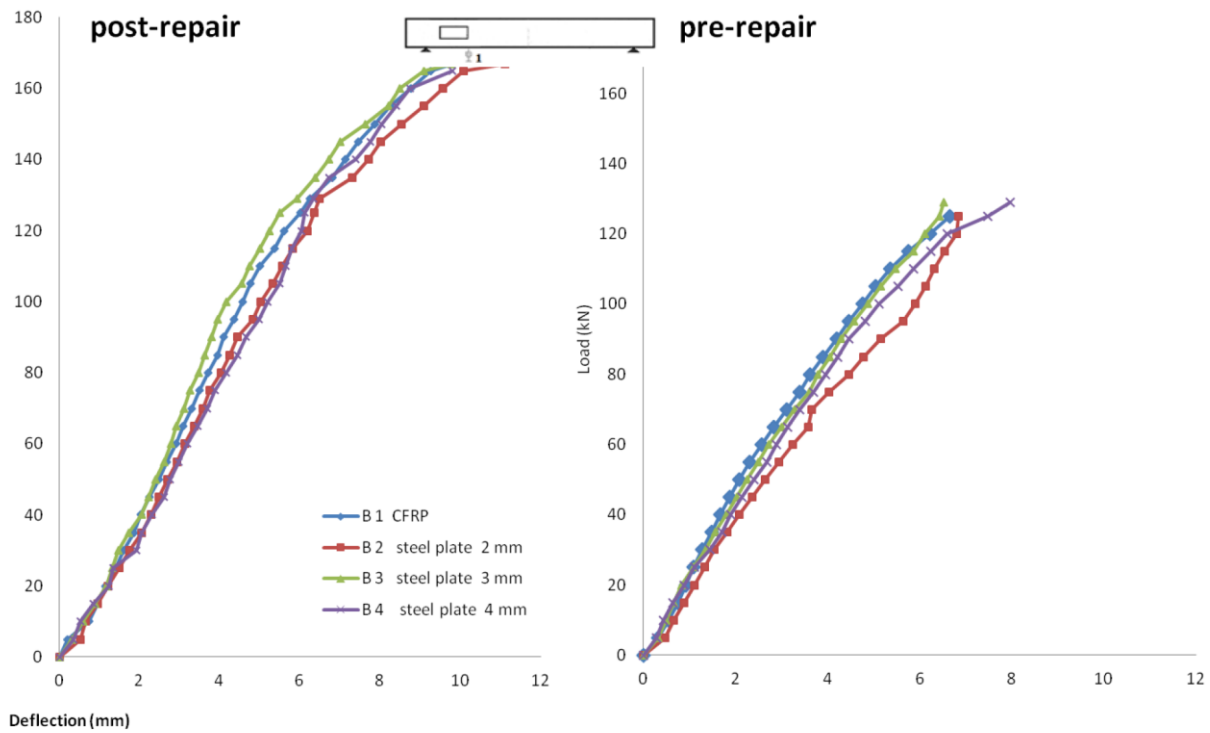
Fig. 4 Load–deflection curves at the edge of the opening at pre and post repair stages

The load-deflection relationship at the mid span and below the edge of the opening is presented in this section. All the beams showed lower deflection at the mid span as compared to the deflection at the edge of the opening. For deflection at the edge of the opening, the reduction in deflection values found to be 10 % for CFRP, as shown in Table 4. For steel plates, the reductions in deflection were 7 %, 9 %, and 10 % for thicknesses of 2 mm, 3 mm and 4 mm, respectively. Thus, it is clear that the externally bonded plates applied around the web opening are capable of reducing 10 % of the deflection at pre-repair stage.

The beam B2, which was repaired by a steel plate with a thickness of 2mm, shows an effect on deflection at the edge of the opening, where at load of 128 kN the deflection is 6.98 mm and 6.49 mm at pre and post repair stages, respectively. For beam B3, good effect on the load capacity and a good effect on deflection were proved. The highest value of deflection was 6.52 mm obtained at the edge of the opening and it was at the pre-repaired stage at a failure load of 129 kN. However, at the post-repair stage, the deflection for the same load of 129 kN was 5.92 mm. As shown in Fig. 4, which shows the load against deflection at edge of opening curves at pre and post repair stages, the highest effect on deflection was for beams B1 and B4, while the lowest effect on deflection was for beam B2. The value of deflection for beam B1 at the pre-repair stage was 6.58 mm at a failure load of 125.2 kN, while the deflection was 5.95 mm at the post-repair stage at the same load of 125.2 kN.
