## Technical Note

# Repair effectiveness of CFRP and steel plates in RC beams with web opening: effect of plate thickness

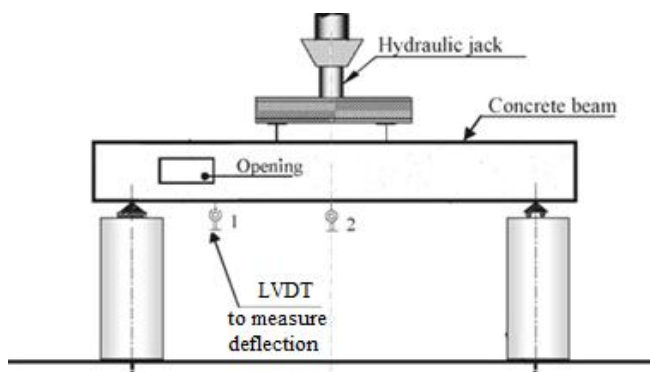
Fig. 1 Test set-up

All beams were tested as simple supported beams subjected to a four-point load, as illustrated in Fig. 1. A universal testing machine with 300 kN capacity was used in order to apply the load on a steel distribution I- beam, which was used to generate the two concentrated loads on the beam. The load was applied gradually with a speed of 4 kN/min and was then released with the same average. Two linear variable differential transformers (LVDT) were used in each test to monitor vertical deflection at two locations, edge of the opening and mid-span of the beam as shown in Fig. 1. For each beam, one strain gauge was attached to the main flexure steel bars below the opening, as shown in Fig. 2 (a). For all the beams, two strain gauges were attached directly to the CFRP and steel plate on the sides of beams to monitor strain variation in CFRP and steel plates, as shown in Fig. 2 (b). All the used electrical devices (load cell, LVDT, and strain gauges) are attached to the data logger in order to monitor the variation in load, deflection and strain values, corresponding to applied loads. The readings were carried out at each 5 kN load step and up to the ultimate applied load. All the beams were subjected to failure load at the pre-repair stages. The beams were then unloaded by bringing back the loading to zero.

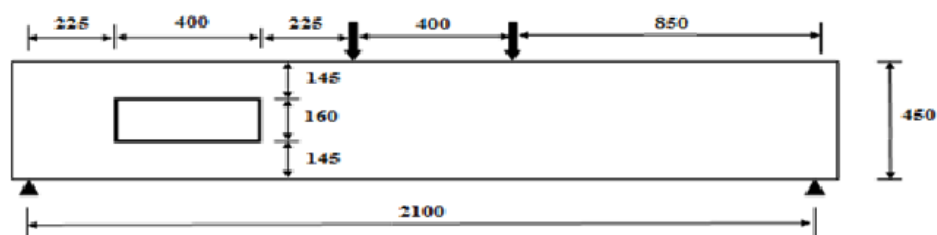
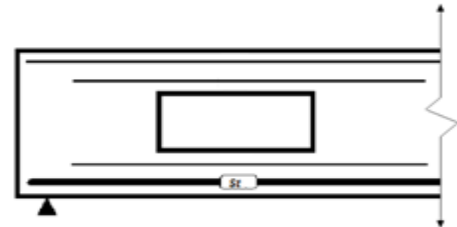
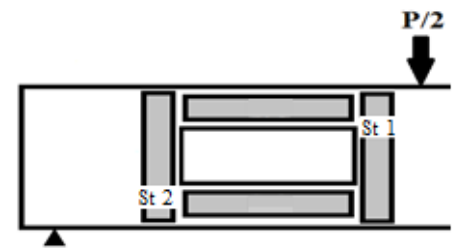
(a) Flexural bar

(b) Externally bonded plates  
Fig. 2 Locations of strain gauge

The load-strain relationship of steel reinforcement is presented in this section. The strain gauge (St) was attached onto the main steel reinforcement bar at the middle of the opening in the bottom chord. Fig. 6 shows the load against steel bar strain of the strain gauge (St) at the pre and post repair stages. For all the beams at the pre-repair stage, the strain gauge (St) shows an increase in strain value with the

The behaviour of load-strain relationship for externally bonded CFRP and steel plates is presented in this section. Strain gauge are fixed at two locations, one locations is on the opening corner near the support (ST2) and another location is at the opening corner near the point of applied load (ST1), as shown in Fig. 2(b). The load against strain curves for beams B1, B2, B3 and B4 are shown in Figs. 7, 8, 9 and 10, respectively. The recorded strains indicate that the value of strain for all beams did not reach the ultimate

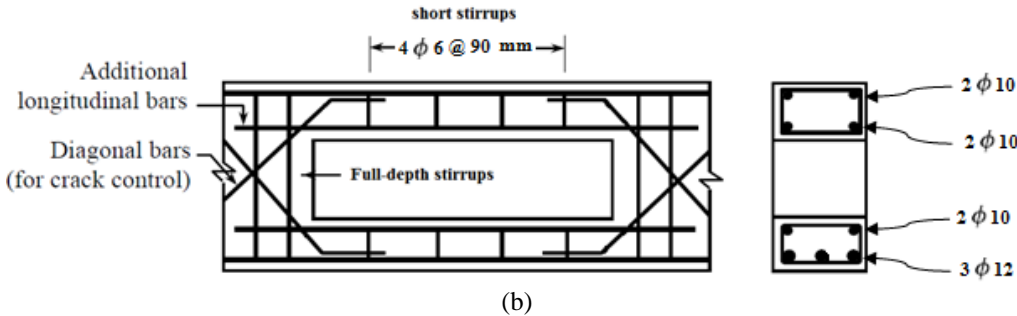
Fig. 3 Beams description, (a) Opening location, (b) Steel reinforcement at the opening

All the RC beams contain a large rectangular opening with a size of  $160 \times 400$  (depth  $\times$  width) mm. The opening was located at the mid of the shear span with a distance of 225 mm away from support and 225 mm away from the concentrated load. The distance between the two concentrated loads is 400 mm and the shear span is 850 mm, as shown in Fig. 3 (a). Beams with an opening were designed according to the plastic hinge method, [17]. The beams were reinforced with three steel bars with a diameter of 12 mm as a major reinforcement in the tension zone and two of a 10 mm diameter at the compression zone. Additional longitudinal bars were provided as two 10 mm diameter steel bars at the top and bottom chords of the opening, and diagonal bars for crack control were also added at the corner of the opening. Steel stirrups of a 6 mm diameter were used at 90 mm spacing along the top and bottom chords.

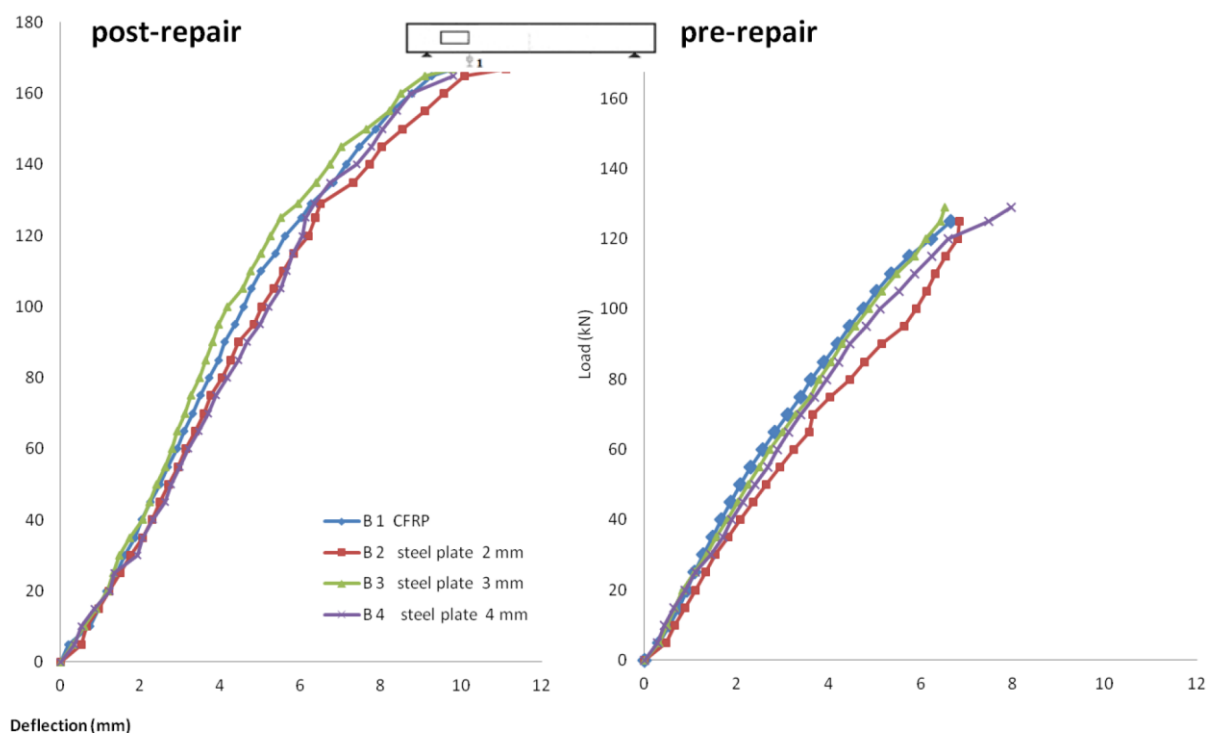
**Fig. 4** Load–deflection curves at the edge of the opening at pre and post repair stages

The load-deflection relationship at the mid span and below the edge of the opening is presented in this section. All the beams showed lower deflection at the mid span as compared to the deflection at the edge of the opening. For deflection at the edge of the opening, the reduction in deflection values found to be 10 % for CFRP, as shown in Table 4. For steel plates, the reductions in deflection were 7 %, 9 %, and 10 % for thicknesses of 2 mm, 3 mm and 4 mm, respectively. Thus, it is clear that the externally bonded plates applied around the web opening are capable of reducing 10 % of the deflection at pre-repair stage.

The beam B2, which was repaired by a steel plate with a thickness of 2mm, shows an effect on deflection at the edge of the opening, where at load of 128 kN the deflection is 6.98 mm and 6.49 mm at pre and post repair stages, respectively. For beam B3, good effect on the load capacity and a good effect on deflection were proved. The highest value of deflection was 6.52 mm obtained at the edge of the opening and it was at the pre-repaired stage at a failure load of 129 kN. However, at the post-repair stage, the deflection for the same load of 129 kN was 5.92 mm. As shown in Fig. 4, which shows the load against deflection at edge of opening curves at pre and post repair stages, the highest effect on deflection was for beams B1 and B4, while the lowest effect on deflection was for beam B2. The value of deflection for beam B1 at the pre-repair stage was 6.58 mm at a failure load of 125.2 kN, while the deflection was 5.95 mm at the post-repair stage at the same load of 125.2 kN.

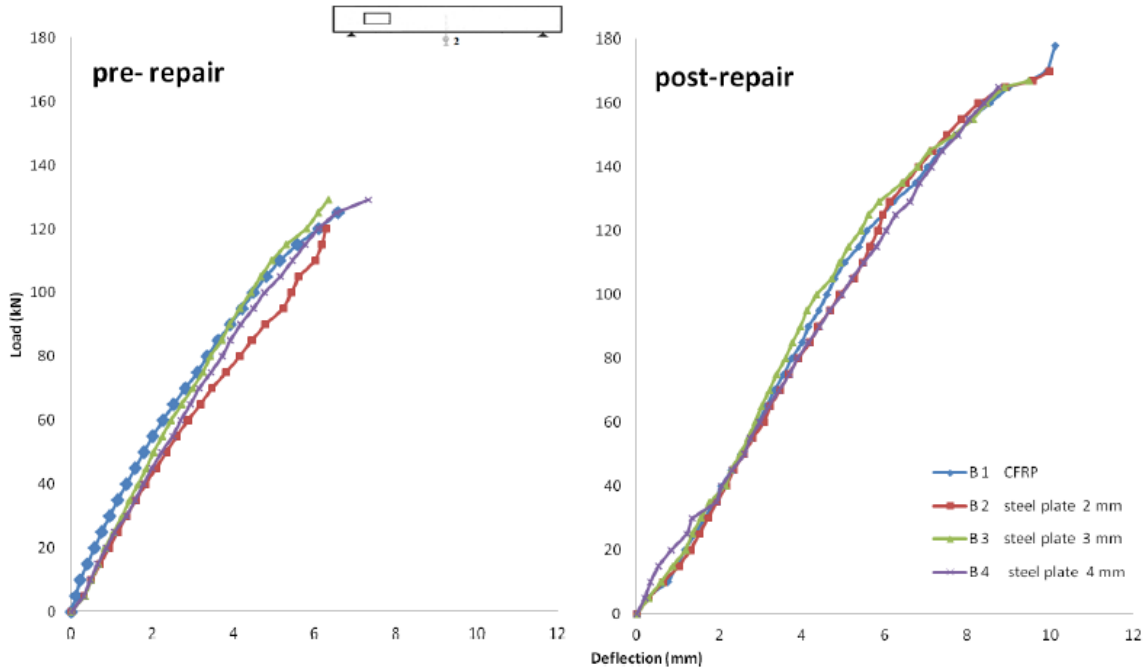
**Fig 5.** Load against deflection curves at the mid-span at pre and post repair stages

For beam B3, the value of deflection at the pre-repair stage at failure load of 129 kN was 6.35 mm, while at post-repair stage it was 5.85 mm at the same load of 128 kN. The value of deflection for beam B4 at the pre-repair stage was 6.74 mm at a failure load of 129.3 kN, while at the post-repair stage the deflection was 6.14 mm at the same load of 129.3 kN. The result shows that the influence of steel plates on deflection at the edge of the opening increases with the increase in steel plate thickness. The results indicate that the CFRP and steel plates have good effectiveness in reducing the deflection for the repaired beams at the edge of the opening and mid-span of the beam. From Fig. 5, which shows the load against deflection at mid-span curves at pre and post repair stages, it can be seen that curves for repaired beams show

somewhat similar behaviour because both CFRP and steel plates around the opening serve in resisting stress concentration at opening corners. Thus, it is delaying the cracking and controlling width and propagation of cracks. The highest value of deflection was obtained was located at the edge of the opening. The results are in agreement with Tan et al. [20], who found that for beams with an opening, the maximum deflection usually occurs at the high moment end of the opening. The decrease in deflection is smaller for the repaired beams, since the CFRP and steel plates prevent cracks from developing and widening. Furthermore, some contribution to the stiffness of beams was caused by the CFRP and steel plate outside the cracking region. The result shows that increasing steel plate thickness has little effect on reducing the deflection.

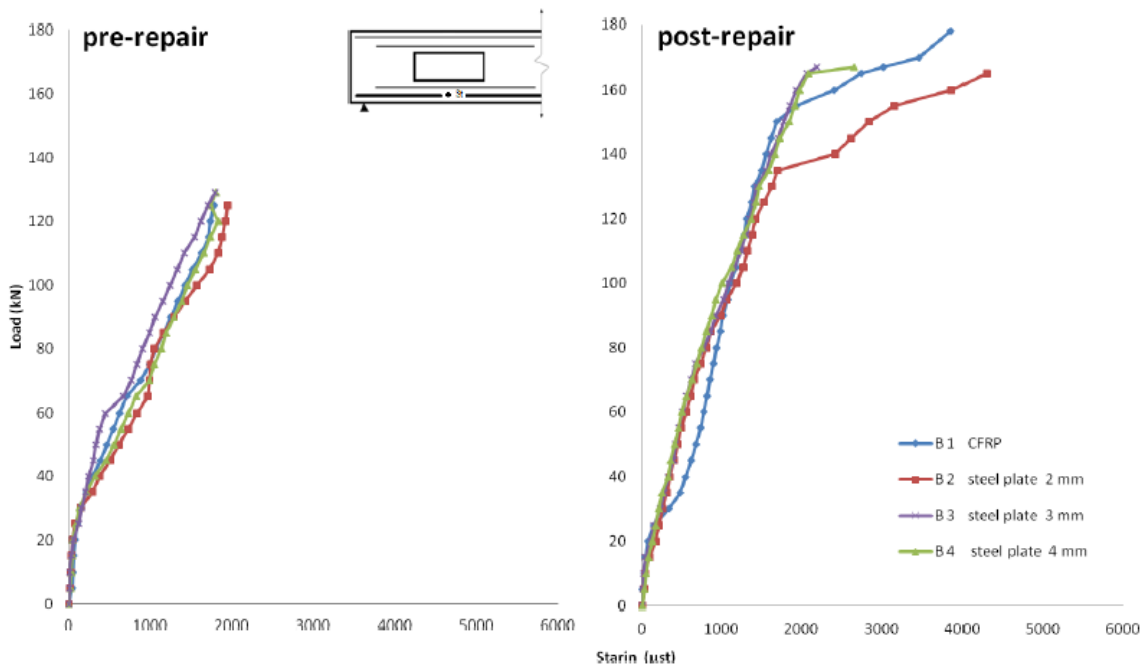
**Fig. 6** Load against steel bar strain of (St) at pre and post repair stages

increase in applied load and reaches its yielded strain at the ultimate load. At the post-repair stage, the externally bonded CFRP and steel plate shared the strain with steel bars where the strain gauge (St) reached strain values less than the strain at the pre-repair stage at same load. This was subjected to a different in the decrease of strain values percentage a depending on the material and thickness that were used, as shown in Table 5.

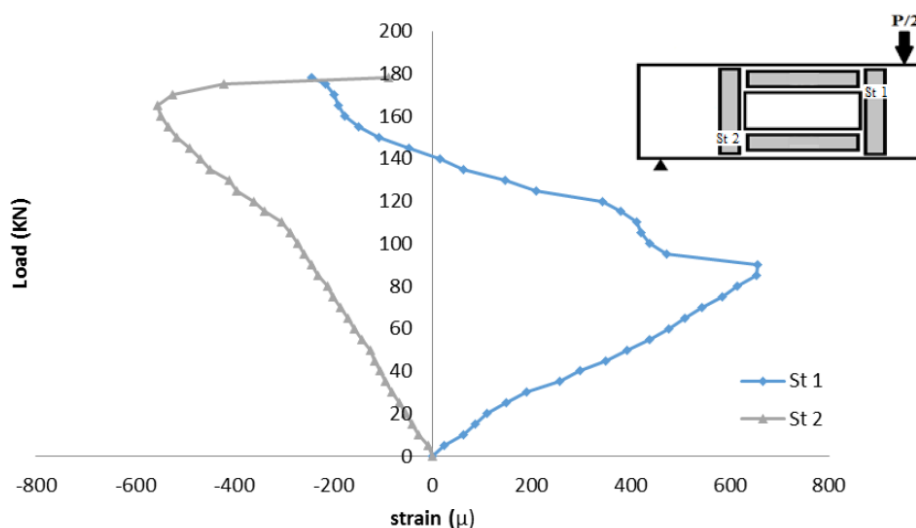
**Fig. 7** Load against strain of externally bonded CFRP plates of beam B1

As can be seen from Fig. 7, for beam B1 the maximum CFRP strain measured at failure was in strain ST1. For beam B3, the steel plate strain measured at failure was deferent at each location, because the value of the strain greatly depends on the location of the strain gauge with respect to a crack, as shown in Fig. 9. It can be observed from Fig. 10 that for beam B4, the maximum CFRP strain measured at failure was in strain ST1, on the bottom chord of the opening. CFRP and steel plates were not fractured or debonded from the concrete surface, and this ultimately indicates that CFRP and steel plates could provide additional strength if the beams did not fail by concrete diagonal shear cracks.

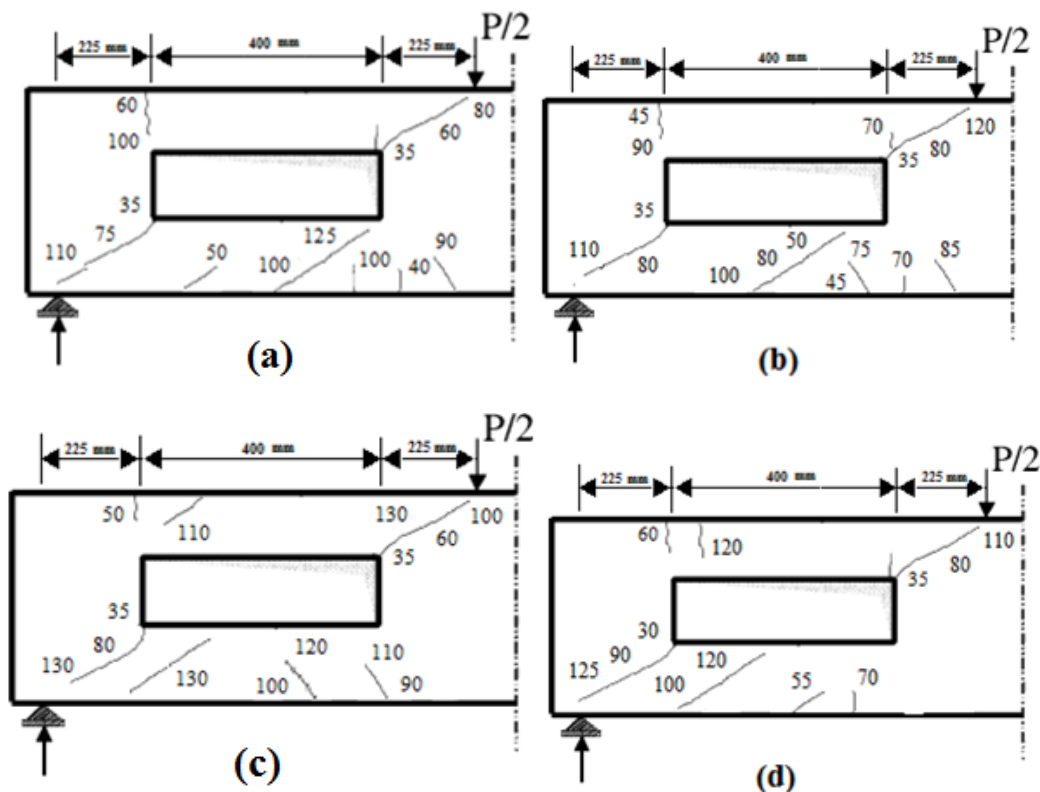
Fig. 11 Crack patterns and failure modes of beams at the pre-repair stage (a) Beam B1, (b) Beam B2, (c) Beam B3, (d) Beam B4

The crack pattern and the failure modes for all beams at pre and post repair stages are presented in this section. Figs. 11 and 12 show the crack pattern and the failure mode for all the beams at the pre and post repair stages, respectively. The failure modes of all the beams are similar because the failure occurs due to failure in concrete as diagonal shear failure before the externally bonded plates reach the ultimate strain. It can be seen from Fig. 11 (b) that the first diagonal crack for beam B2 was observed at the corner of the opening at a load of 35 kN; additional cracks were formed with the increase of the applied load. Failure of the beam occurred when the total applied load reached 128 kN. At the post-repair stage, many cracks were formed at the solid span of the beam, and the failure of the beam occurred at a load of 163.4 kN. At failure, concrete diagonal shear failure was observed around the

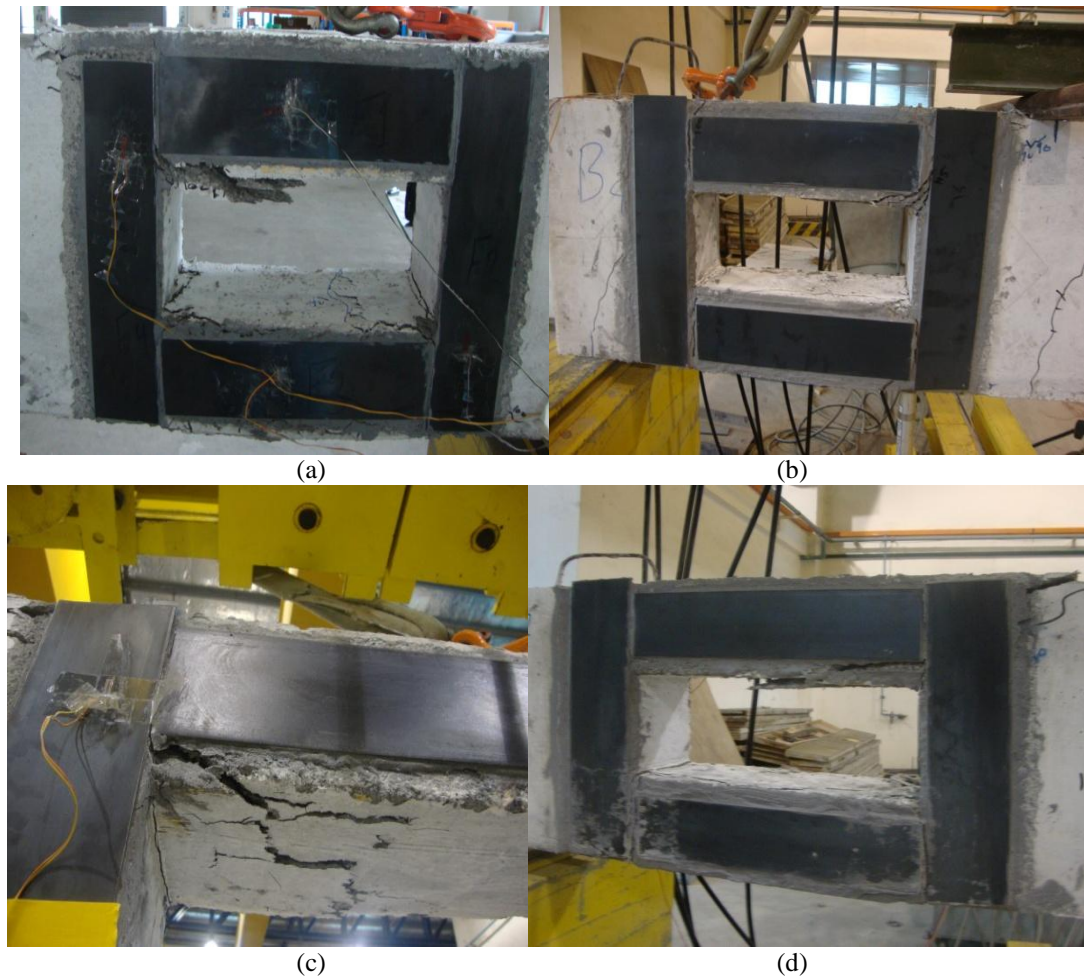
Fig. 12 Failure modes of beams at the post-repair stage (a) Beam B1, (b) Beam B2, (c) Beam B3, (d) Beam B4

opening, as shown in Fig. 12 (b).

This mode of failure is called splitting failure, which is due to relatively high longitudinal compressive stress developed at the top of the chords, which created transverse tension, and led to splitting failure, as according to Khalifa and Nanni [22]. The CFRP sheet did not fracture or debond from the concrete surface at the ultimate load. As can be seen from Fig. 11 (d), the first diagonal crack for beam B4 was observed at the corner of the opening at a load of 35 kN, additional cracks were formed with the increase of the applied load. Failure of the beam occurred when the total applied load reached 129.3 kN. As shown in Fig. 12 (d) for beam B4 at the post-repair stage, many cracks were formed at the solid span of the beam and the failure of the beam occurred at a load of 170 kN. At failure, crushing of the concrete was observed on the top and bottom face of the chord members, due to high compressive stress in concrete before the externally bonded plates reach the maximum strain.
