Investigation of long term coupled effect of high temperature and constant high humidity on corrosion rehabilitated patches of reinforced concrete structures

Abstract

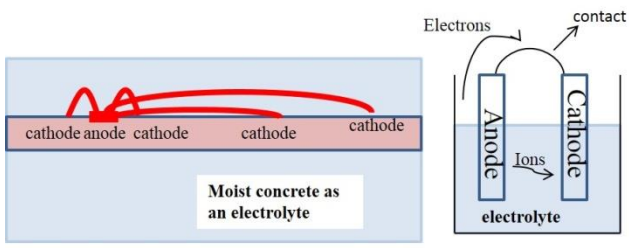
Figure 1 Separation of cathode and anode

The authors of this research paper, previously investigated and established the phenomenon of macro-cell formation in the repaired reinforced concrete patches due to the separation of anode and cathode [9], which is illustrated in Fig. 1. They also corroborated that the presence of high chloride content aided by the severe environmental conditions i.e. varying temperature and high constant humidity, not only break the passive film which protects steel from further corrosion but also accelerate the corrosion of reinforcement steel bars even in repaired reinforced concrete patches [10]. However, what would be the effect of long term coupled effect of varying temperature and constant high humidity on macro-cell corrosion of such repaired RC patches remained a question and leads to the objectives of this research paper.

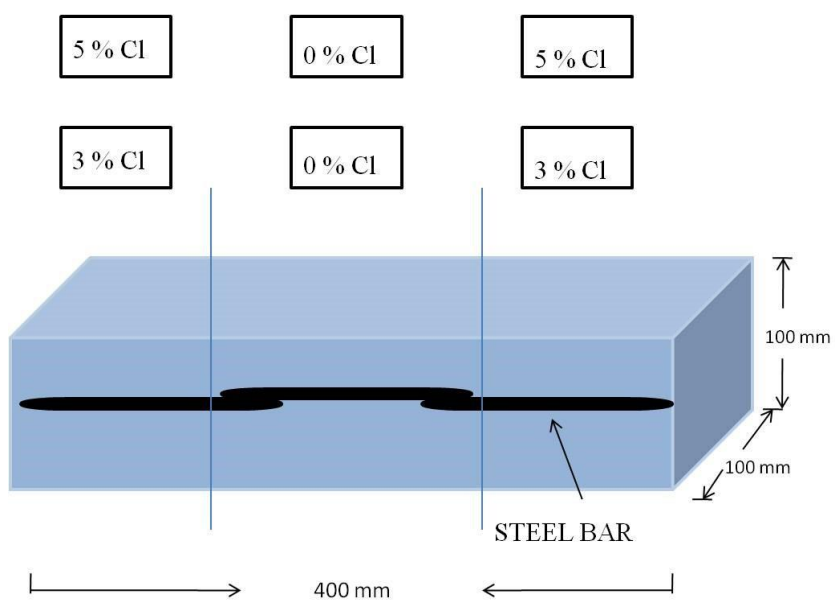
Fig. 2 Schematic representation of the identical test specimen

elsewhere [10]. The schematic diagram of these specimens is shown in Fig. 2 and the complete mixing procedure is shown in Fig. 3. Since the objective of this research is to find the long term coupled effect of varying temperature and high humidity on macro-cell corrosion phenomenon, these specimens were kept at 50°C, 40°C and 30°C temperature conditions and 85% relative humidity in environment control chambers for 2 years.

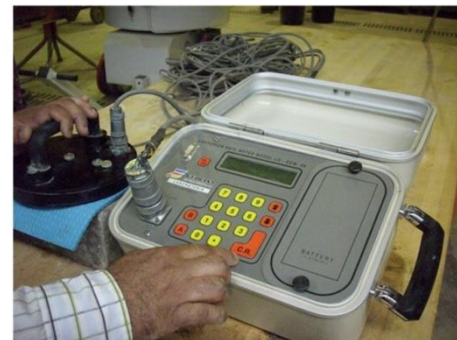
Figure 4 GECOR-8 (Corrosion Measurement device)

The steel rebar corrosion current (I_{corr}) and corrosion potential (E_{corr}) were measured for all specimens using a GECOR device [11] and ASTM C-876 [12]. The GECOR measures the corrosion rate as reflected by the corrosion current density and the half-cell corrosion potential. A true measure of the corrosion rate is possible by the polarization resistance technique. It has been well established by Stern and Geary that the corrosion current is linearly related to the polarization resistance, which gives a direct quantitative measurement of the amount of steel turning into oxide at the time of measurement. By Faraday's equation, this can be extrapolated to direct metal sectional loss. The corrosion current values in GECOR (GECOR-8, 2012) are calculated from the polarization resistance R_p using the relation $I_{corr} = B/R_p$, where I_{corr} is given in $\mu A/cm^2$ when R_p is given in $k\Omega/cm^2$ and $B = 26$ mV. The I_{corr} is directly proportional to corrosion rate through the relation, corrosion rate ($\mu m/year$) = $11.6 \times I_{corr}$. This gives a tool for quantifying the average reduction of rebar diameter over time. The measurement of corrosion rate usually involves applying electrical signal through a connection to the steel bar. In GECOR this signal is confined to the steel rebar in a circle with a diameter of 110 mm. There is evidence that this technique gives a more accurate measurement of the corrosion rate [13]. The GECOR device is quite valuable and versatile for the corrosion measurement of steel in concrete. See Fig. 4 for further illustration.

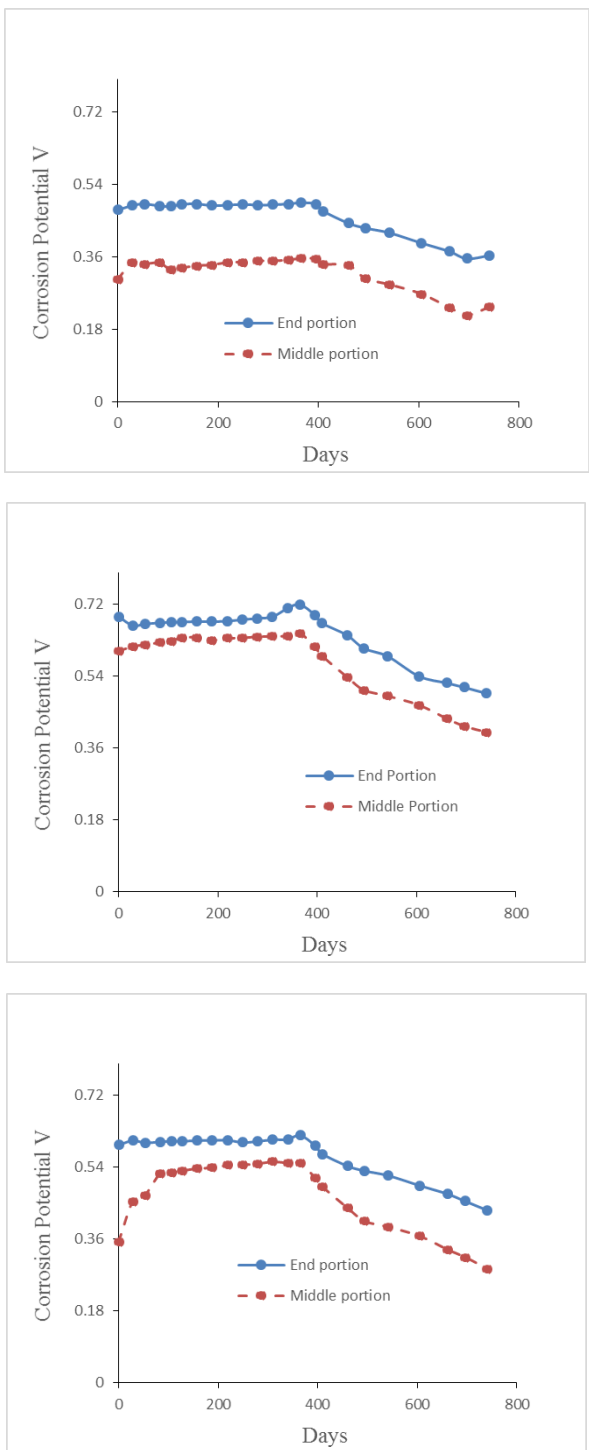
Fig. 5 (a-c) Corrosion potential measurement for 5% contaminated chloride specimen at the end kept at 30°C, 40°C and 50°C

1) At the middle non contaminated portion of the specimen having 5% chloride at the end portions and kept at 50°C (#1 and #2), the maximum corrosion of **-0.235** Volts was found after 2 years as compared to **-0.285** Volts at 30°C in the middle zero chloride portion of the same specimens (#5 and #6). However previously, much higher readings of these specimens were obtained on completion of one year observations [10]. The reason of this phenomenon could be the long term coupled effect of temperature and constant high humidity due to which the decline in corrosion potential after two years was significant. The results are shown in Figs. 5 and 6.

2) The maximum corrosion potential reading of the specimens #1 and #2 was found **-0.363** Volts as compared to high chloride induced potentials of **-0.432** Volts (figure 5) of the same specimens #5 and #6 at 30°C (figure 4)

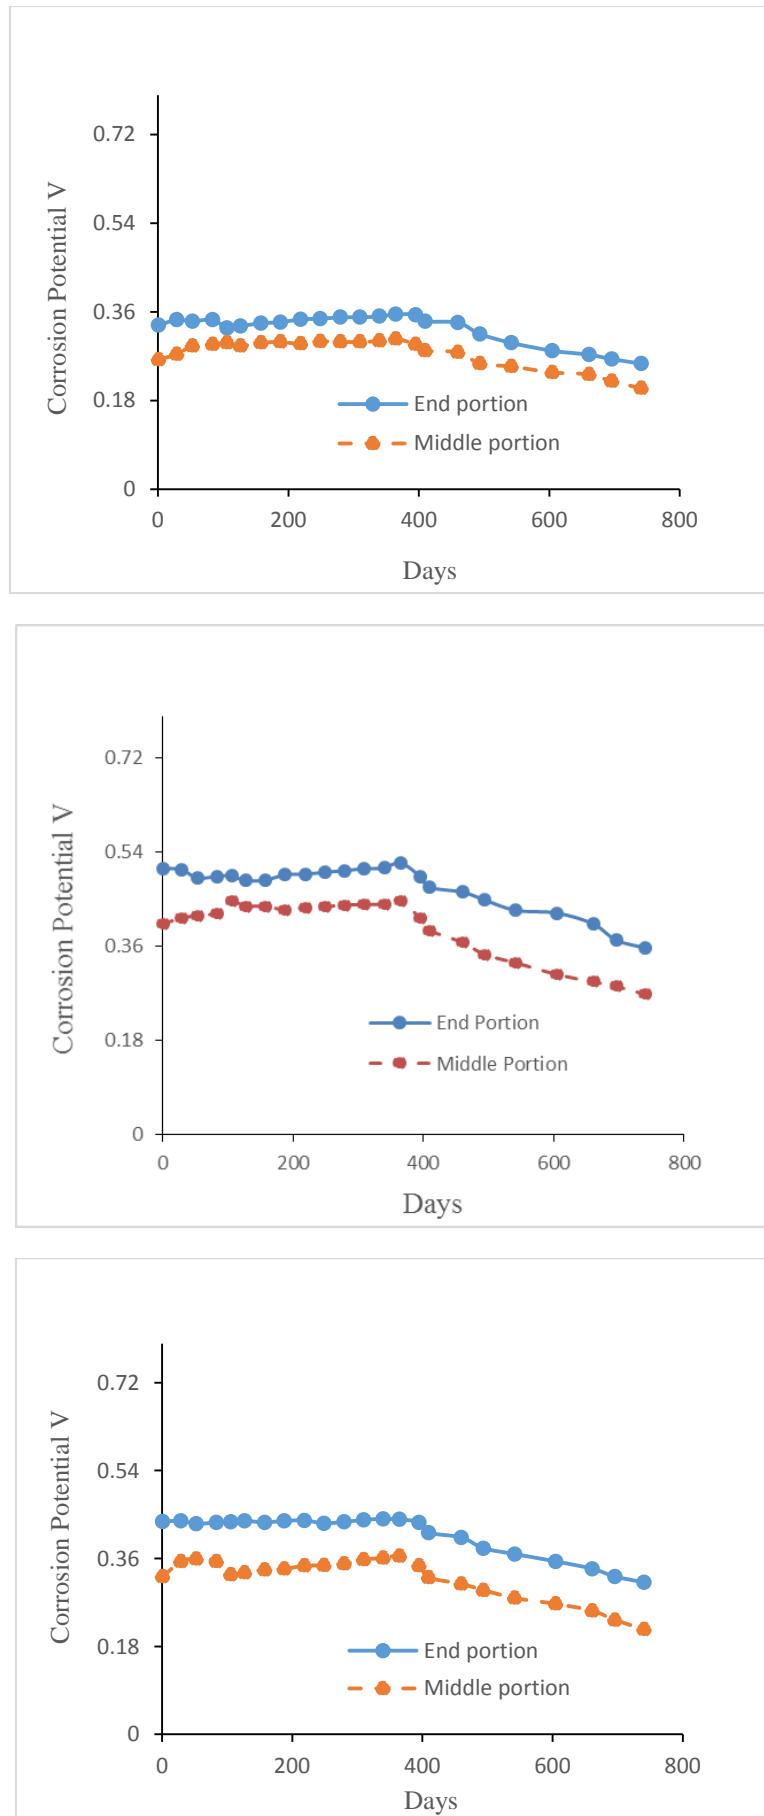
Fig. 6 (a-c) Corrosion potential measurement for 3% chloride contaminated specimen at the end kept at 30°C, 40°C and 50°C
