## Investigation of long term coupled effect of high temperature and constant high humidity on corrosion rehabilitated patches of reinforced concrete structures

### Abstract

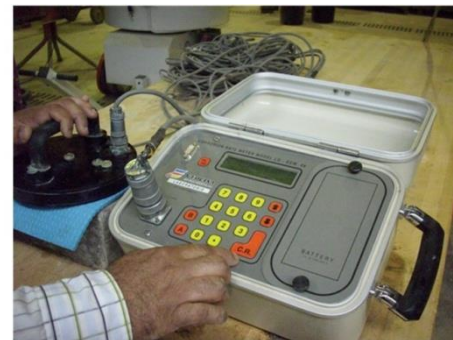
Figure 4 GECOR-8 (Corrosion Measurement device)

The steel rebar corrosion current ( $I_{corr}$ ) and corrosion potential ( $E_{corr}$ ) were measured for all specimens using a GECOR device [11] and ASTM C-876 [12]. The GECOR measures the corrosion rate as reflected by the corrosion current density and the half-cell corrosion potential. A true measure of the corrosion rate is possible by the polarization resistance technique. It has been well established by Stern and Geary that the corrosion current is linearly related to the polarization resistance, which gives a direct quantitative measurement of the amount of steel turning into oxide at the time of measurement. By Faraday's equation, this can be extrapolated to direct metal sectional loss. The corrosion current values in GECOR (GECOR-8, 2012) are calculated from the polarization resistance  $R_p$  using the relation  $I_{corr} = B/R_p$ , where  $I_{corr}$  is given in  $\mu A/cm^2$  when  $R_p$  is given in  $k\Omega/cm^2$  and  $B = 26$  mV. The  $I_{corr}$  is directly proportional to corrosion rate through the relation, corrosion rate ( $\mu m/year$ ) =  $11.6 \times I_{corr}$ . This gives a tool for quantifying the average reduction of rebar diameter over time. The measurement of corrosion rate usually involves applying electrical signal through a connection to the steel bar. In GECOR this signal is confined to the steel rebar in a circle with a diameter of 110 mm. There is evidence that this technique gives a more accurate measurement of the corrosion rate [13]. The GECOR device is quite valuable and versatile for the corrosion measurement of steel in concrete. See Fig. 4 for further illustration.

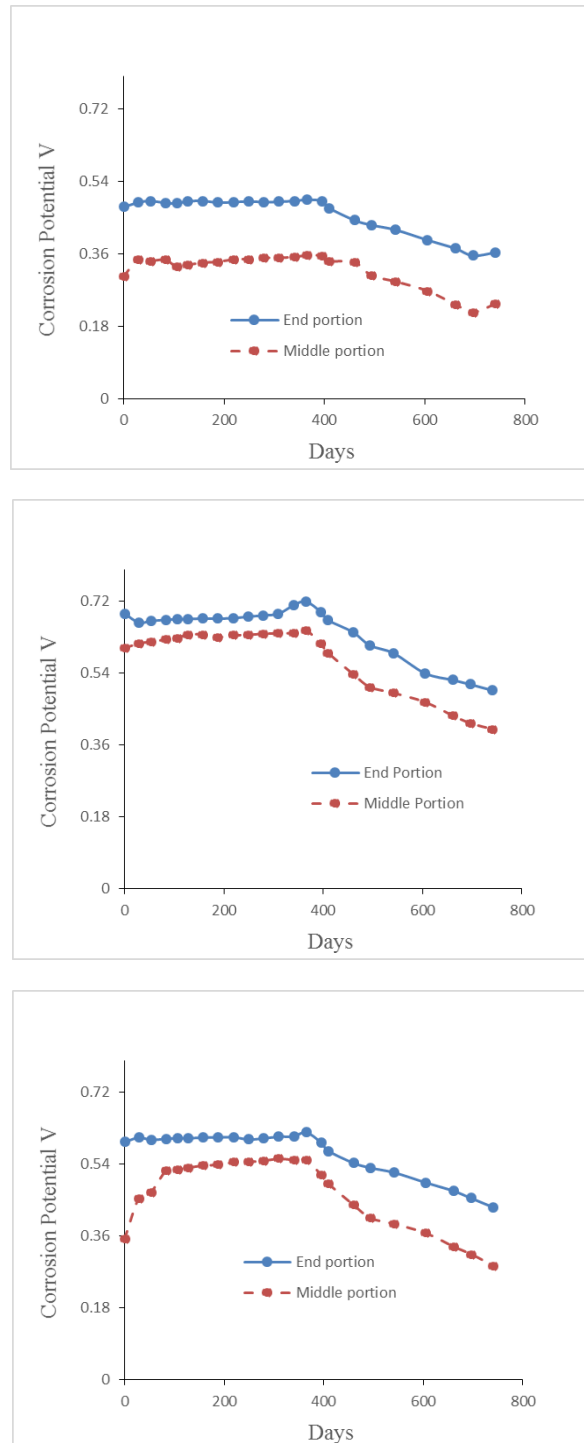
**Fig. 5** (a-c) Corrosion potential measurement for 5% contaminated chloride specimen at the end kept at 30°C, 40°C and 50°C

1) At the middle non contaminated portion of the specimen having 5% chloride at the end portions and kept at  $50^\circ C$  (#1 and #2), the maximum corrosion of **-0.235** Volts was found after 2 years as compared to **-0.285** Volts at  $30^\circ C$  in the middle zero chloride portion of the same specimens (#5 and #6). However previously, much higher readings of these specimens were obtained on completion of one year observations [10]. The reason of this phenomenon could be the long term coupled effect of temperature and constant high humidity due to which the decline in corrosion potential after two years was significant. The results are shown in Figs. 5 and 6.

2) The maximum corrosion potential reading of the specimens #1 and #2 was found **-0.363** Volts as compared to high chloride induced potentials of **-0.432** Volts (figure 5) of the same specimens #5 and #6 at  $30^\circ C$  (figure 4)

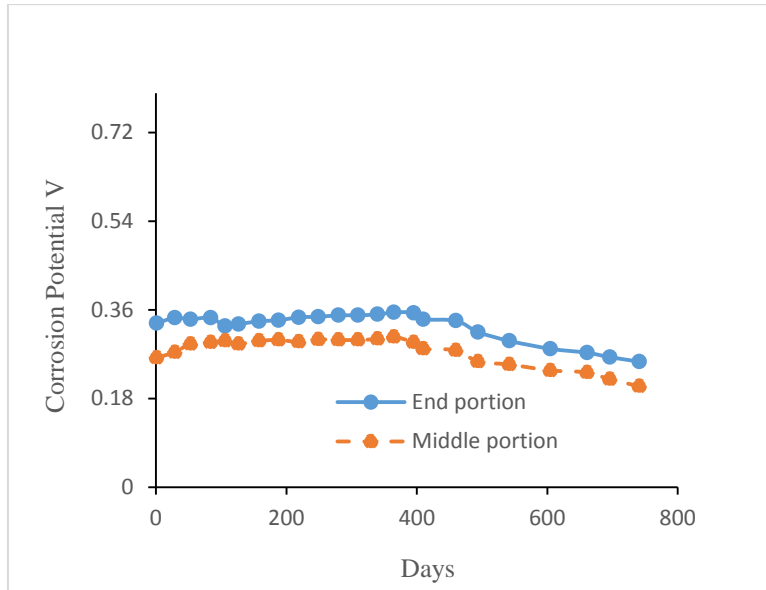
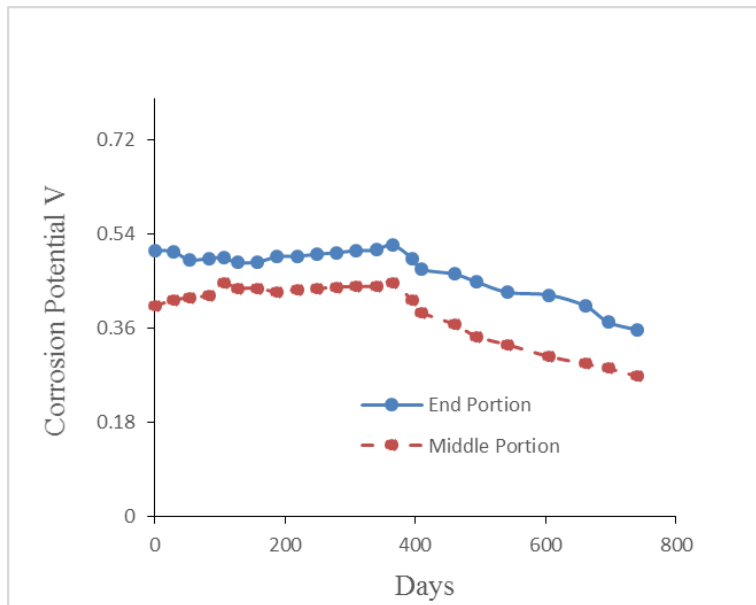
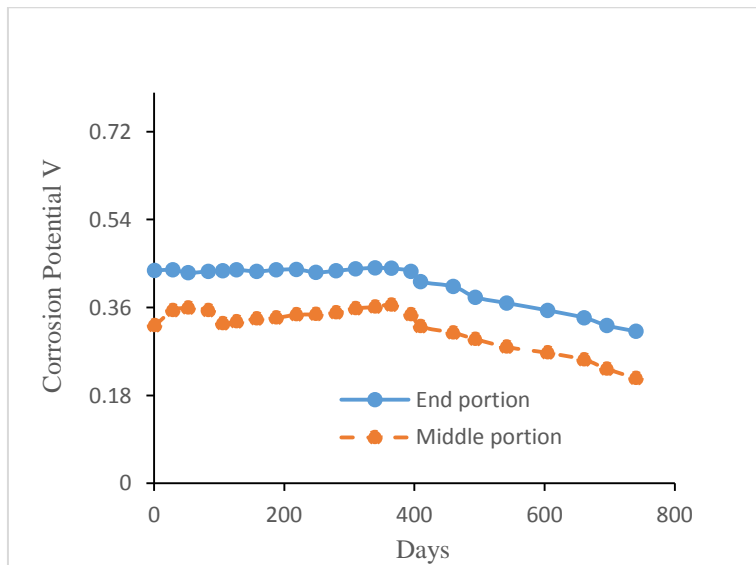
**Fig. 6** (a-c) Corrosion potential measurement for 3% chloride contaminated specimen at the end kept at 30°C, 40°C and 50°C

5) In the 3 % chloride contaminated specimens (#7 and #8) at the end, the corrosion potential of **-0.255** Volts was obtained as compared to high **-0.311** Volts of same specimens (#11 and #12) which were kept at 30 °C.

6) In specimen #7 and #8, the corrosion potential of **-0.205** volts at the middle non contaminated portion was obtained as compared to **-0.215** Volt at 30°C.

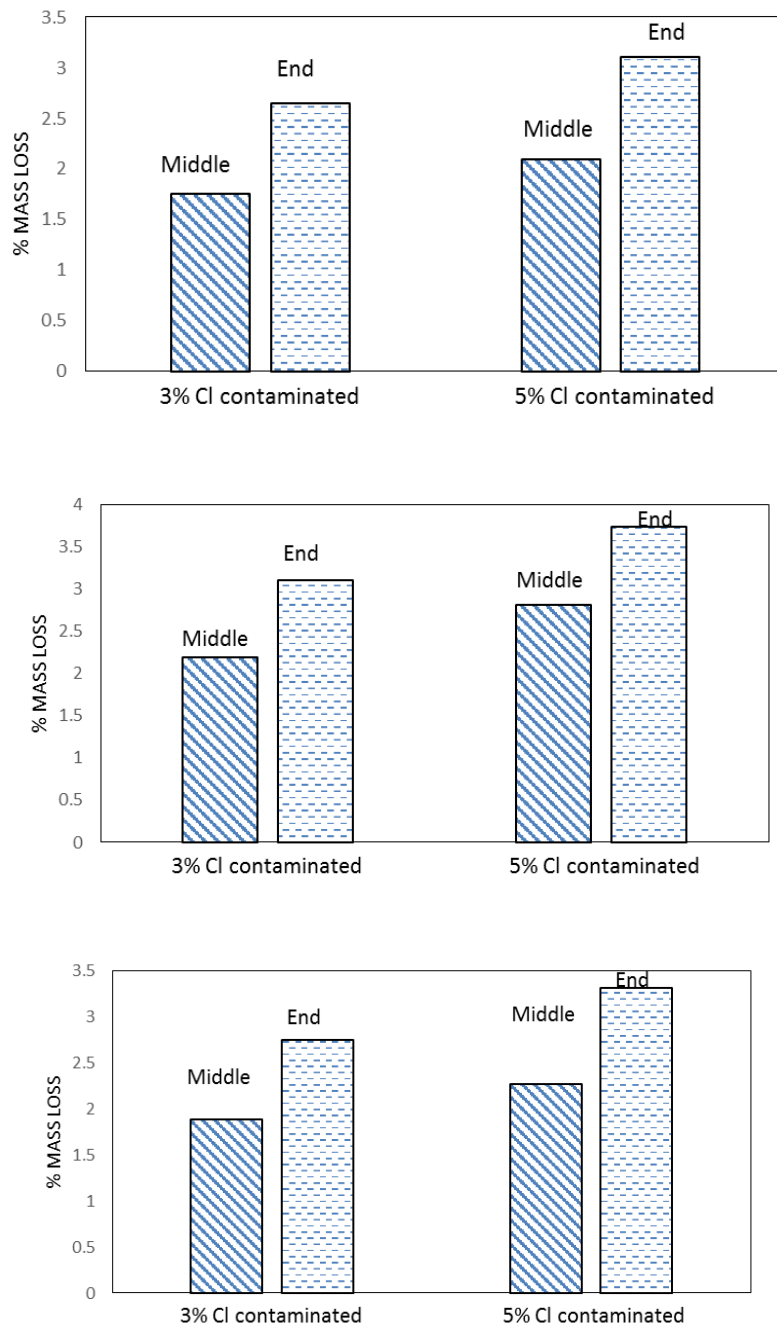
Fig. 7 % Mass loss for 3% and 5% chloride contaminated specimen at the end kept at 30°C, 40°C and 50°C

1) The steel bar from the end portion of 5% chloride contaminated concrete gave the highest % mass loss of 3.73 at 40°C while the steel bar from its middle portion gave 2.81 % mass loss. When the steel taken from the end portion of the same specimen kept at 30°C gave the highest % mass loss of 3.11 and 2.09 % obtained from its middle steel. However interestingly even after exposure of two years observation, the

steel of the end portion of the same specimen kept at 50°C gave the highest % mass loss of 3.31 and middle steel gave 2.27 % mass losses which was lower than the mass losses at 40°C. The results are shown in Fig. 7.

2) The steel from the end portions of 3 % chloride contaminated concrete specimens kept at 30°C, 40°C and 50°C gave 2.65, 3.11 and 2.75 % mass loss respectively. While the middle steels from the uncontaminated portion of these specimens gave 1.75, 2.19 and 1.88 % mass losses respectively as shown in figure 7. Similarly in the 3% chloride contaminated specimens reduced % mass losses at 50°C obtained as compared to the mass loss at 40°C, confirming the authenticity of the results of this research.

As it can be seen from gravimetric mass loss results of various specimens put in varying temperatures, shown in figure 7(a-c), the steels from the middle portion of all the specimens simulating the actual patch repair in field, were corroded and gave approximately 70% of the mass loss obtained in their respective contaminated end portions, indicating the chloride transfer and vulnerability of repaired portion against corrosion.
