Investigation of long term coupled effect of high temperature and constant high humidity on corrosion rehabilitated patches of reinforced concrete structures

Abstract

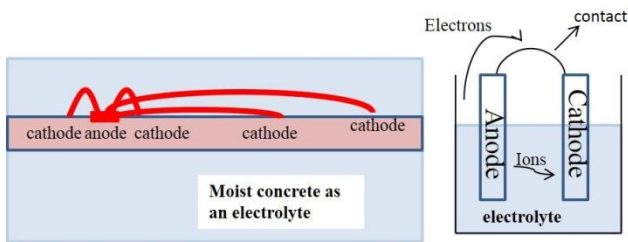
Figure 1 Separation of cathode and anode

The authors of this research paper, previously investigated and established the phenomenon of macro-cell formation in the repaired reinforced concrete patches due to the separation of anode and cathode [9], which is illustrated in Fig. 1. They also corroborated that the presence of high chloride content aided by the severe environmental conditions i.e. varying temperature and high constant humidity, not only break the passive film which protects steel from further corrosion but also accelerate the corrosion of reinforcement steel bars even in repaired reinforced concrete patches [10]. However, what would be the effect of long term coupled effect of varying temperature and constant high humidity on macro-cell corrosion of such repaired RC patches remained a question and leads to the objectives of this research paper.
