Investigation of long term coupled effect of high temperature and constant high humidity on corrosion rehabilitated patches of reinforced concrete structures

Abstract

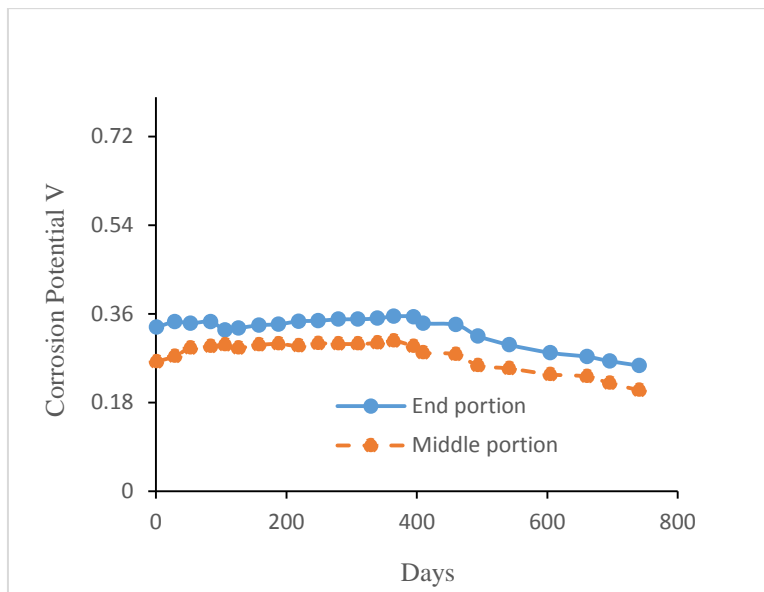
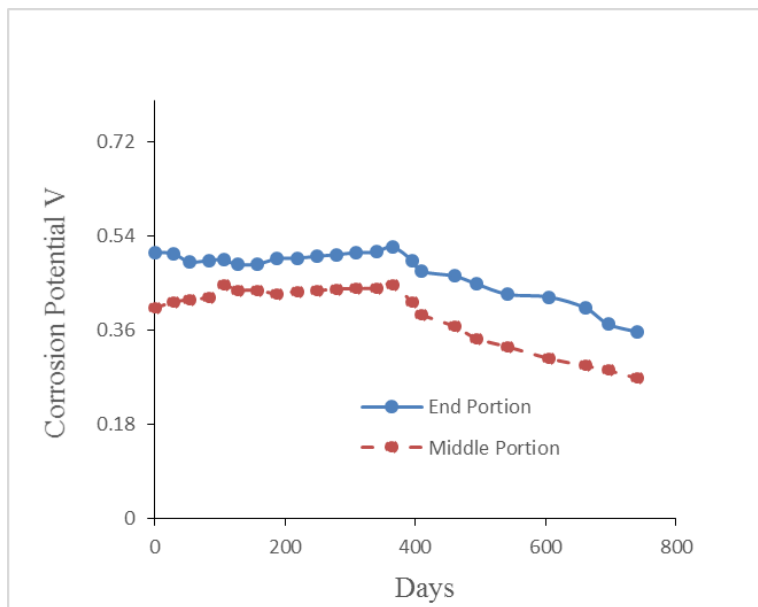
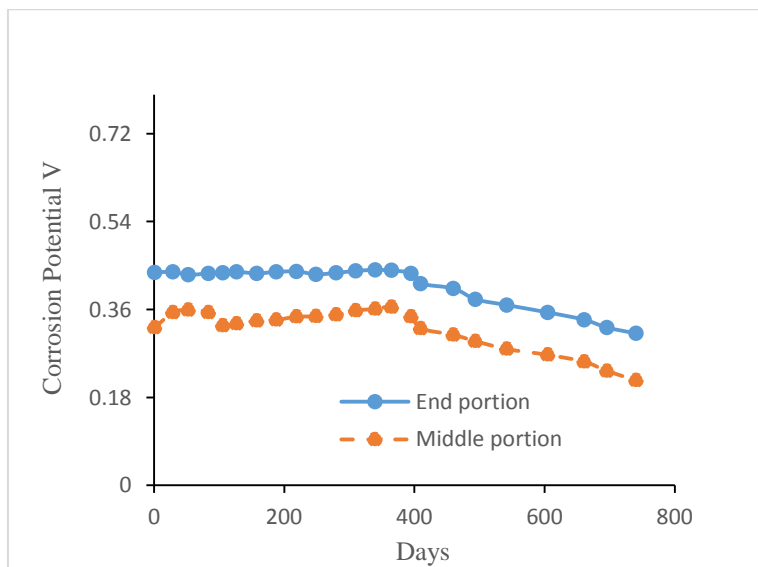
Fig. 6 (a-c) Corrosion potential measurement for 3% chloride contaminated specimen at the end kept at 30°C, 40°C and 50°C

1) At the middle non contaminated portion of the specimen having 5% chloride at the end portions and kept at $50^\circ C$ (#1 and #2), the maximum corrosion of **-0.235** Volts was found after 2 years as compared to **-0.285** Volts at $30^\circ C$ in the middle zero chloride portion of the same specimens (#5 and #6). However previously, much higher readings of these specimens were obtained on completion of one year observations [10]. The reason of this phenomenon could be the long term coupled effect of temperature and constant high humidity due to which the decline in corrosion potential after two years was significant. The results are shown in Figs. 5 and 6.

5) In the 3 % chloride contaminated specimens (#7 and #8) at the end, the corrosion potential of **-0.255** Volts was obtained as compared to high **-0.311** Volts of same specimens (#11 and #12) which were kept at 30 C°.

6) In specimen #7 and #8, the corrosion potential of **-0.205** volts at the middle non contaminated portion was obtained as compared to **-0.215** Volt at 30°C.

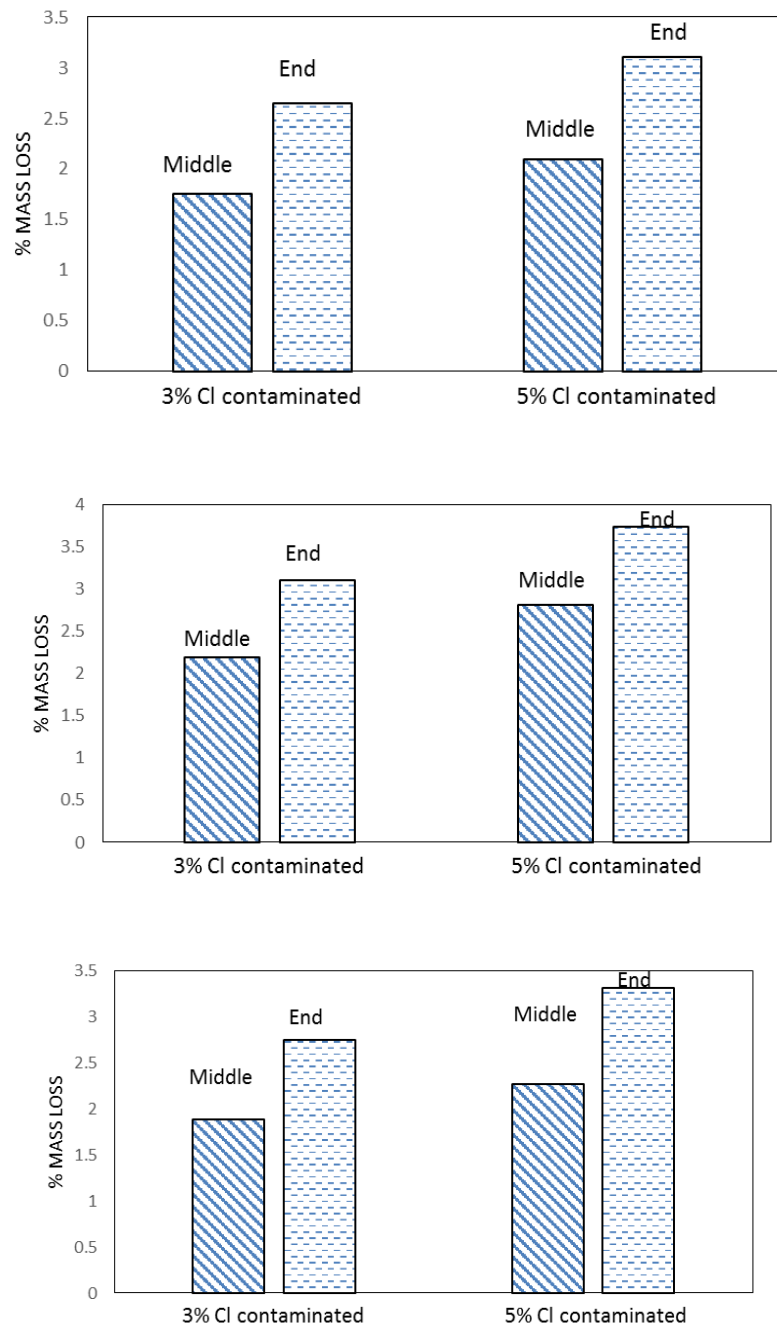
Fig. 7 % Mass loss for 3% and 5% chloride contaminated specimen at the end kept at 30°C, 40°C and 50°C

1) The steel bar from the end portion of 5% chloride contaminated concrete gave the highest % mass loss of 3.73 at 40°C while the steel bar from its middle portion gave 2.81 % mass loss. When the steel taken from the end portion of the same specimen kept at 30°C gave the highest % mass loss of 3.11 and 2.09 % obtained from its middle steel. However interestingly even after exposure of two years observation, the

steel of the end portion of the same specimen kept at 50°C gave the highest % mass loss of 3.31 and middle steel gave 2.27 % mass losses which was lower than the mass losses at 40°C. The results are shown in Fig. 7.

2) The steel from the end portions of 3 % chloride contaminated concrete specimens kept at 30°C, 40°C and 50°C gave 2.65, 3.11 and 2.75 % mass loss respectively. While the middle steels from the uncontaminated portion of these specimens gave 1.75, 2.19 and 1.88 % mass losses respectively as shown in figure 7. Similarly in the 3% chloride contaminated specimens reduced % mass losses at 50°C obtained as compared to the mass loss at 40°C, confirming the authenticity of the results of this research.

As it can be seen from gravimetric mass loss results of various specimens put in varying temperatures, shown in figure 7(a-c), the steels from the middle portion of all the specimens simulating the actual patch repair in field, were corroded and gave approximately 70% of the mass loss obtained in their respective contaminated end portions, indicating the chloride transfer and vulnerability of repaired portion against corrosion.
