## Investigation of long term coupled effect of high temperature and constant high humidity on corrosion rehabilitated patches of reinforced concrete structures

M. Wasim<sup>1</sup>, Raja Rizwan Hussain<sup>2\*</sup>, M. A. Baloch<sup>3</sup>

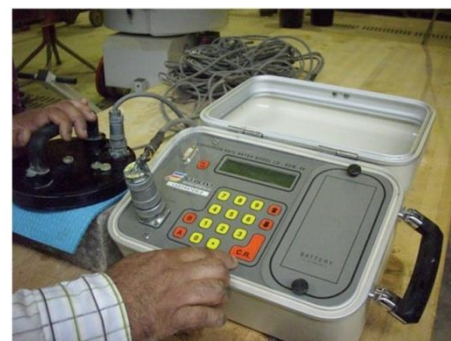
Figure 4 GECOR-8 (Corrosion Measurement device)

The steel rebar corrosion current ( $I_{corr}$ ) and corrosion potential ( $E_{corr}$ ) were measured for all specimens using a GECOR device [11] and ASTM C-876 [12]. The GECOR measures the corrosion rate as reflected by the corrosion current density and the half-cell corrosion potential. A true measure of the corrosion rate is possible by the polarization resistance technique. It has been well established by Stern and Geary that the corrosion current is linearly related to the polarization resistance, which gives a direct quantitative measurement of the amount of steel turning into oxide at the time of measurement. By Faraday's equation, this can be extrapolated to direct metal sectional loss. The corrosion current values in GECOR (GECOR-8, 2012) are calculated from the polarization resistance  $R_p$  using the relation  $I_{corr} = B/R_p$ , where  $I_{corr}$  is given in  $\mu A/cm^2$  when  $R_p$  is given in  $k\Omega/cm^2$  and  $B = 26$  mV. The  $I_{corr}$  is directly proportional to corrosion rate through the relation, corrosion rate ( $\mu m/year$ ) =  $11.6 \times I_{corr}$ . This gives a tool for quantifying the average reduction of rebar diameter over time. The measurement of corrosion rate usually involves applying electrical signal through a connection to the steel bar. In GECOR this signal is confined to the steel rebar in a circle with a diameter of 110 mm. There is evidence that this technique gives a more accurate measurement of the corrosion rate [13]. The GECOR device is quite valuable and versatile for the corrosion measurement of steel in concrete. See Fig. 4 for further illustration.

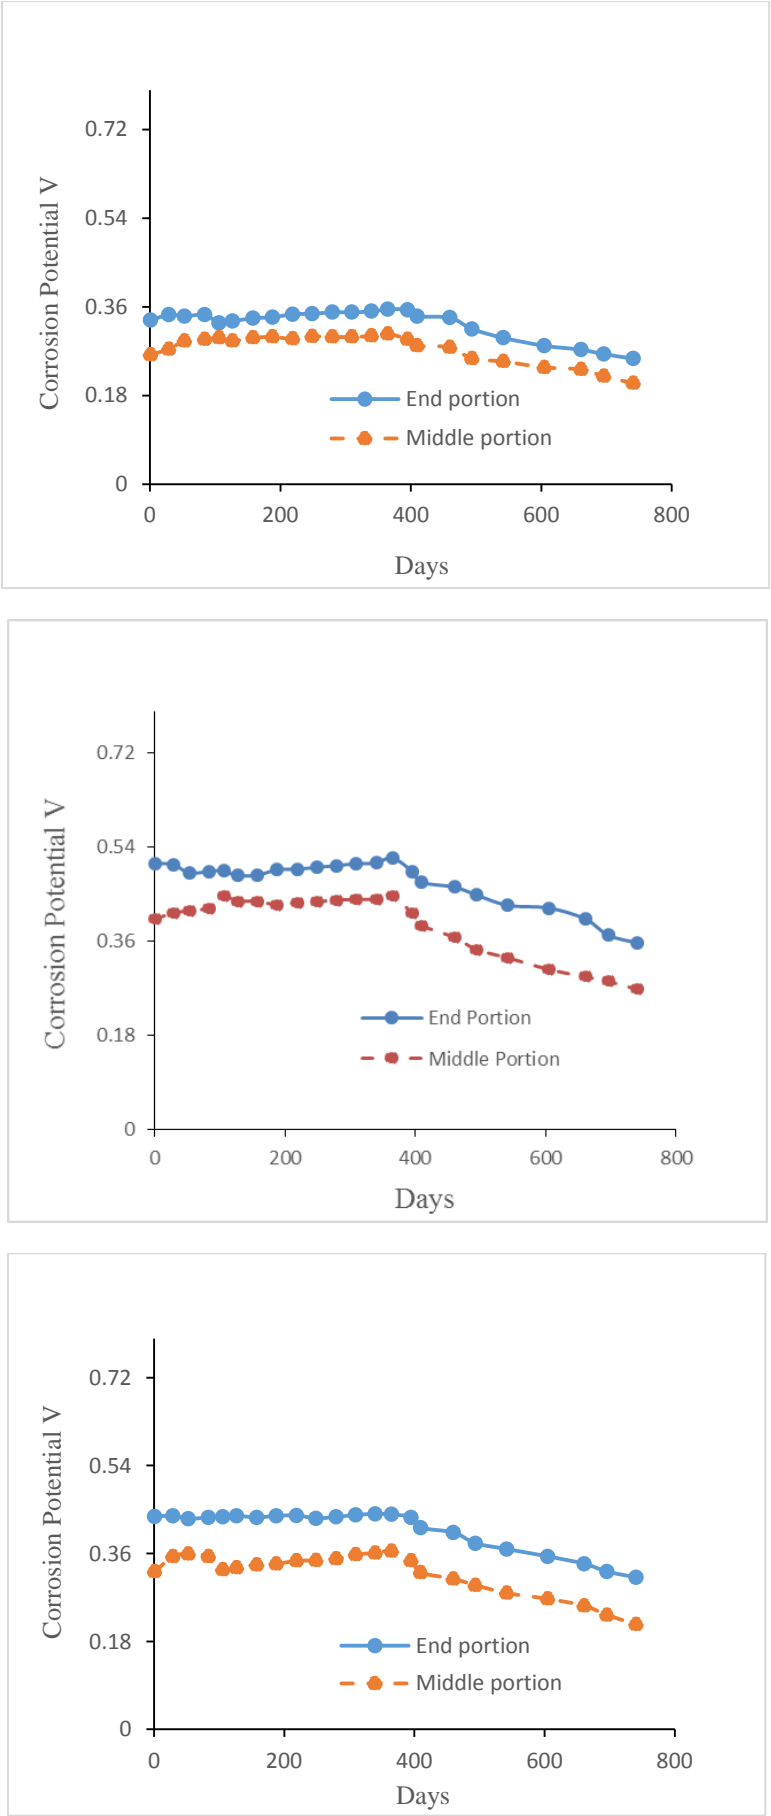
**Fig. 6** (a-c) Corrosion potential measurement for 3% chloride contaminated specimen at the end kept at 30°C, 40°C and 50°C

1) At the middle non contaminated portion of the specimen having 5% chloride at the end portions and kept at 50°C (#1 and #2), the maximum corrosion of **-0.235** Volts was found after 2 years as compared to **-0.285** Volts at 30°C in the middle zero chloride portion of the same specimens (#5 and #6). However previously, much higher readings of these specimens were obtained on completion of one year observations [10]. The reason of this phenomenon could be the long term coupled effect of temperature and constant high humidity due to which the decline in corrosion potential after two years was significant. The results are shown in Figs. 5 and 6.
