Investigation of long term coupled effect of high temperature and constant high humidity on corrosion rehabilitated patches of reinforced concrete structures

Abstract

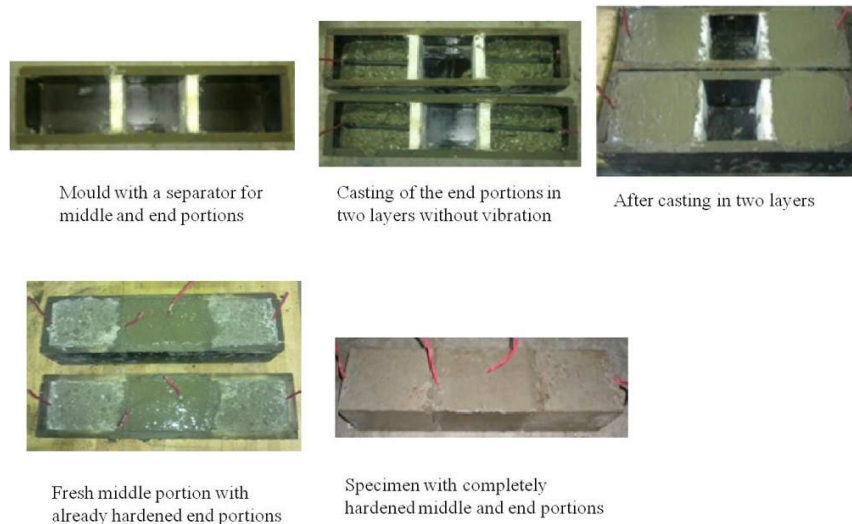
Figure 3 Specimens preparation

elsewhere [10]. The schematic diagram of these specimens is shown in Fig. 2 and the complete mixing procedure is shown in Fig. 3. Since the objective of this research is to find the long term coupled effect of varying temperature and high humidity on macro-cell corrosion phenomenon, these specimens were kept at 50°C, 40°C and 30°C temperature conditions and 85% relative humidity in environment control chambers for 2 years.

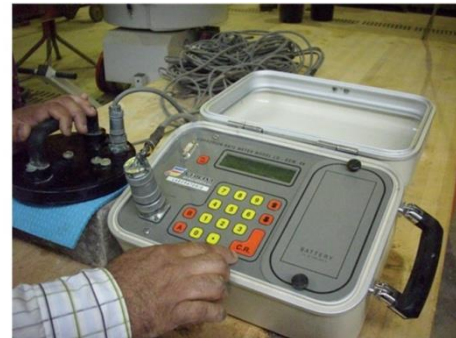
Figure 4 GECOR-8 (Corrosion Measurement device)

The steel rebar corrosion current (I_{corr}) and corrosion potential (E_{corr}) were measured for all specimens using a GECOR device [11] and ASTM C-876 [12]. The GECOR measures the corrosion rate as reflected by the corrosion current density and the half-cell corrosion potential. A true measure of the corrosion rate is possible by the polarization resistance technique. It has been well established by Stern and Geary that the corrosion current is linearly related to the polarization resistance, which gives a direct quantitative measurement of the amount of steel turning into oxide at the time of measurement. By Faraday's equation, this can be extrapolated to direct metal sectional loss. The corrosion current values in GECOR (GECOR-8, 2012) are calculated from the polarization resistance R_p using the relation $I_{corr} = B/R_p$, where I_{corr} is given in $\mu A/cm^2$ when R_p is given in $k\Omega/cm^2$ and $B = 26$ mV. The I_{corr} is directly proportional to corrosion rate through the relation, corrosion rate ($\mu m/year$) = $11.6 \times I_{corr}$. This gives a tool for quantifying the average reduction of rebar diameter over time. The measurement of corrosion rate usually involves applying electrical signal through a connection to the steel bar. In GECOR this signal is confined to the steel rebar in a circle with a diameter of 110 mm. There is evidence that this technique gives a more accurate measurement of the corrosion rate [13]. The GECOR device is quite valuable and versatile for the corrosion measurement of steel in concrete. See Fig. 4 for further illustration.
