Investigation of long term coupled effect of high temperature and constant high humidity on corrosion rehabilitated patches of reinforced concrete structures

Abstract

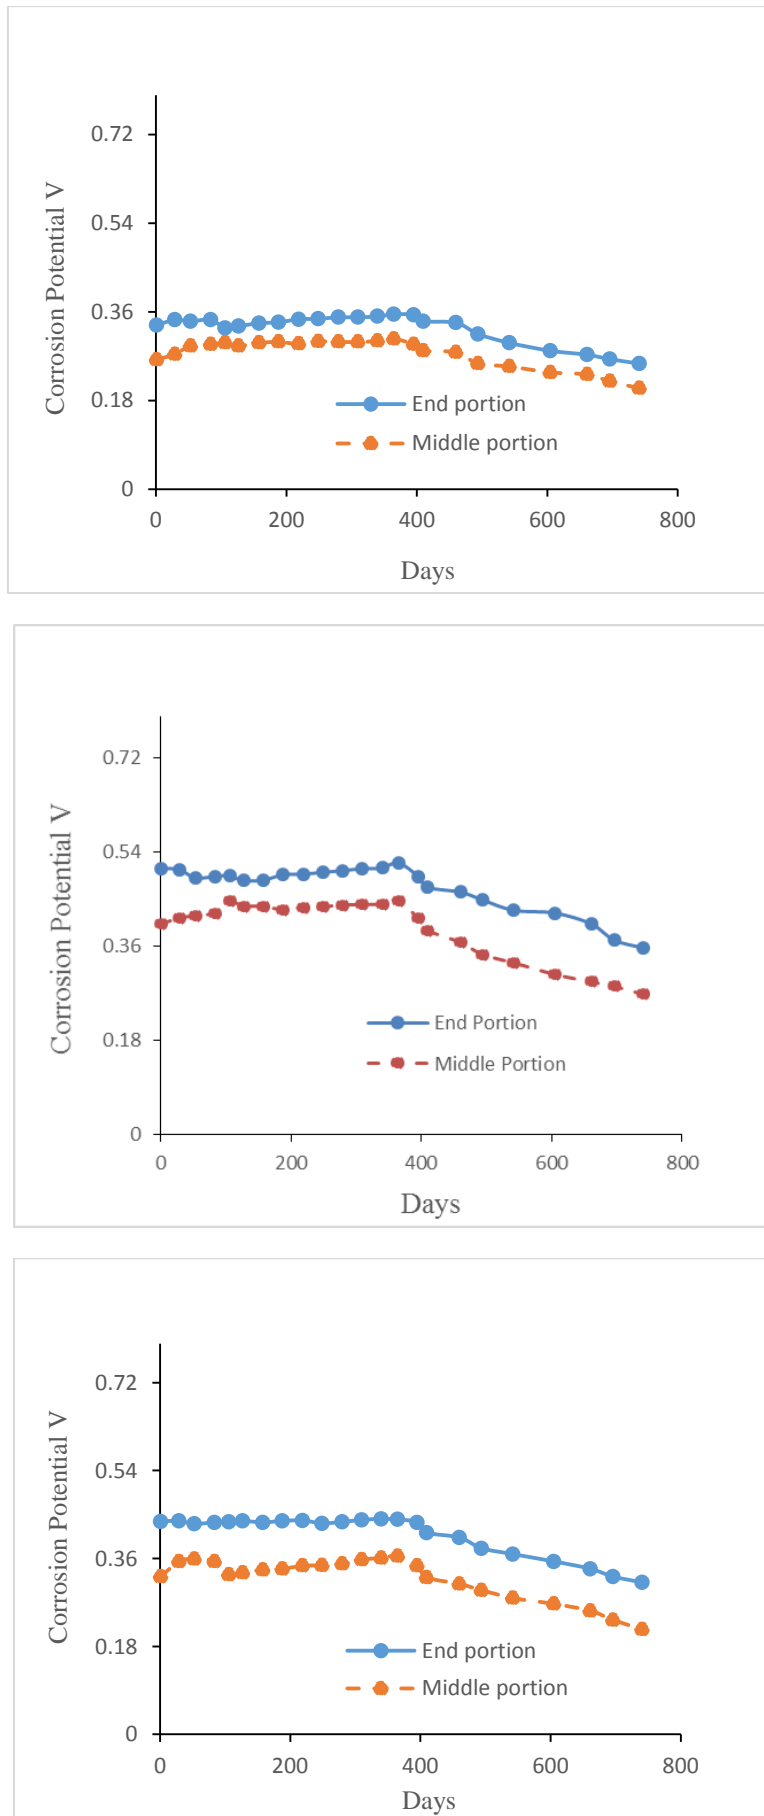
5) In the 3 % chloride contaminated specimens (#7 and #8) at the end, the corrosion potential of **-0.255** Volts was obtained as compared to high **-0.311** Volts of same specimens (#11 and #12) which were kept at 30 C°.

6) In specimen #7 and #8, the corrosion potential of **-0.205** volts at the middle non contaminated portion was obtained as compared to **-0.215** Volt at 30°C.

Fig. 6 (a-c) Corrosion potential measurement for 3% chloride contaminated specimen at the end kept at 30°C, 40°C and 50°C
