# Biodeterioration of Coastal Concrete Structures by Marine Green Algae

**Abstract:** Puducherry is a coastal region in India where the growth of *Ulva fasciata* (Delile) is very abundant on all marine structures. Though the detrimental effect of this macro algae *Ulva fasciata* is a secondary one, its effect has to ascertain. To know its effect, the basic mechanism by which *Ulva fasciata* deteriorates concrete structures, M20 grade concrete cubes were casted and kept in the coastal area where there is abundant growth of *Ulva fasciata* and also laboratory simulation has been carried out. To ascertain the detrimental effect by the macro algae on concrete surface, samples were collected from the concrete cubes kept in the coastal area and also from the laboratory simulated one. The collected samples were analyzed by SEM, EDX and XRD to establish the degree of deterioration done by marine algae on concrete surface. The SEM and EDX results showed that there is a remarkable change in the base materials viz., Ca and Si content and XRD results revealed the absence of Calcium Hydroxide. Both the results confirmed the biodeterioration of concrete by the marine green algae.

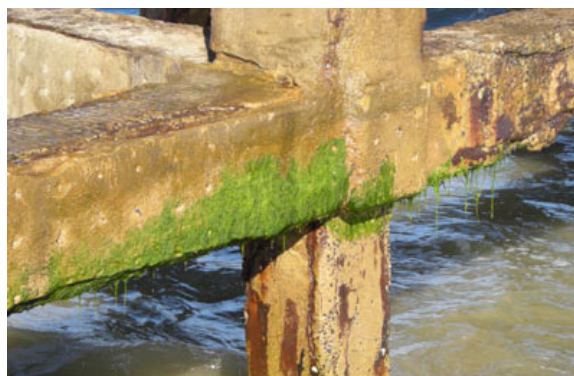
**Fig.1.** Growth of Marine Seaweed on Structural Components

Puducherry is an Indian coastal region on the Bay of Bengal. There are many marine structures located in the coastal area. These structures deteriorate due to the macro flora Figure 1 present in the sea water [4,5,6,7,8,9]. Though a secondary deterioration process, there is significant effect due to this macro flora [10,11,12]. The ambient condition prevailing in the coastal area helps the growth of *Ulva fasciata* round the year. The growth of *Ulva fasciata* on concrete structure in Puducherry region is found almost on all the structures. This study aims to ascertain the effect of marine chlorophyceae *Ulva fasciata* on concrete structure. For this, concrete cubes were immersed in the coastal area where there is abundant growth of *Ulva fasciata* and also simulated in the laboratory. Apart from this

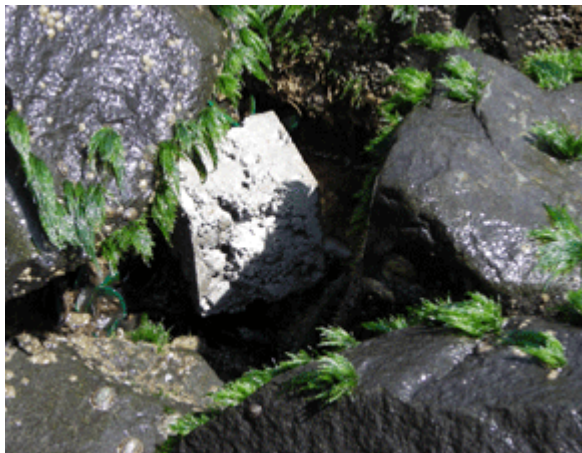
**Fig. 2.** shows the natural culture of the marine algae *Ulva fasciata* on concrete cube

- a) To culture *Ulva fasciata* naturally, several concrete cubes were kept in coastal area where there was abundant growth of *Ulva*

- fasciata (figure-2)
- b) Concrete cubes were allowed to cure in ordinary water.
  - c) Laboratory simulation has been carried out to culture the macro algae on the concrete cube. For the simulation, Humidity oven was used (Figure-3). The details of oven are as follows:

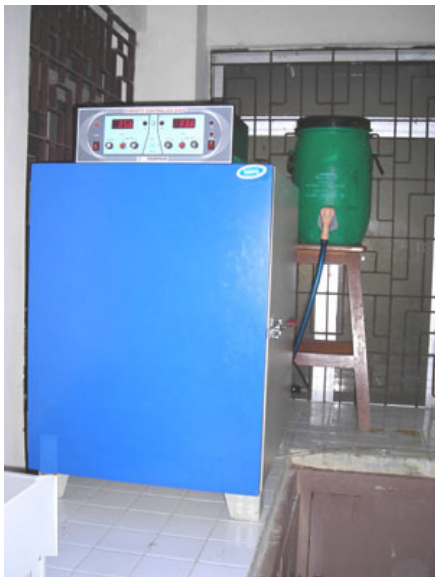
**Fig. 3.** shows the Laboratory culture of the marine algae *Ulva fasciata* on concrete cube

Double walled, inner S.S.304 / 316 grade & outer S. Steel or GI dully Epoxy Powder coat / finish, gap filled with Glass wool with outer metallic door provided. Chamber is illuminated

The ambient condition maintained in the chamber is as follows. Samples were incubated under lighting conditions of 2000 lx, 12 h/day with a “daylight” with white fluorescent lamp. The temperature is maintained at 30 °C. The relative humidity is maintained as 90% [4].

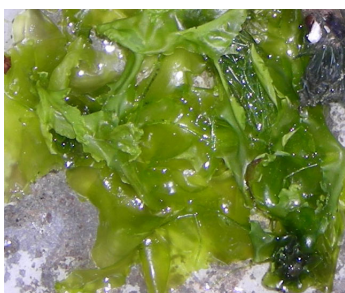
Fig. 5. *Ulva fasciata* species

The species collected by scarping from the surface of concrete was identified as *Ulva fasciata* Figure-5
