# Experimental Studies on GFRP Repaired Hollow-Block Concrete Sections

**Abstract:** This study evaluates two different types of techniques for concrete hollow-block sections reinforced with traditional steel rebars and wire meshes, and compares their structural behaviour to that of an ordinary reinforced concrete beam section. The comparisons are based on the responses both before and after they were repaired with glass fibre reinforced polymers (GFRP). The specimens were subjected to concentrated loading up to initial failure. After failure, the specimens were repaired and loaded once again until ultimate failure. It was shown that the success of the repair by GFRP depended on the mode of failure of the hollow-block concrete beams.

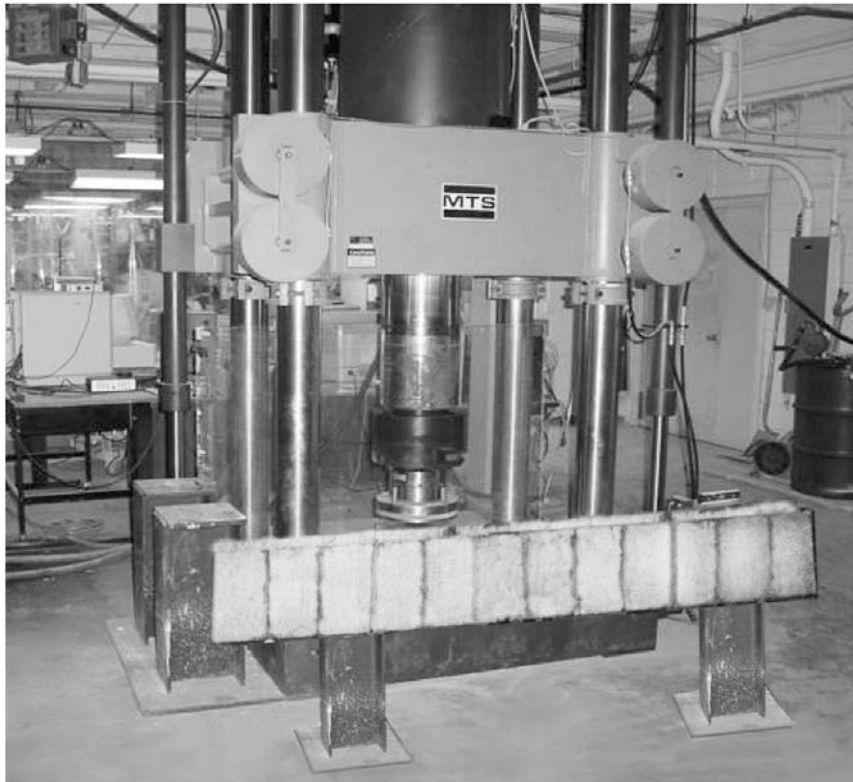
**Fig.1** Test Set-up

concentrated load acting at mid-span, as shown in Fig 1.

The specimens were tested using a 980 kN Universal testing Machine; a dial gauge having a travel of 25 mm was used to record the vertical deflection at the bottom of the mid-span of the beam.

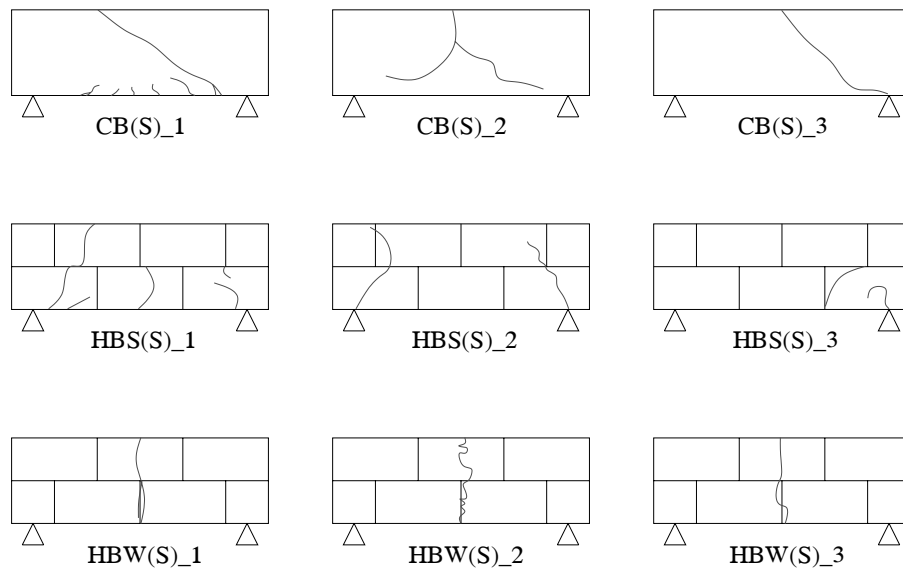
Fig. 2(a) Crack patterns for Short Beams

Figure 2(a) shows that short beam specimen types BC(S) and HBS(S) mainly developed shear cracks. The exception was HBS(S)<sub>3</sub>, in which the cracks were developed near one of the supports. The failure for this case was due to probable adjustment problem in its supports.

Here, it should be noted that flexural cracks appeared in the flexural span as the load was increased in all the beam specimens. However, further increase of load caused the development of the shear cracks which resulted in the final failure of the beams. Accordingly, it can be stated that ultimate strength of the masonry beams reinforced using steel bars was due to shear and that failure of the reinforced concrete specimens was similar to the masonry beam specimens. For the HBW(S) beam specimens, cracks developed near mid-span and started from bottom to top. These cracks indicate clearly that the lightly reinforced beam specimens

Various failure modes were recorded for the different beam types. The recorded crack patterns for the different beams tested in this study are given in Figure 2(a, b). The investigation of failure modes can be

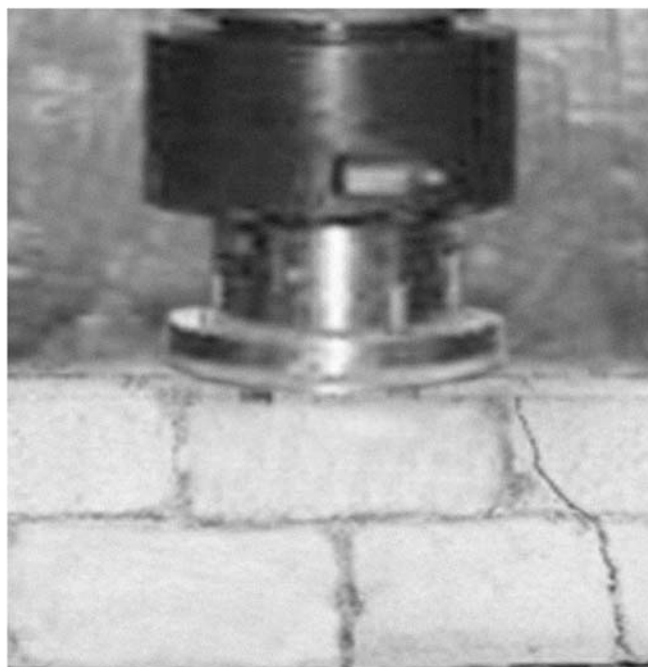
After the initial fracture, the cracks for both groups (small and long beams) opened relatively rapidly. In all cases of the beams failing in shear, the complete collapse of the specimens was prevented due to the dowel action of the reinforcing bars, as shown in Fig. 3.

**Fig. 3** Shear Failure for Beam Tests

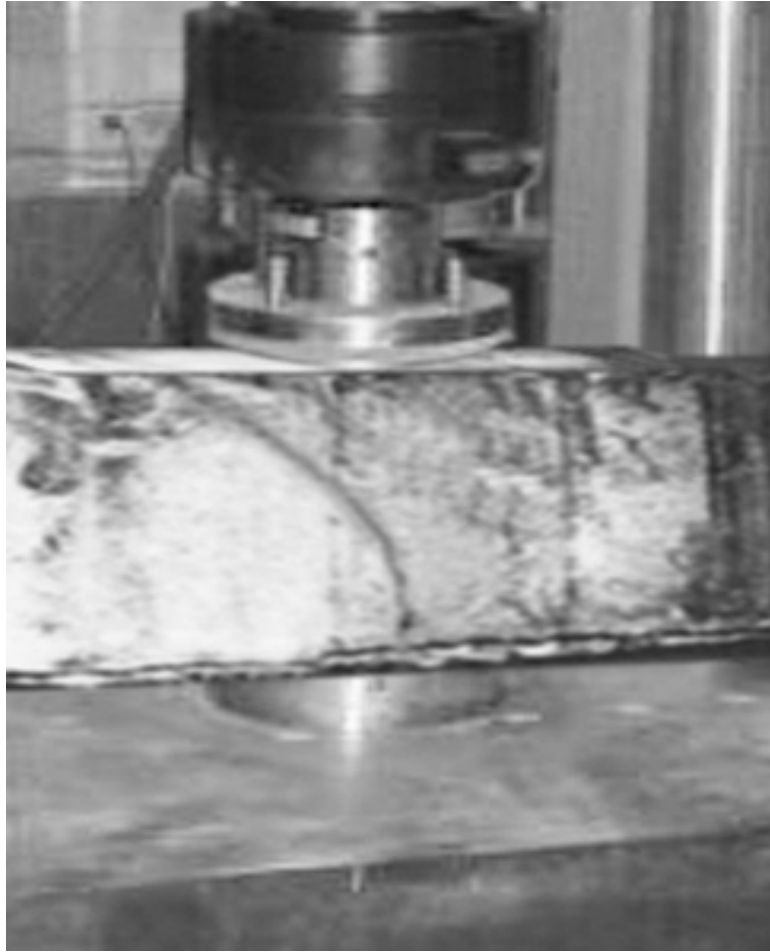
**Fig. 4** Shear Failure of Beam with GFRP

For all the beam specimens repaired by GFRP sheets, it was observed that most of the crack patterns recorded was similar to those of the original beams. These cracks either resulted in fracture of the GFRP layer or resulted in its delamination from the two vertical sides of the beams, as shown in Fig. 4.

The ratios of the load carrying capacities of the beams after repair to their load carrying capacities before repair ( $P_{rep}/P_{vir}$ ) are presented in column 7 of Table 1. It is seen that the ratio of restored load carrying capacities for the CB(S) and HBS(S) were 47% and 76%, respectively. The load carrying capacities of all the remaining beams were restored. CB(S) and HBS(S) failed at lower loads and higher deformations without having increased toughness. These beams failed in shear. This implies that the repair of shear damaged beams was not efficient.
