Technical Note

Construction of relief wells under artesian flow conditions at dam toes:
engineering experiences from Karkheh earth dam, Iran

M. Heidarzadeh^{1,*}, A. A. Mirghasemi², H. Niroomand³

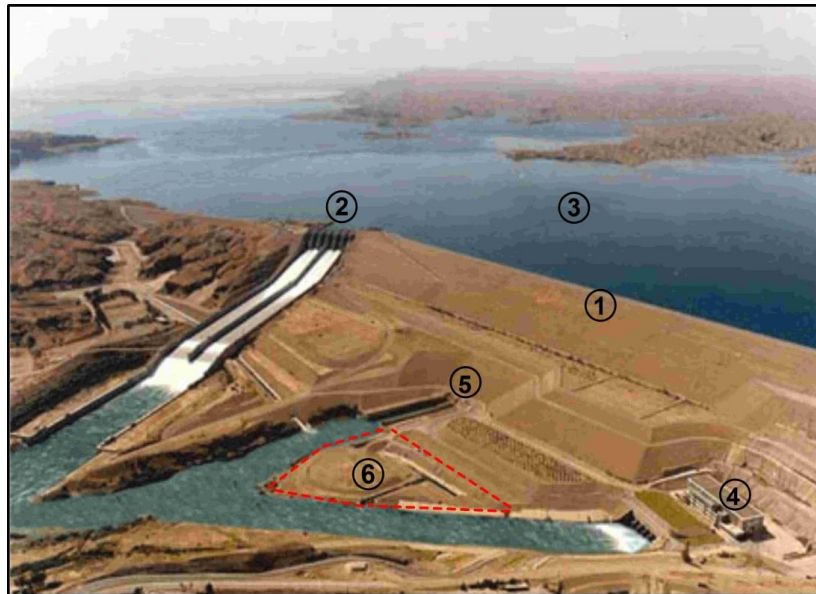
Fig. 1 General plan of the Karkheh dam project. The numbers represent: 1, dam crest; 2, spillway; 3, reservoir; 4, powerhouse; 5, diversion culverts; and 6, the location of the new relief wells at dam toe (the red-dashed polygon)

Karkheh, an earth and rockfill dam with the height and length of 127 and 3030 m respectively, is the largest dam in Iran in view of reservoir capacity (Fig. 1). The capacity of

the Karkheh River, a power house with total capacity of 400 MW at the left abutment and a gate-controlled chute-type spillway (Fig. 1). The Karkheh Dam provides about 4 billion cubic meter of regulated water to irrigate 320,000 hectares of downstream farmlands.

Considering the presence of an artesian aquifer in the foundation of the Karkheh dam and associated probable uplift pressure in the future, some relief wells were constructed in the downstream toe of the dam during its construction (1995-2001) (red-dashed polygon in Fig. 1). These well penetrated from 10 to 20 m into the artesian aquifer with spacing of about 20 m from each other. In total, 19 relief wells with the diameter of 2 or 3 inches were constructed to relieve part of the excess uplift pressure of the artesian aquifer and consequently to improve the safety factor of the area against instability (Mahab Ghodss Engineers 1998 [10]). After the reservoir impoundment in February 2001, these wells discharged water from the confined aquifer and relieved the existing hydrostatic pressure. Due to some shortcomings in the installation of these wells, and improper estimation of the foundation permeability (Mirghasemi and Pakzad 2005 [11]), they were not able to effectively discharge water from the confined aquifer. At the highest reservoir level, the total amount of water discharge from 19 relief wells was about 35 lit/sec which was a disappointing record.

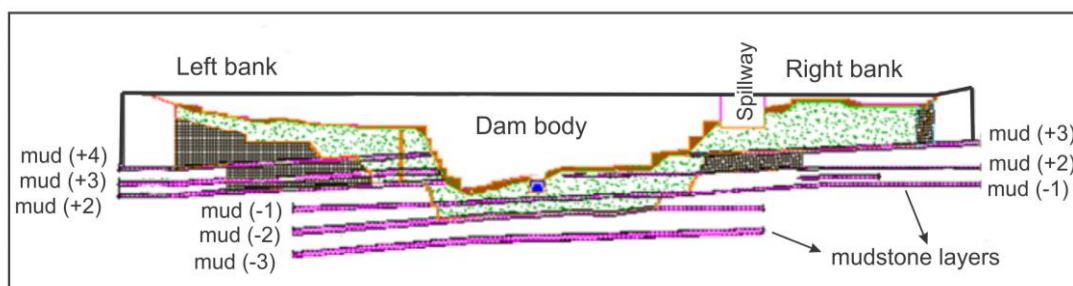
Fig. 2 Karkheh dam longitudinal section showing dam geological layers. Dotted and hatched areas represent the extensions of the dam's old and new plastic-concrete cutoff walls. The figure is exaggerated in the vertical direction

dam is responsible for the establishment of high uplift pressure at the downstream toe of the dam. Karkheh dam is placed on a horizontally-stratified foundation which is a combination of permeable conglomerate and relatively impervious mudstone layers (Fig. 2). The overall permeability of the conglomerate is estimated to be in the relatively high range of about $4-9 \times 10^{-4}$ m/s. The impervious horizontal mudstone layers stratify the conglomerate with 3 to 9 m thickness and a permeability of about 10^{-7} to 10^{-10} m/s, which are bedded horizontally in the area of the project (Fig. 2). In Fig. 2, the mudstone layers are numbered due to the river bed level so that the layers located above and below the river bed level are entitled with plus and minus numbers, respectively.

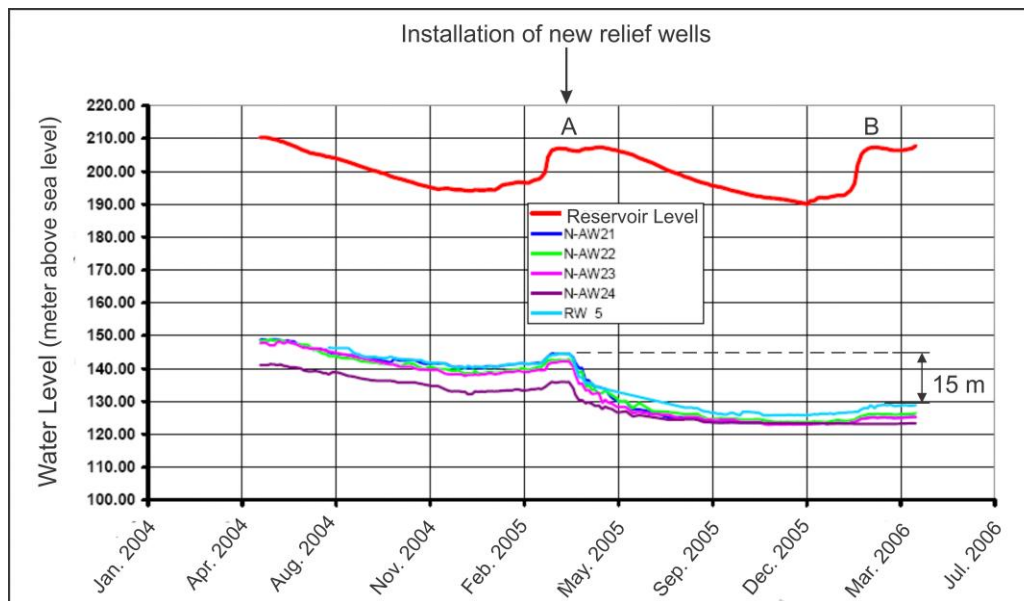
Fig. 3 Water level fluctuations for the conglomerate layer between mudstone layers (-3) and (-2) in some observational wells, installed in the downstream of the Karkheh dam. The thick-red line at the top of the figure shows reservoir water level

To monitor the performance of these relief wells and to determine their precise effect on the reduction of the uplift pressure, some observational wells were installed in the artesian aquifer. Figure 3 presents fluctuations of water level in the conglomerate layer between mud (-3) and mud (-2) at 5 observational wells, installed at the downstream of the dam. These observational wells were installed at the dam toe in the area shown with the red-dashed polygon in Fig. 1. As can be seen, for the reservoir water level of around 200 m (in September 2004, Fig. 3), the water level in the observational wells was around 140 m. Since the elevation of the dam toe is around 120 m, the water levels in the observational wells produce an uplift pressure of around 20 m (i.e., 2 atm) to the dam toe. For the reservoir water level of 210 m (in April 2004, Fig. 3), the hydrostatic pressure to the dam toe is about 30 m above the ground level (Fig. 3). Such high uplift pressures decrease the safety factor of the dam toe to the unsafe value of 0.95 (Mahab Ghodss Engineers 2004 [5]). Therefore, installation of new relief wells was necessary to relieve part of these excessive uplift pressures and to assure the stability of the dam toe.

wells was used (Fig. 3). Based on these observational wells, the water surface was estimated about 15-20 m above the ground surface at different locations in the region shown by dashed-red polygon in Fig. 1. For controlling artesian flow, a 20-inch diameter vertical pipe with a length of 15-20 m was attached to the top of the 20-inch casing (Fig. 5). The artesian water flow was stopped by adding this long vertical pipe to the top of the well. After the artesian water flow was stopped, filter materials were placed and the interface of the mudstone layer (-2) was blocked (Figs. 4-5).

The best way to evaluate the performance of new relief wells in reducing the regional uplift pressure is measurements from downstream observational wells (Fig. 3). As shown by an arrow in Fig. 3, new relief wells started to be installed around March 2005 (point A in Fig. 3) where the water elevation in the observational wells was about 145 m. Reservoir water level was at 208 m above sea level at this time. It is clear that to evaluate the performance of new relief wells, different water elevations in the observational wells should be compared with each other at the same reservoir water level. Around one year after the installation of new relief wells (i.e., February 2006), the reservoir water level reached the same level of 208 m (point B in Fig. 3). It can be seen that at point B, the water elevation in observational wells decreased to the value of 130 m suggesting a 15-m decrease in regional uplift pressure. This shows that the new relief wells were successful in releasing part of the extreme uplift pressures. Table 1 presents the amount of water discharge of each of the newly-installed large-diameter relief wells. The discharge from each newly-installed small-diameter well was around 10 lit/s. From Table 1 and taking into consideration the discharge from small-diameter wells, the total water discharge of the new relief wells is about 900 lit/s. The drainage discharge from all old relief wells (9 wells- Fig. 6) was around 35 lit/s.

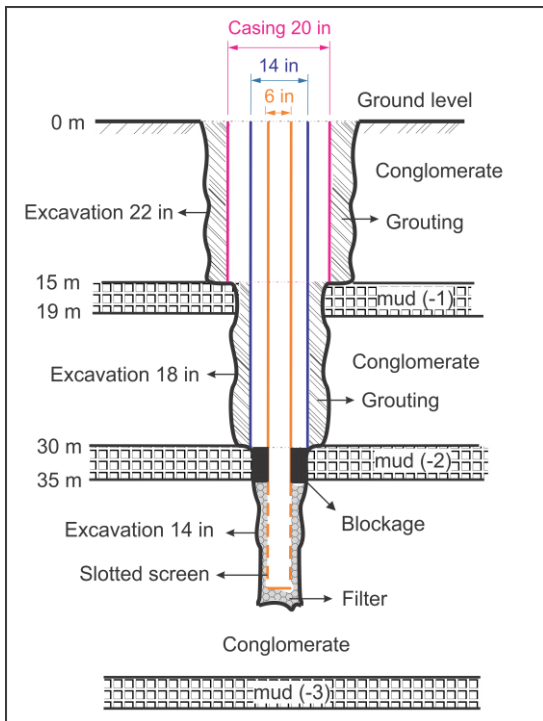
Fig. 4 Sketch showing the details of the telescopic well used for the installation of new relief wells at the toe of the Karkheh dam

The method used in Karkheh dam is based on a telescopic drilling technique in which drilling diameter decreases by depth. This method, which is pretty old and is popular in oil industry, presented various advantages in our practice which is discussed later in the article. Figure 4 shows the details of the telescopic well used for the installation of new relief wells at the Karkheh dam toe.

In this technique, first, using the direct rotary method, the well was drilled down to a few meters below the top of the mudstone layer No. (-1) with a diameter of 22 inches. Then, a 20-inch diameter casing was installed to 1 meter below the top of the mudstone layer No. (-1) (Fig. 4). Sand backfill having grade size in the range of 0-5 mm was placed in the space between the borehole wall and the casing. It can be noted that a one-inch narrow pipe was attached to the casing during its installation. This narrow pipe was used later to inject grouting materials to the sand backfill using low pressures in the range of 1-5 kg/cm². The grouting materials were a combination of water, cement with the water/cement ratio of 1/2, and conbex-100 to the amount of 0.5 percent by volume of cement. Then, the well construction was stopped for about 3 days to

The next step was installation of a 14-inch casing down to 1 meter below the top of mud (-2) (Fig. 4). The boring diameter for this casing was 18 inches (Fig. 4). Similar to the first step, the conglomerate layer confined between mud layers (-1) and (-2) was water proofed using grouting. This stage of water proofing was more challenging because the aquifer located in the bottom of mud (-2) was artesian.

The most challenging task during the installation of new relief wells was cutting of the mudstone no. (-2) in order to penetrate into the artesian aquifer (Fig. 4). As mentioned above, the conglomerate layer confined between mudstone layers (-3) and (-2) was under extreme artesian pressure of around 20-30 m above the ground level. Therefore, it was necessary to control the existing artesian conditions in order to be able to block the aquifer and to place the filter material (Fig. 4). Before proceeding this step, we needed to estimate the amount of existing uplift pressure in the artesian aquifer and consequently to calculate the potentiometric head of the water. For this, information obtained from observational

To stop uncontrolled artesian flow encountered during the installation of the first observational well, at first, the well was filled with a large amount of surcharge consisting of concrete, gravel and clay. However, it was not successful after two days of filling and artesian flow continued to wash out soil particles. At this stage, we noticed that the artesian pressure for the conglomerate layer between mudstones (-3) and (-2) is far more than our previous expectations. In fact, this incident was an opportunity to have a realistic understanding of the concentrated and high uplift pressure at the Karkheh dam toe. Finally, we reached the idea that the well needs to be re-drilled and its walls should be grouted down to the mudstone (-2). In this process, about 20 tons of cement was grouted along with the placement of 10 m³ of sand (0-20 mm). In fact, the idea for the installation of new relief wells using the method shown in Fig. 4 was the outcome of our challenges with the failure of this observational well.

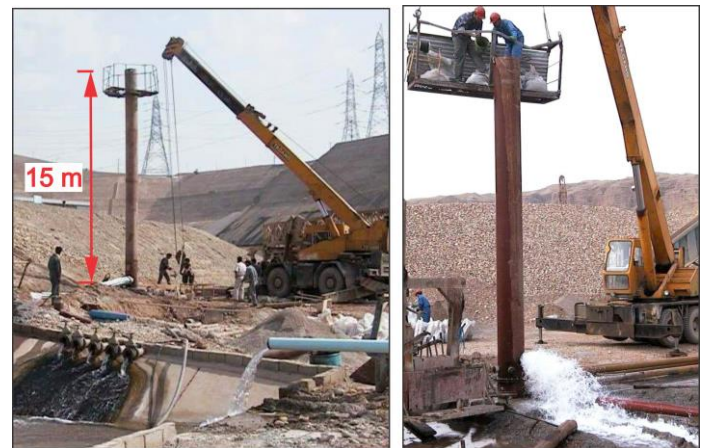
Fig. 5 (Left): controlling the artesian flows by adding long vertical pipes at the top of the relief wells at the Karkheh dam site. (Right): placing filter materials after controlling of the artesian flow

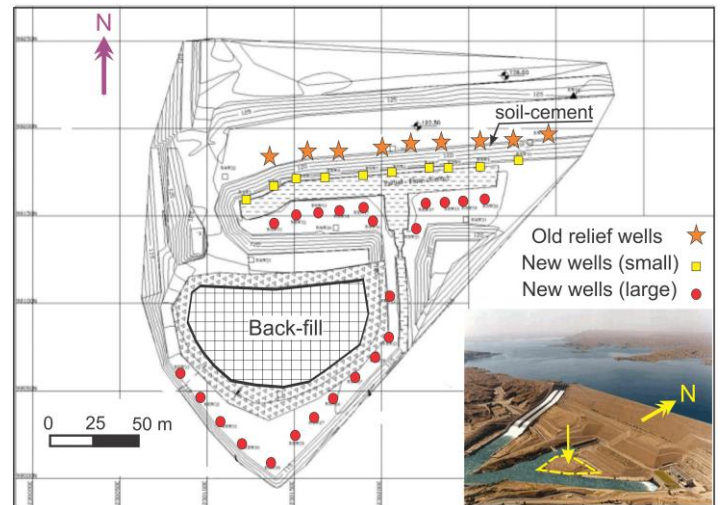
Fig. 6 Location and arrangement of the old and new relief wells installed at the downstream toe of the Karkheh dam

Using this technique, 33 new relief wells were installed at the toe of the dam which are shown in Fig. 6. As shown in Fig. 6, new relief wells are of two types: 10 wells with small diameter and 23 wells with a larger diameter of 6 in. The small-diameter wells are installed at the northern part of the dam toe (Fig. 6) where construction of larger-diameter wells was not possible due to some limitations. In addition to relief well installation, back filling of the dam toe also was considered to increase the safety factor of the area which is shown in Fig. 6.

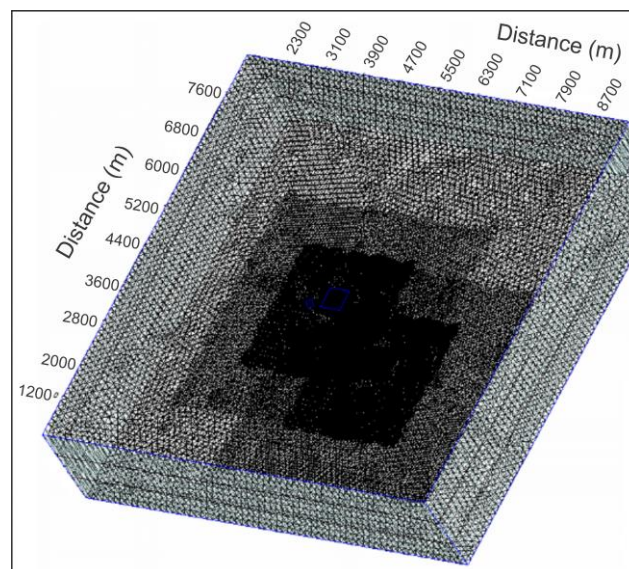
Fig. 7 Computational 3D mesh used for modeling the artesian aquifer confined between mudstone layers (-3) and (-2) at the Karkheh dam toe

In our model, a rectangular domain having dimension of 8 km \times 8 km was modeled using 70876 nodes and 105516 6-noded triangular-prismatic 3D elements. We assumed the steady state seepage condition for our modeling (Fig. 7). The domain length of 8 km seems enough because the mudstone layer (-2) crosses the reservoir at the distance of 4 km from dam axis.

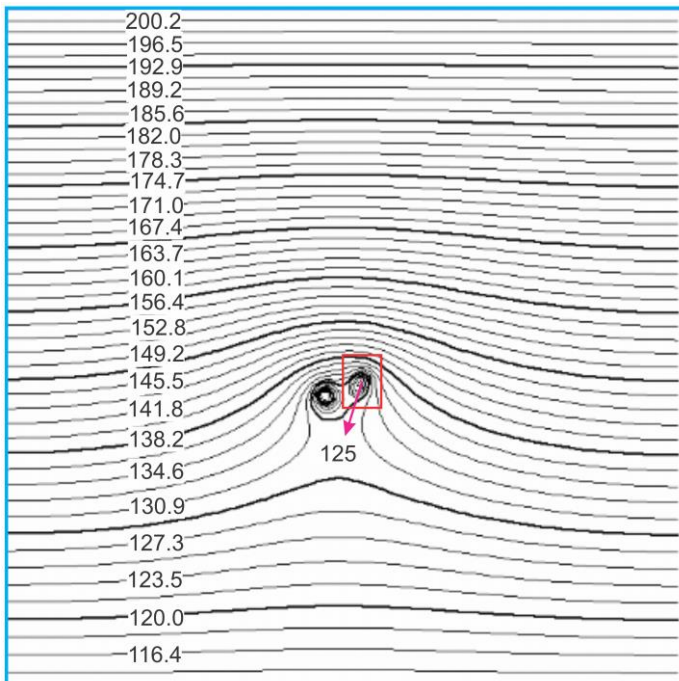
Fig. 8 Results of 3D seepage simulations for the artesian aquifer confined between mudstone layers (-3) and (-2) at the Karkheh dam toe. The lines represent iso-potential lines. The numbers are water head in meter above sea level. The red rectangle shows the dam toe where the new relief wells were installed

This calibration resulted in the horizontal permeability of 1.6×10^{-3} m/s. Figure 8 shows the iso-potential lines for the modeled region indicating that the water head significantly decreased at the dam toe (red-rectangle in Fig. 8) due to the installation of the new relief wells. According to Fig. 8, the modeled water level at the downstream toe is around 125 m which is close to the observed values (Fig. 8 and Table 2). In other words, the

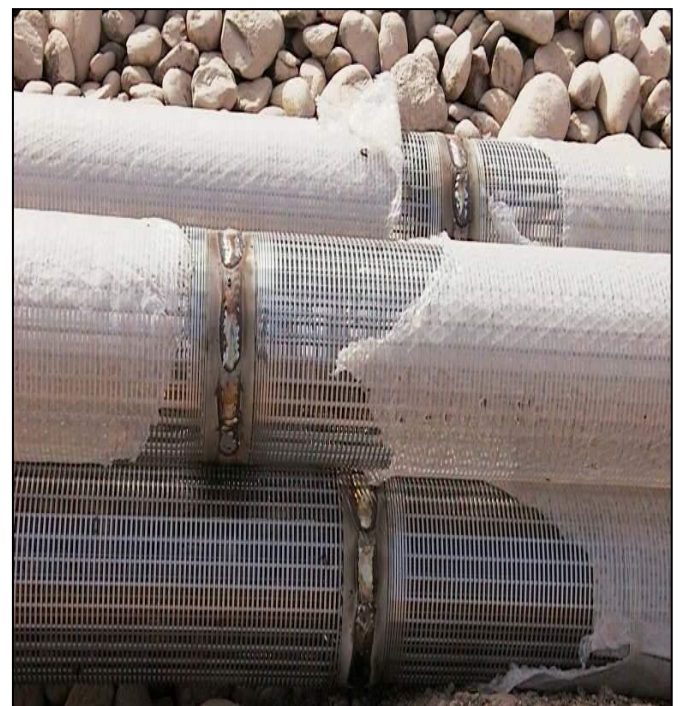
Fig. 9 Picture showing the arrangement and size of the well screens used for the new relief wells at the Karkheh dam

Our experience suggests that the arrangement of the openings and their size are of vital importance for the proper function of the wells. As discussed above, one of the main shortcomings of the old wells was inappropriate opening arrangement and size. For the new wells, we changed the arrangement of the screens and used a regular shape for them (Fig. 9). In addition, we significantly increased the ratio of opening area to the total well area. In fact, there is no limit for the maximum screen area as long as the filter materials are prevented from entering the well. Therefore, we maximized the opening area of the wells (Fig. 9).
