## Experimental in-plane behavior and retrofitting method of mud-brick walls

F. Tootoonchy, B. Asgarian\*, F. Danesh

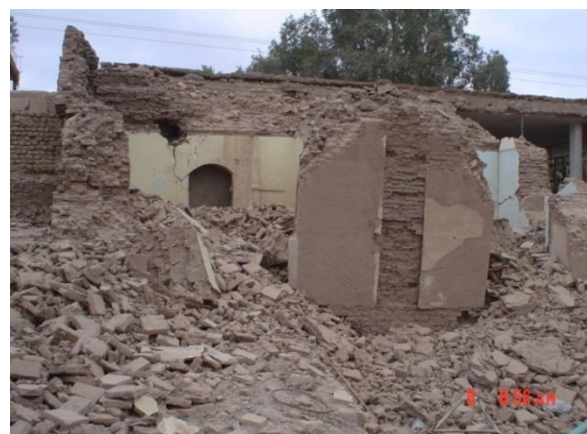
Fig. 1 A view of one sample destroyed adobe house after Bam earthquake

Adobe building made from mud-brick is a construction system that uses mud-brick to form bearing or non-bearing walls. It is estimated that about 30% of world's population lives in adobe and mud-brick buildings. In addition a number of historical and archeological building made from mud-brick. A lot of mud-brick buildings are in seismic active areas. As mud-brick is very brittle and low-strength material with heavy mass. Building made from this type of material are highly vulnerable in seismic active areas. A sample of destroyed adobe house after Bam earthquake is shown in Fig. 1.

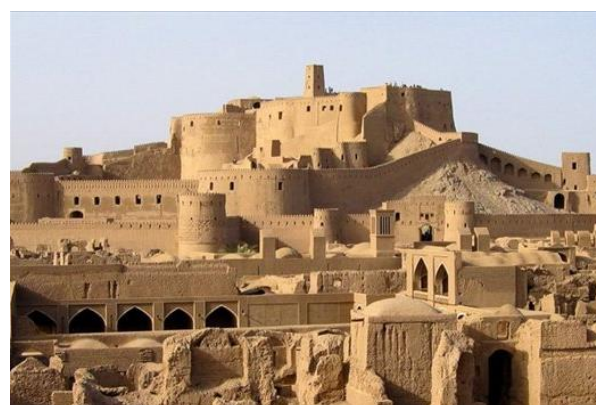
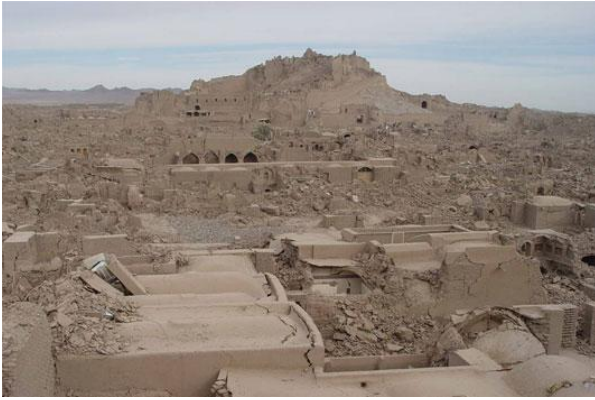
**Fig. 2** View of Bam Citadel before and after Bam earthquake

The largest mud-brick structure is the Bam citadel which has been suffered serious damages during 2003 Bam earthquake. During Bam 2003 earthquake, most of the adobe buildings were destroyed, more than 26,000 people were died and over 60,000 were left without shelter [1]. Fig. 2 shows Bam citadel before and after 2003 earthquake.

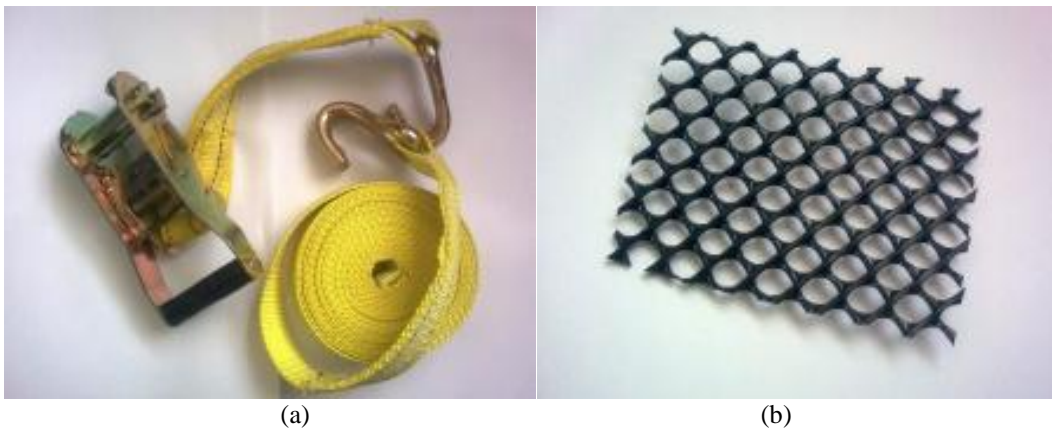
**Fig. 4** (a) Tarpaulin belt, (b) Polypropylene lace

In this regards, some mud-bricks similar to original ones were reproduced from red clay of Abyaneh. Six scaled walls with the dimension of about  $1\text{m} \times 1\text{m}$  were constructed by using same red clay mortar. After about one month from the construction time, scaled walls were tested against horizontal loads applied at top of them in the presence of vertical load as shown in Table 1. In the first four samples (MW1 through MW4), the walls were subjected to lateral loads in presence of different amount of vertical stress as shown in Table 1. Meanwhile, no retrofitting was considered for these walls. Tested samples No. 5 and No. 6 (RMW1 & RMW2) had the same dimensions and vertical stress as sample No. 3, but these walls were retrofitted with propylene laces and tarpaulin belts as shown in Fig. 4. Polypropylene laces and tarpaulin belts (with 50 mm wide) were used to improve the performance of these walls (RMW1 and RMW2). Propylene lace which in  $10^{\text{mm}}$  mesh (Fig. 4) is strong enough to environmental conditions and has ductile behavior.

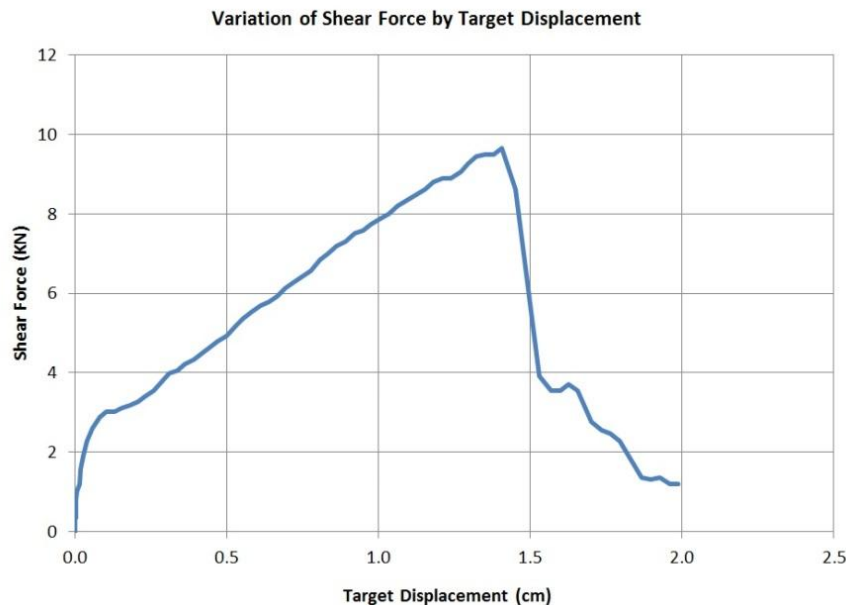
Fig. 10 Curve of shear force against sliding displacement of wall crown MW1

Shear force-lateral displacement curve of MW1 is shown in Fig. 10. Short initial elastic behavior can be observed at the start of the test which was then adjusted by forming a crack in the bed joint. Then, a sudden strength fall was observed during rocking motion mechanism.

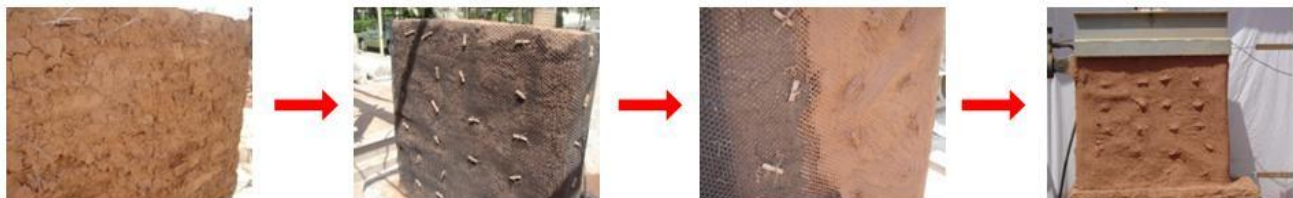
**Fig. 14** Installation process of polypropylene lace on adobe walls

behavior and to prevent the wall uplift and rocking motion mechanism was proposed. For this purpose, RMW1 is surrounded only by polypropylene lace. After installing twisted wires in the wall at a distance of about 0.2<sup>m</sup>, this net is fixed to the wall and then it is filled with clay mortar. The proposed method is a simple and cheap way which can be executed by an un-skilled labor. In the proposed method, when the wall is subjected to lateral loads, a tension force occurs in membrane net of polypropylene lace; by increasing the wall volume, its reaction is imposed on the wall in the form of a pressure confining force. It causes an increase in the shear capacity, ductility and energy absorption of the retrofitted wall compared to original ones. Fig. 14 shows the installation stages of the proposed method. Table 1 also shows the details of a test performed on a reinforced wall with polypropylene lace.

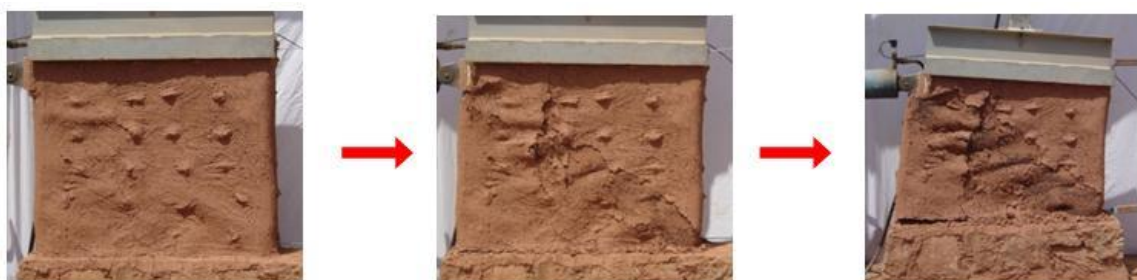
**Fig. 15** Damage mechanism of RMW1 wall

To compare the results, a vertical uniform load same as MW3 was applied to retrofitted walls and then the lateral displacement was applied to walls. Fig. 15 shows the views of the RMW1 during the test. It can be seen that the volume of the wall toe was increased during test and the surrounding net was stretched. Then, the volume of the wall was increased around the wall diagonal. Moreover, diagonal cracks were formed without any collapse despite the fact that wall underwent a considerable deformation. Ultimately, rocking motion mechanism was formed following appearance of diagonal cracks. Fig. 16 presents variation of shear force against lateral displacement of RMW1 wall.

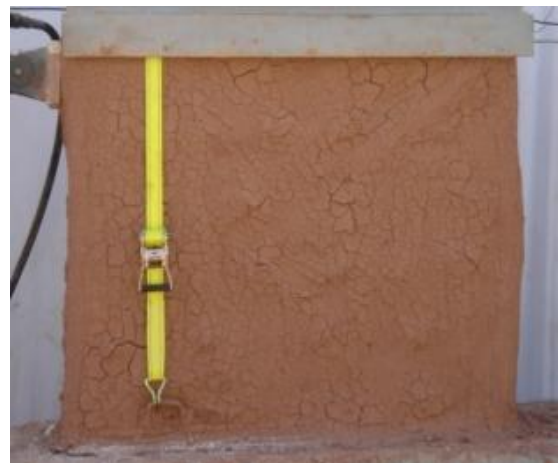
**Fig. 17** Use of tarpaulin belts to prevent rocking motion mechanism

It was observed that the application of polypropylene lace caused suitable cohesiveness of the wall compared to the behavior of the similar wall without proposed retrofit method (MW3). It can also be seen that using polypropylene lace resulted proper integrity of the wall. Actually, better performance of the wall was observed by postponing the occurrence of rocking motion mechanism. The sample RMW2 was connected to its foundation by tarpaulin belts (Fig. 17) in addition to using the polypropylene lace same as RMW1 sample. Adding tarpaulin belts helps the wall to postpone or even prevent rocking motion mechanism. Table 1 also shows the details of a test performed on RMW2.

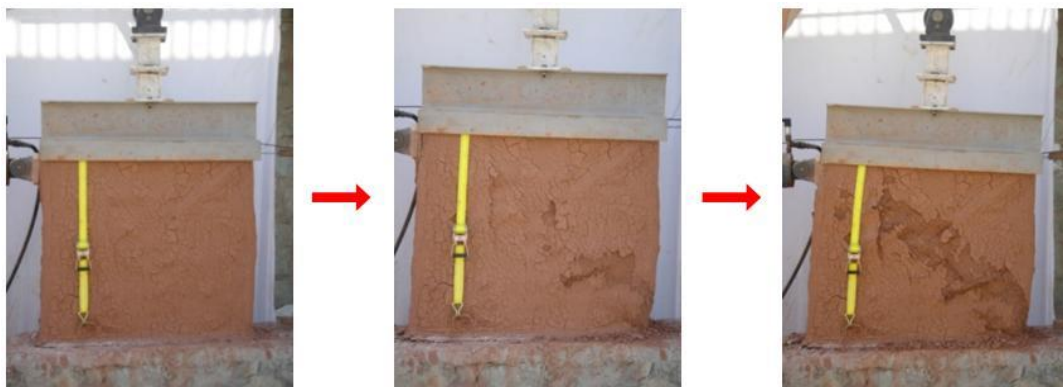
**Fig. 18** Damage mechanism of RMW2 wall

Fig. 18 shows the damage mechanism of RMW2 wall. It was observed that with starting the load and upon completion of initial stages, volume of the wall toe was increased. Since, there was no possibility of occurrence of rocking motion mechanism, the wall begins forming diagonal cracks and ultimately the test is stopped by tearing of the net from the overlapping point in the wall toe.

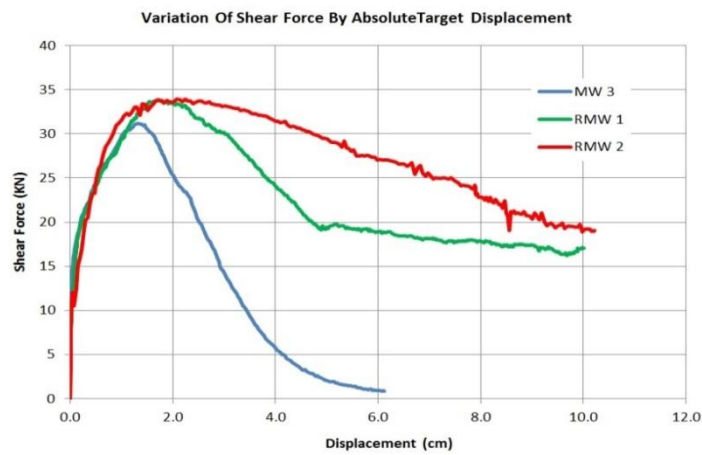
**Fig. 20** Comparison of experimental behavior of MW3, RMW1, RMW2 walls

Shear force-lateral displacement curve of RMW2 is shown in Fig. 19. Fig. 20 compares shear force-lateral displacement of MW3, RMW1 and RMW2. This Fig.

shows that proposed retrofitting method increases shear capacity and energy absorption of the mud-brick wall significantly.
