## Investigation of long term coupled effect of high temperature and constant high humidity on corrosion rehabilitated patches of reinforced concrete structures

### Abstract

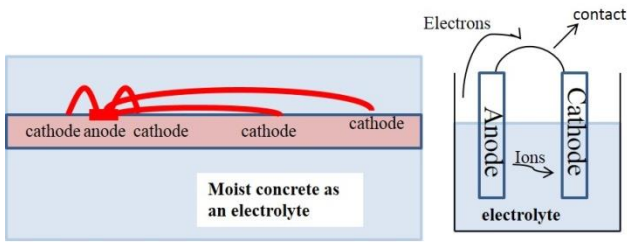
Figure 1 Separation of cathode and anode

The authors of this research paper, previously investigated and established the phenomenon of macro-cell formation in the repaired reinforced concrete patches due to the separation of anode and cathode [9], which is illustrated in Fig. 1. They also corroborated that the presence of high chloride content aided by the severe environmental conditions i.e. varying temperature and high constant humidity, not only break the passive film which protects steel from further corrosion but also accelerate the corrosion of reinforcement steel bars even in repaired reinforced concrete patches [10]. However, what would be the effect of long term coupled effect of varying temperature and constant high humidity on macro-cell corrosion of such repaired RC patches remained a question and leads to the objectives of this research paper.
