Biodeterioration of Coastal Concrete Structures by Marine Green Algae

Abstract: Puducherry is a coastal region in India where the growth of *Ulva fasciata* (Delile) is very abundant on all marine structures. Though the detrimental effect of this macro algae *Ulva fasciata* is a secondary one, its effect has to ascertain. To know its effect, the basic mechanism by which *Ulva fasciata* deteriorates concrete structures, M20 grade concrete cubes were casted and kept in the coastal area where there is abundant growth of *Ulva fasciata* and also laboratory simulation has been carried out. To ascertain the detrimental effect by the macro algae on concrete surface, samples were collected from the concrete cubes kept in the coastal area and also from the laboratory simulated one. The collected samples were analyzed by SEM, EDX and XRD to establish the degree of deterioration done by marine algae on concrete surface. The SEM and EDX results showed that there is a remarkable change in the base materials viz., Ca and Si content and XRD results revealed the absence of Calcium Hydroxide. Both the results confirmed the biodeterioration of concrete by the marine green algae.

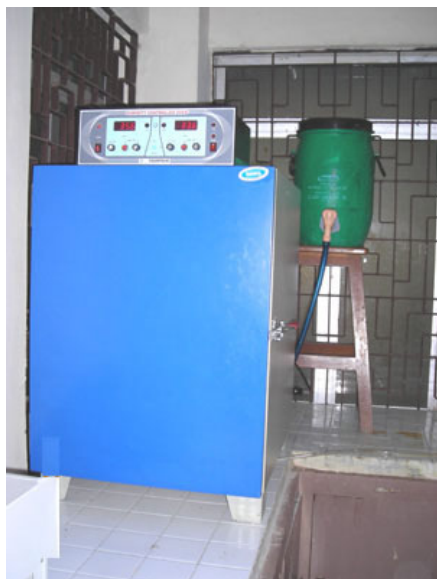
Fig. 3. shows the Laboratory culture of the marine algae *Ulva fasciata* on concrete cube

- fasciata (figure-2)
- b) Concrete cubes were allowed to cure in ordinary water.
 - c) Laboratory simulation has been carried out to culture the macro algae on the concrete cube. For the simulation, Humidity oven was used (Figure-3). The details of oven are as follows:

Construction

Double walled, inner S.S.304 / 316 grade & outer S. Steel or GI dully Epoxy Powder coat / finish, gap filled with Glass wool with outer metallic door provided. Chamber is illuminated

Cooling Facility

By Hermetically sealed branded compressor coupled with air cooled condensing unit fitted with Motor, fan blade, Electrical Accessories etc. Mounted on bottom of unit on heavy base frame.

The ambient condition maintained in the chamber is as follows. Samples were incubated under lighting conditions of 2000 lx, 12 h/day with a “daylight” with white fluorescent lamp. The temperature is maintained at 30 °C. The relative humidity is maintained as 90% [4].
