# Experimental Studies on GFRP Repaired Hollow-Block Concrete Sections

**Abstract:** This study evaluates two different types of techniques for concrete hollow-block sections reinforced with traditional steel rebars and wire meshes, and compares their structural behaviour to that of an ordinary reinforced concrete beam section. The comparisons are based on the responses both before and after they were repaired with glass fibre reinforced polymers (GFRP). The specimens were subjected to concentrated loading up to initial failure. After failure, the specimens were repaired and loaded once again until ultimate failure. It was shown that the success of the repair by GFRP depended on the mode of failure of the hollow-block concrete beams.

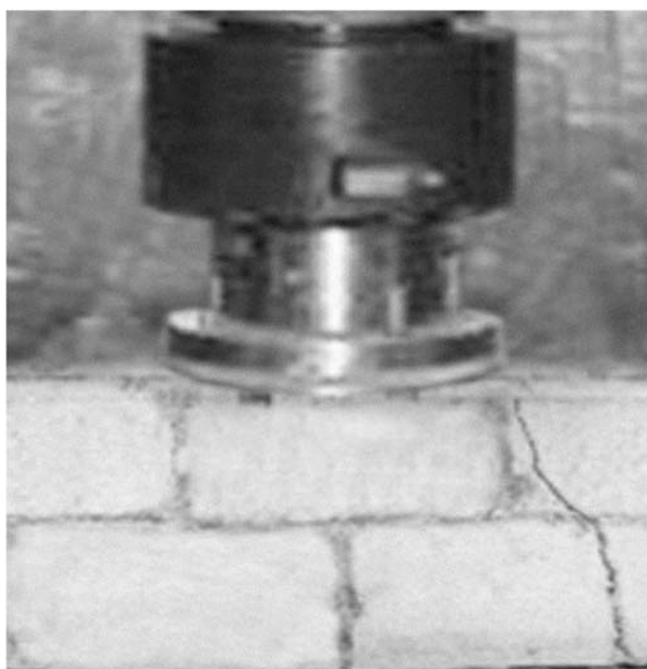
**Fig. 3** Shear Failure for Beam Tests

After the initial fracture, the cracks for both groups (small and long beams) opened relatively rapidly. In all cases of the beams failing in shear, the complete collapse of the specimens was prevented due to the dowel action of the reinforcing bars, as shown in Fig. 3.
