Technical Note

## Construction of relief wells under artesian flow conditions at dam toes: engineering experiences from Karkheh earth dam, Iran

M. Heidarzadeh<sup>1,\*</sup>, A. A. Mirghasemi<sup>2</sup>, H. Niroomand<sup>3</sup>

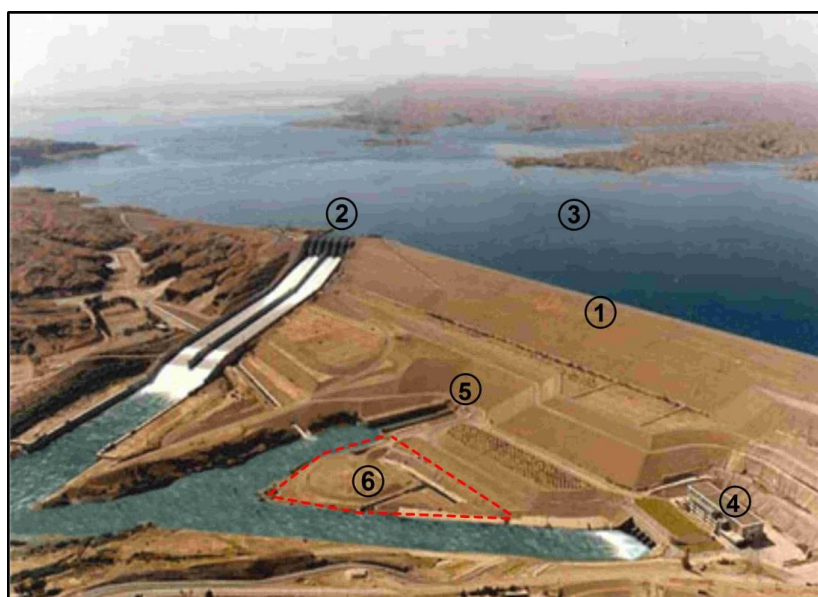
**Fig. 1** General plan of the Karkheh dam project. The numbers represent: 1, dam crest; 2, spillway; 3, reservoir; 4, powerhouse; 5, diversion culverts; and 6, the location of the new relief wells at dam toe (the red-dashed polygon)

Karkheh, an earth and rockfill dam with the height and length of 127 and 3030 m respectively, is the largest dam in Iran in view of reservoir capacity (Fig. 1). The capacity of

the Karkheh River, a power house with total capacity of 400 MW at the left abutment and a gate-controlled chute-type spillway (Fig. 1). The Karkheh Dam provides about 4 billion cubic meter of regulated water to irrigate 320,000 hectares of downstream farmlands.

Considering the presence of an artesian aquifer in the foundation of the Karkheh dam and associated probable uplift pressure in the future, some relief wells were constructed in the downstream toe of the dam during its construction (1995-2001) (red-dashed polygon in Fig. 1). These well penetrated from 10 to 20 m into the artesian aquifer with spacing of about 20 m from each other. In total, 19 relief wells with the diameter of 2 or 3 inches were constructed to relieve part of the excess uplift pressure of the artesian aquifer and consequently to improve the safety factor of the area against instability (Mahab Ghodss Engineers 1998 [10]). After the reservoir impoundment in February 2001, these wells discharged water from the confined aquifer and relieved the existing hydrostatic pressure. Due to some shortcomings in the installation of these wells, and improper estimation of the foundation permeability (Mirghasemi and Pakzad 2005 [11]), they were not able to effectively discharge water from the confined aquifer. At the highest reservoir level, the total amount of water discharge from 19 relief wells was about 35 lit/sec which was a disappointing record.

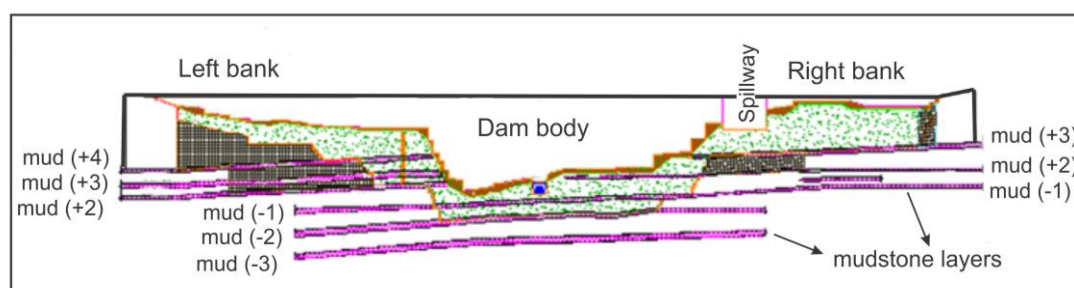
**Fig. 2** Karkheh dam longitudinal section showing dam geological layers. Dotted and hatched areas represent the extensions of the dam's old and new plastic-concrete cutoff walls. The figure is exaggerated in the vertical direction

dam is responsible for the establishment of high uplift pressure at the downstream toe of the dam. Karkheh dam is placed on a horizontally-stratified foundation which is a combination of permeable conglomerate and relatively impervious mudstone layers (Fig. 2). The overall permeability of the conglomerate is estimated to be in the relatively high range of about  $4-9 \times 10^{-4}$  m/s. The impervious horizontal mudstone layers stratify the conglomerate with 3 to 9 m thickness and a permeability of about  $10^{-7}$  to  $10^{-10}$  m/s, which are bedded horizontally in the area of the project (Fig. 2). In Fig. 2, the mudstone layers are numbered due to the river bed level so that the layers located above and below the river bed level are entitled with plus and minus numbers, respectively.

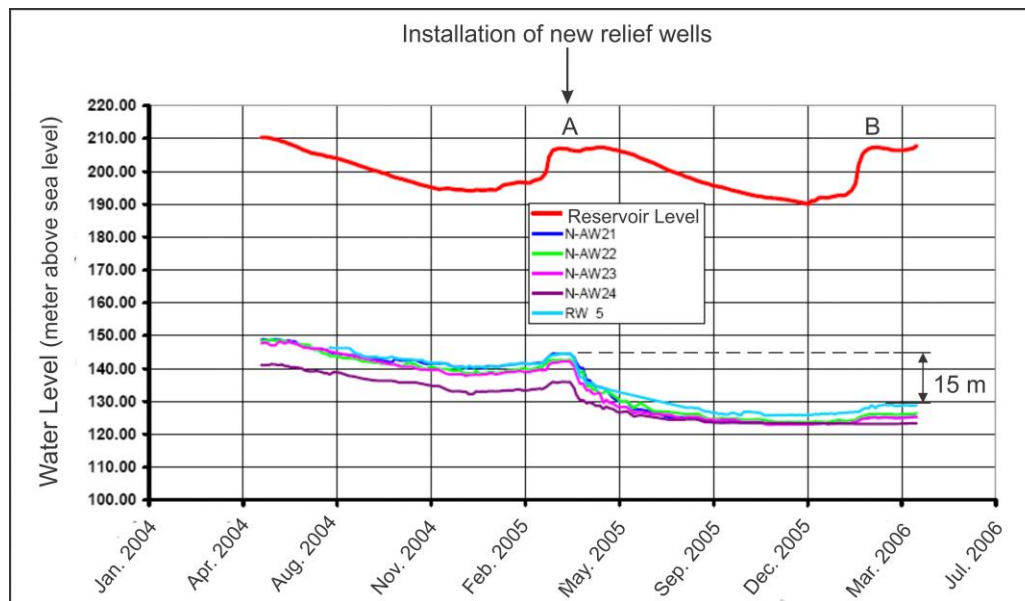
**Fig. 3** Water level fluctuations for the conglomerate layer between mudstone layers (-3) and (-2) in some observational wells, installed in the downstream of the Karkheh dam. The thick-red line at the top of the figure shows reservoir water level

To monitor the performance of these relief wells and to determine their precise effect on the reduction of the uplift pressure, some observational wells were installed in the artesian aquifer. Figure 3 presents fluctuations of water level in the conglomerate layer between mud (-3) and mud (-2) at 5 observational wells, installed at the downstream of the dam. These observational wells were installed at the dam toe in the area shown with the red-dashed polygon in Fig. 1. As can be seen, for the reservoir water level of around 200 m (in September 2004, Fig. 3), the water level in the observational wells was around 140 m. Since the elevation of the dam toe is around 120 m, the water levels in the observational wells produce an uplift pressure of around 20 m (i.e., 2 atm) to the dam toe. For the reservoir water level of 210 m (in April 2004, Fig. 3), the hydrostatic pressure to the dam toe is about 30 m above the ground level (Fig. 3). Such high uplift pressures decrease the safety factor of the dam toe to the unsafe value of 0.95 (Mahab Ghodss Engineers 2004 [5]). Therefore, installation of new relief wells was necessary to relieve part of these excessive uplift pressures and to assure the stability of the dam toe.

The best way to evaluate the performance of new relief wells in reducing the regional uplift pressure is measurements from downstream observational wells (Fig. 3). As shown by an arrow in Fig. 3, new relief wells started to be installed around March 2005 (point A in Fig. 3) where the water elevation in the observational wells was about 145 m. Reservoir water level was at 208 m above sea level at this time. It is clear that to evaluate the performance of new relief wells, different water elevations in the observational wells should be compared with each other at the same reservoir water level. Around one year after the installation of new relief wells (i.e., February 2006), the reservoir water level reached the same level of 208 m (point B in Fig. 3). It can be seen that at point B, the water elevation in observational wells decreased to the value of 130 m suggesting a 15-m decrease in regional uplift pressure. This shows that the new relief wells were successful in releasing part of the extreme uplift pressures. Table 1 presents the amount of water discharge of each of the newly-installed large-diameter relief wells. The discharge from each newly-installed small-diameter well was around 10 lit/s. From Table 1 and taking into consideration the discharge from small-diameter wells, the total water discharge of the new relief wells is about 900 lit/s. The drainage discharge from all old relief wells (9 wells- Fig. 6) was around 35 lit/s.

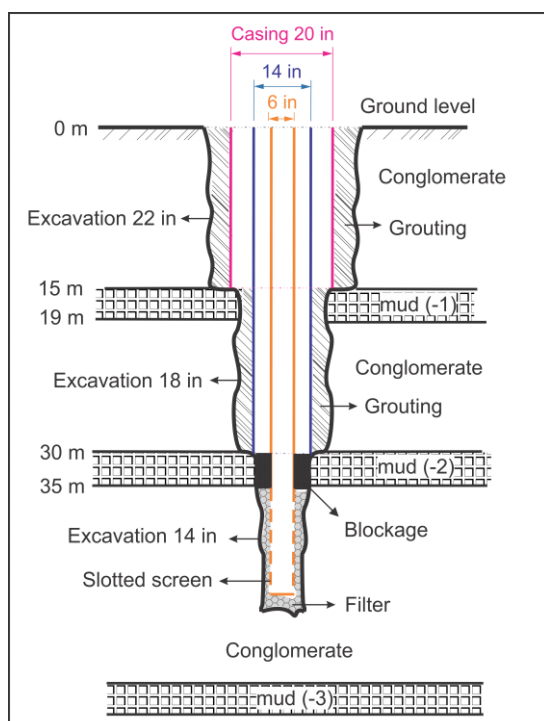
**Fig. 4** Sketch showing the details of the telescopic well used for the installation of new relief wells at the toe of the Karkheh dam

The method used in Karkheh dam is based on a telescopic drilling technique in which drilling diameter decreases by depth. This method, which is pretty old and is popular in oil industry, presented various advantages in our practice which is discussed later in the article. Figure 4 shows the details of the telescopic well used for the installation of new relief wells at the Karkheh dam toe.

In this technique, first, using the direct rotary method, the well was drilled down to a few meters below the top of the mudstone layer No. (-1) with a diameter of 22 inches. Then, a 20-inche diameter casing was installed to 1 meter below the top of the mudstone layer No. (-1) (Fig. 4). Sand backfill having grade size in the range of 0-5 mm was placed in the space between the borehole wall and the casing. It can be noted that a one-inch narrow pipe was attached to the casing during its installation. This narrow pipe was used later to inject grouting materials to the sand backfill using low pressures in the range of 1-5 kg/cm<sup>2</sup>. The grouting materials were a combination of water, cement with the water/cement ratio of 1/2, and conbex-100 to the amount of 0.5 percent by volume of cement. Then, the well construction was stopped for about 3 days to

The next step was installation of a 14-inch casing down to 1 meter below the top of mud (-2) (Fig. 4). The boring diameter for this casing was 18 inches (Fig. 4). Similar to the first step, the conglomerate layer confined between mud layers (-1) and (-2) was water proofed using grouting. This stage of water proofing was more challenging because the aquifer located in the bottom of mud (-2) was artesian.

The most challenging task during the installation of new relief wells was cutting of the mudstone no. (-2) in order to penetrate into the artesian aquifer (Fig. 4). As mentioned above, the conglomerate layer confined between mudstone layers (-3) and (-2) was under extreme artesian pressure of around 20-30 m above the ground level. Therefore, it was necessary to control the existing artesian conditions in order to be able to block the aquifer and to place the filter material (Fig. 4). Before proceeding this step, we needed to estimate the amount of existing uplift pressure in the artesian aquifer and consequently to calculate the potentiometric head of the water. For this, information obtained from observational

To stop uncontrolled artesian flow encountered during the installation of the first observational well, at first, the well was filled with a large amount of surcharge consisting of concrete, gravel and clay. However, it was not successful after two days of filling and artesian flow continued to wash out soil particles. At this stage, we noticed that the artesian pressure for the conglomerate layer between mudstones (-3) and (-2) is far more than our previous expectations. In fact, this incident was an opportunity to have a realistic understanding of the concentrated and high uplift pressure at the Karkheh dam toe. Finally, we reached the idea that the well needs to be re-drilled and its walls should be grouted down to the mudstone (-2). In this process, about 20 tons of cement was grouted along with the placement of 10 m<sup>3</sup> of sand (0-20 mm). In fact, the idea for the installation of new relief wells using the method shown in Fig. 4 was the outcome of our challenges with the failure of this observational well.

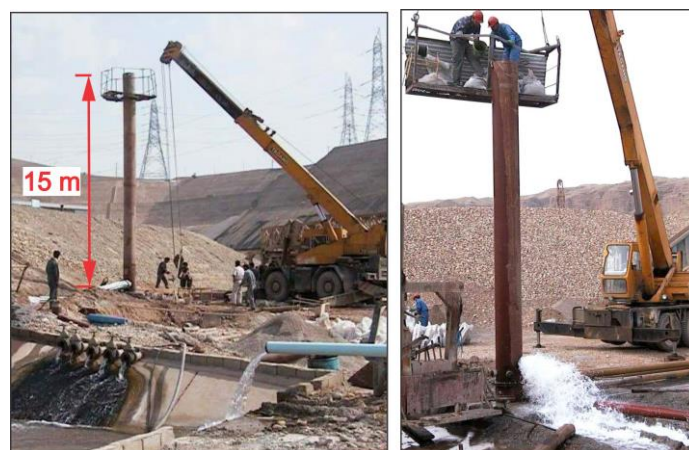
**Fig. 5** (Left): controlling the artesian flows by adding long vertical pipes at the top of the relief wells at the Karkheh dam site. (Right): placing filter materials after controlling of the artesian flow

wells was used (Fig. 3). Based on these observational wells, the water surface was estimated about 15-20 m above the ground surface at different locations in the region shown by dashed-red polygon in Fig. 1. For controlling artesian flow, a 20-inch diameter vertical pipe with a length of 15-20 m was attached to the top of the 20-inch casing (Fig. 5). The artesian water flow was stopped by adding this long vertical pipe to the top of the well. After the artesian water flow was stopped, filter materials were placed and the interface of the mudstone layer (-2) was blocked (Figs. 4-5).

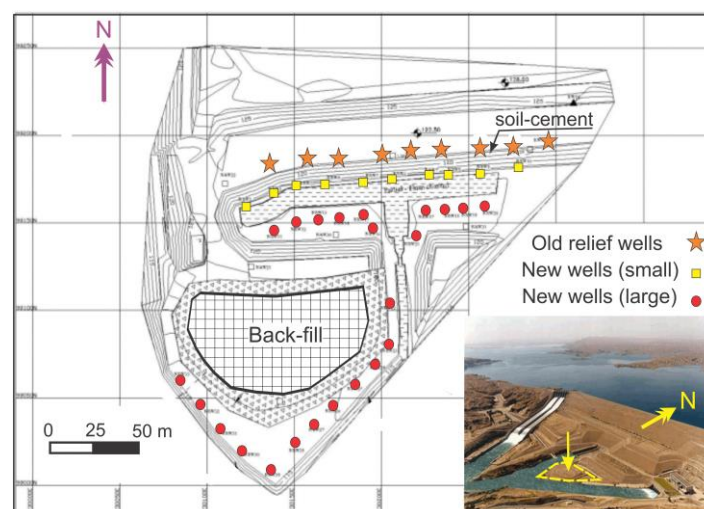
**Fig. 6** Location and arrangement of the old and new relief wells installed at the downstream toe of the Karkheh dam

Using this technique, 33 new relief wells were installed at the toe of the dam which are shown in Fig. 6. As shown in Fig. 6, new relief wells are of two types: 10 wells with small diameter and 23 wells with a larger diameter of 6 in. The small-diameter wells are installed at the northern part of the dam toe (Fig. 6) where construction of larger-diameter wells was not possible due to some limitations. In addition to relief well installation, back filling of the dam toe also was considered to increase the safety factor of the area which is shown in Fig. 6.

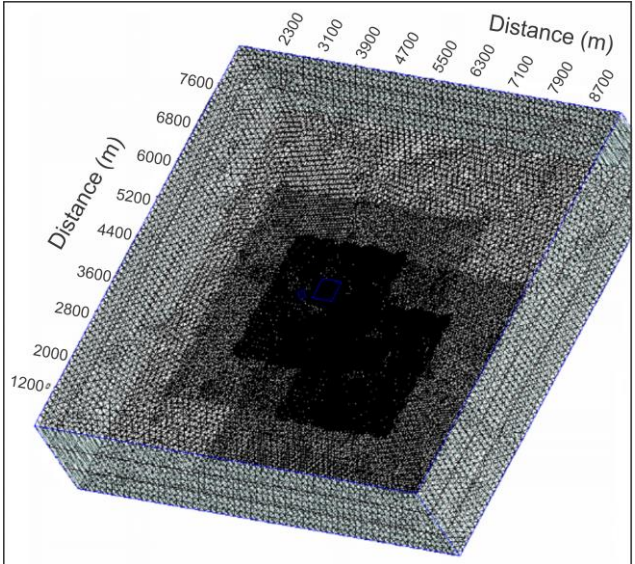
**Fig. 7** Computational 3D mesh used for modeling the artesian aquifer confined between mudstone layers (-3) and (-2) at the Karkheh dam toe

In our model, a rectangular domain having dimension of 8 km  $\times$  8 km was modeled using 70876 nodes and 105516 6-noded triangular-prismatic 3D elements. We assumed the steady state seepage condition for our modeling (Fig. 7). The domain length of 8 km seems enough because the mudstone layer (-2) crosses the reservoir at the distance of 4 km from dam axis.

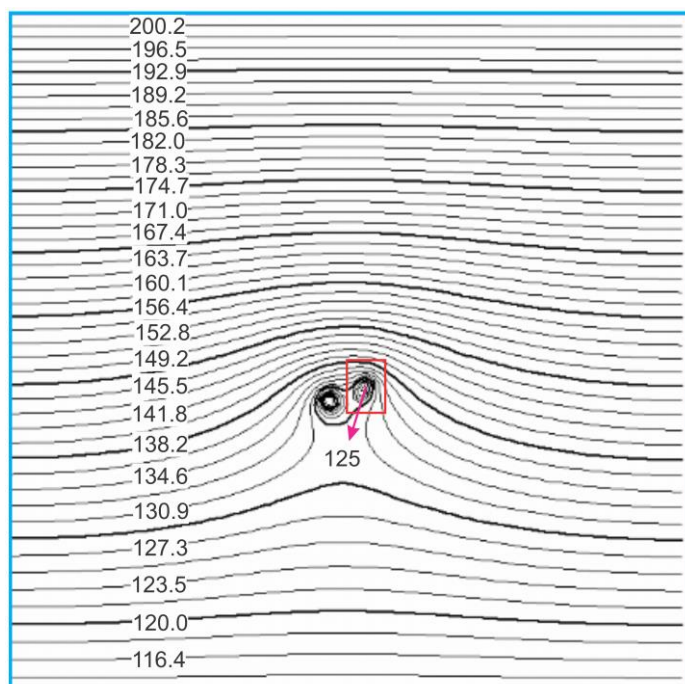
**Fig. 8** Results of 3D seepage simulations for the artesian aquifer confined between mudstone layers (-3) and (-2) at the Karkheh dam toe. The lines represent iso-potential lines. The numbers are water head in meter above sea level. The red rectangle shows the dam toe where the new relief wells were installed

This calibration resulted in the horizontal permeability of  $1.6 \times 10^{-3}$  m/s. Figure 8 shows the iso-potential lines for the modeled region indicating that the water head significantly decreased at the dam toe (red-rectangle in Fig. 8) due to the installation of the new relief wells. According to Fig. 8, the modeled water level at the downstream toe is around 125 m which is close to the observed values (Fig. 8 and Table 2). In other words, the

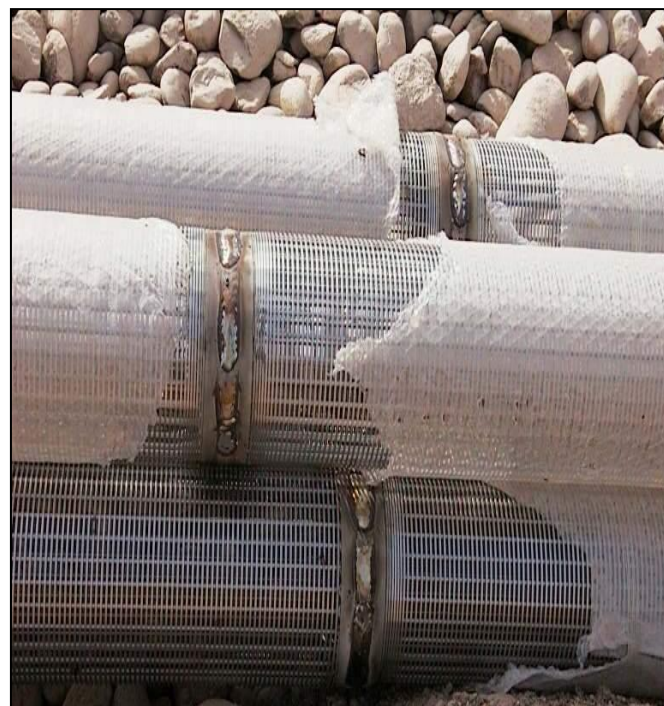
**Fig. 9** Picture showing the arrangement and size of the well screens used for the new relief wells at the Karkheh dam

Our experience suggests that the arrangement of the openings and their size are of vital importance for the proper function of the wells. As discussed above, one of the main shortcomings of the old wells was inappropriate opening arrangement and size. For the new wells, we changed the arrangement of the screens and used a regular shape for them (Fig. 9). In addition, we significantly increased the ratio of opening area to the total well area. In fact, there is no limit for the maximum screen area as long as the filter materials are prevented from entering the well. Therefore, we maximized the opening area of the wells (Fig. 9).
