International Journal of Civil Engineering

Experimental in-plane behavior and retrofitting method of mud-brick walls

F. Tootoonchy, B. Asgarian*, F. Danesh

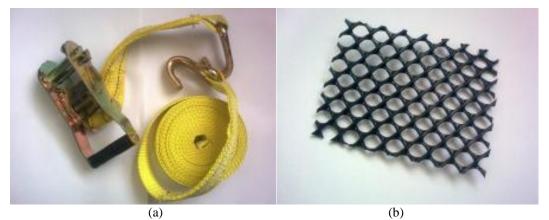
Fig. 4 (a) Tarpaulin belt, (b) Polypropylene lace

In this regards, some mud-bricks similar to original ones were reproduced from red clay of Abyaneh. Six scaled walls with the dimension of about 1m× 1m were constructed by using same red clay mortar. After about one month from the construction time, scaled walls were tested against horizontal loads applied at top of them in the presence of vertical load as shown in Table 1. In the first four samples (MW1 through MW4), the walls were subjected to lateral loads in presence of different amount of vertical stress as shown in Table 1. Meanwhile, no retrofitting was considered for these walls. Tested samples No. 5 and No. 6 (RMW1 & RMW2) had the same dimensions and vertical stress as sample No. 3, but these walls were retrofitted with propylene laces and tarpaulin belts as shown in Fig. 4. Polypropylene laces and tarpaulin belts (with 50 mm wide) were used to improve the performance of these walls (RMW1 and RMW2). Propylene lace which in 10^{mm} mesh (Fig. 4) is strong enough to environmental conditions and has ductile behavior.

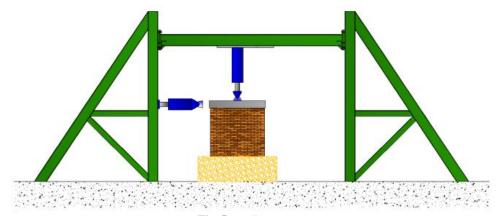
Fig. 5 Loading system

In order to investigate the effect of vertical loads on lateral behavior of the walls, a loading system including loading frame, hydraulic unit, hydraulic jacks, and measuring and data acquisition systems have been used (Fig. 5).

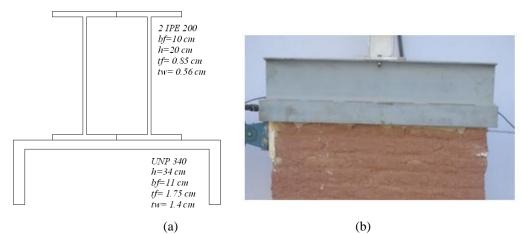
Fig. 6 (a) Beam section, (b) Load distribution beam

To impose uniform vertical stress on the walls, a hydraulic jack and stiff beam have been used in which stiff beam was directly placed on the wall (Fig. 6 and)

distributed uniform pressure during test. For imposing horizontal loads to the walls, hydraulic jack connected directly to the loading frame has been used. To avoid undesirable extra loads, due to top rigid beam movement during experiments, two rollers have been provided in both sides of vertical hydraulic jack, one between vertical jack and loading frame top beam and other between jack and rigid beam as shown in Fig. 7. To measure deformation of the wall, two transducers (LVDTs) were installed on the wall crown and toe.

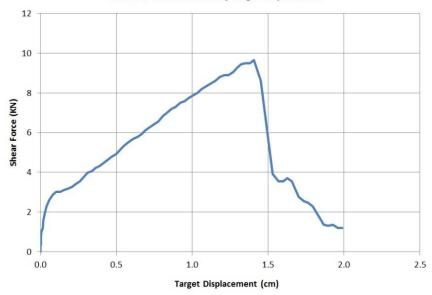
Fig. 10 Curve of shear force against sliding displacement of wall crown MW1

Shear force-lateral displacement curve of MW1 is shown in Fig. 10. Short initial elastic behavior can be observed at the start of the test which was then adjusted by forming a crack in the bed joint. Then, a sudden strength fall was observed during rocking motion mechanism.

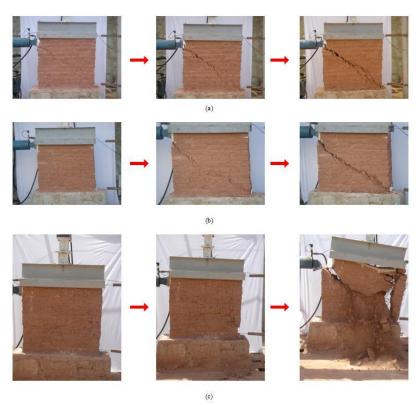
Fig. 12 Damage process: (a) MW2 wall, (b) MW3 wall, (c) MW4 wall

wall diagonal (Fig. 12), a reduction in wall stiffness was observed. Loading is continued until reaching maximum capacity of the wall. The wall toe started crushing and its volume was increased. After a destruction of the wall toe and increase in the cracks depth and length, it leaded to reduce the walls strength.

Fig. 12 shows stages of formation of damage mechanism of MW2, MW3 and MW4 walls which was a combination of shear sliding mechanism in the wall diagonal and crushing of the wall at toe. It is noted that MW4 wall was suddenly damaged due to exceeding high vertical stress.

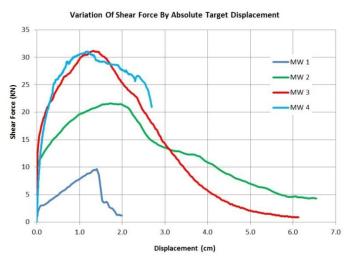
Fig. 13 Comparison of shear curve of MW1, MW2, MW3, MW4 walls

Fig. 13 compares shear force-lateral displacement curves of MW1, MW2, MW3 and MW4 in which effect of compressive stress and friction between joints caused improvement of strength and ductility. Sudden break of MW4 wall compared to the first three walls was observed since this wall has suddenly lost its load bearing capacity due to high vertical stress in wall.

Shear capacity ($F_{\rm max}$) and displacement of walls correspond to $F_{85\%}$ in degrading branch ($\Delta_{85\%}$) is presented in Table 2. As the significant point for the yield of the walls cannot be introduced from Fig. 13, ductility of the walls is not presented directly. However, ductility of the walls without and with proposed retrofitting method can be screened by observation of the walls behavior. It can be seen that the shear capacity of the walls was increased in presence of vertical stress. Meanwhile, ductility of the walls was also increased as the vertical stress was increased except sample No. 4 which has failed due to high vertical load.

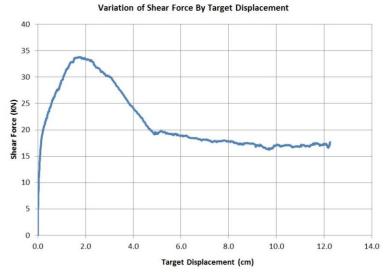
Fig. 16 Experimental behavior of RMW1 wall

To compare the results, a vertical uniform load same as MW3 was applied to retrofitted walls and then the lateral displacement was applied to walls. Fig. 15 shows the views of the RMW1 during the test. It can be seen that the volume of the wall toe was increased during test and the surrounding net was stretched. Then, the volume of the wall was increased around the wall diagonal. Moreover, diagonal cracks were formed without any collapse despite the fact that wall underwent a considerable deformation. Ultimately, rocking motion mechanism was formed following appearance of diagonal cracks. Fig. 16 presents variation of shear force against lateral displacement of RMW1 wall.

It was observed that the application of polypropylene lace caused suitable cohesiveness of the wall compared to the behavior of the similar wall without proposed retrofit method (MW3). It can also be seen that using polypropylene lace resulted proper integrity of the wall. Actually, better performance of the wall was observed by postponing the occurrence of rocking motion mechanism. The sample RMW2 was connected to its foundation by tarpaulin belts (Fig. 17) in addition to using the polypropylene lace same as RMW1 sample. Adding tarpaulin belts helps the wall to postpone or even prevent rocking motion mechanism. Table 1 also shows the details of a test performed on RMW2.

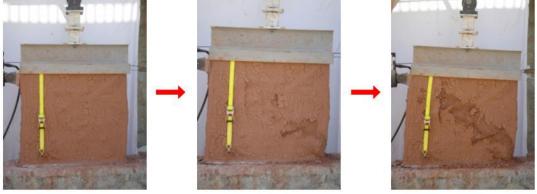
Fig. 18 Damage mechanism of RMW2 wall

Fig. 18 shows the damage mechanism of RMW2 wall. It was observed that with starting the load and upon completion of initial stages, volume of the wall toe was increased. Since, there was no possibility of occurrence of rocking motion mechanism, the wall begins forming diagonal cracks and ultimately the test is stopped by tearing of the net from the overlapping point in the wall toe.

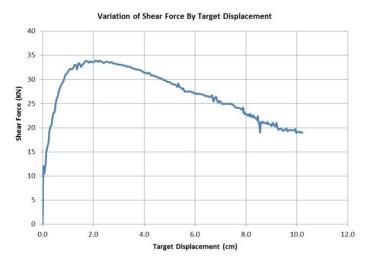
Fig. 19 Experimental behavior of RMW2 wall

Shear force-lateral displacement curve of RMW2 is shown in Fig. 19. Fig. 20 compares shear force-lateral displacement of MW3, RMW1 and RMW2. This Fig.

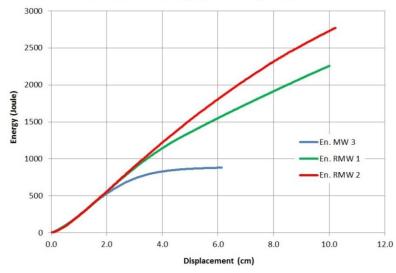
Fig. 22 Energy-displacement curve for retrofitted sample walls compared to non-retrofitted wall

The shear capacity of the wall and its lateral displacement corresponded to 85% of the shear capacity are also shown in Table 2. It can be seen that by retrofitting the wall in addition to increasing shear capacity of the wall, its ductility and energy absorption were increased significantly. The energy deformation curves of the walls without and with proposed retrofitting method are presented in Figs. 21 and 22. It can be seen that the

energy absorption of the walls in large deformation area increased significantly for retrofitted walls. The results for the energy absorption until failure and maximum displacement of the walls are also presented in Table 3. It can be seen that by using proposed retrofitting method, a better performance can be achieved compared to the walls without retrofit.
