## Experimental in-plane behavior and retrofitting method of mud-brick walls

F. Tootoonchy, B. Asgarian\*, F. Danesh

### Abstract

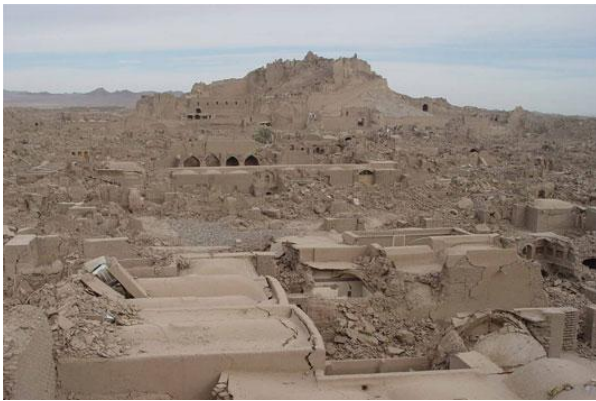
The largest mud-brick structure is the Bam citadel which has been suffered serious damages during 2003 Bam earthquake. During Bam 2003 earthquake, most of the adobe buildings were destroyed, more than 26,000 people were died and over 60,000 were left without shelter [1]. Fig. 2 shows Bam citadel before and after 2003 earthquake.

**Fig. 2** View of Bam Citadel before and after Bam earthquake
