Technical Note

Repair effectiveness of CFRP and steel plates in RC beams with web opening: effect of plate thickness

A. Ahmed A¹, S. Naganathan^{1,*}, K. Nasharuddin¹, M.M. Fayyadh²

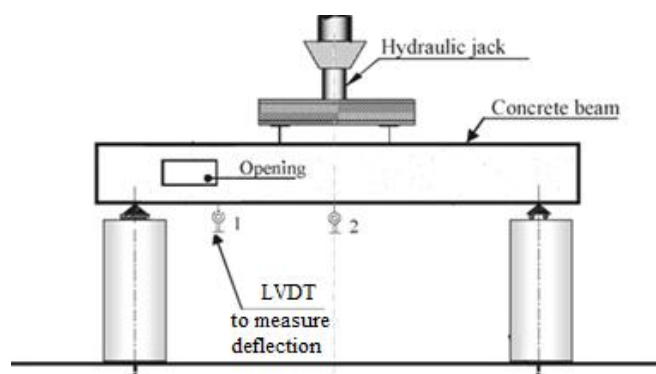
All beams were tested as simple supported beams subjected to a four-point load, as illustrated in Fig. 1. A universal testing machine with 300 kN capacity was used in order to apply the load on a steel distribution I- beam, which was used to generate the two concentrated loads on the beam. The load was applied gradually with a speed of 4 kN/min and was then released with the same average. Two linear variable differential transformers (LVDT) were used in each test to monitor vertical deflection at two locations, edge of the opening and mid-span of the beam as shown in Fig. 1. For each beam, one strain gauge was attached to the main flexure steel bars below the opening, as shown in Fig. 2 (a). For all the beams, two strain gauges were attached directly to the CFRP and steel plate on the sides of beams to monitor strain variation in CFRP and steel plates, as shown in Fig. 2 (b). All the used electrical devices (load cell, LVDT, and strain gauges) are attached to the data logger in order to monitor the variation in load, deflection and strain values, corresponding to applied loads. The readings were carried out at each 5 kN load step and up to the ultimate applied load. All the beams were subjected to failure load at the pre-repair stages. The beams were then unloaded by bringing back the loading to zero.

Fig. 1 Test set-up

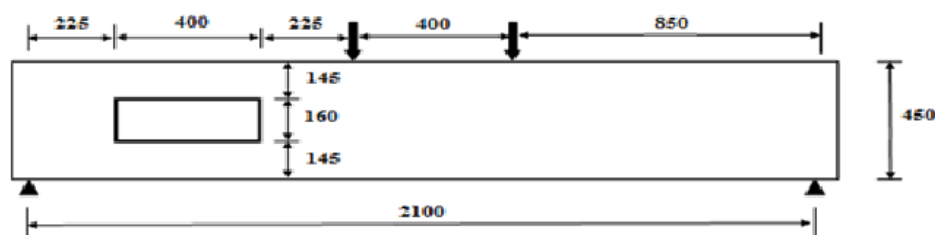
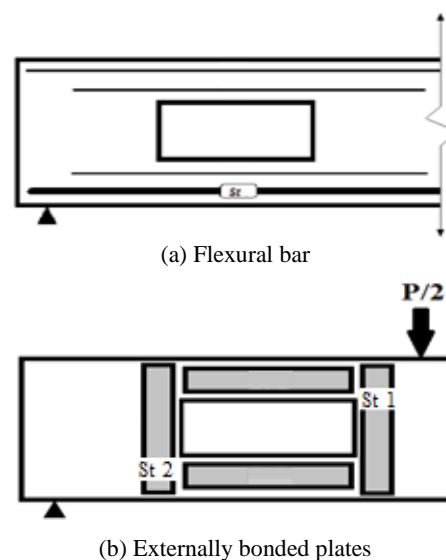
Fig. 2 Locations of strain gauge

The behaviour of load-strain relationship for externally bonded CFRP and steel plates is presented in this section. Strain gauge are fixed at two locations , one locations is on the opening corner near the support (ST2) and another location is at the opening corner near the point of applied load (ST1), as shown in Fig. 2(b). The load against strain curves for beams B1, B2, B3 and B4 are shown in Figs. 7, 8, 9 and 10, respectively. The recorded strains indicate that the value of strain for all beams did not reach the ultimate

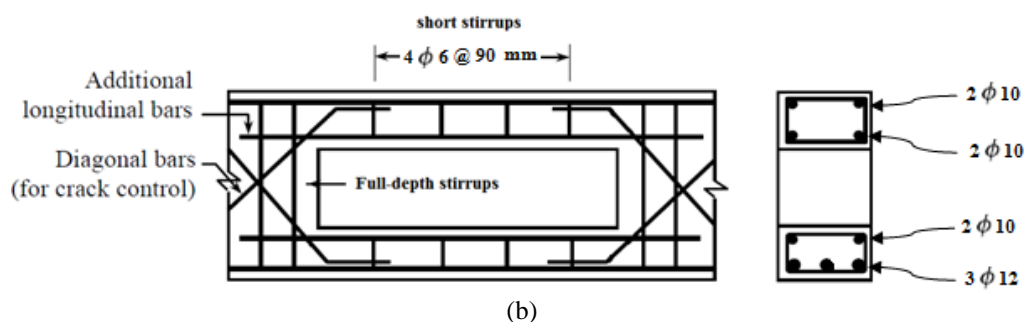
All the RC beams contain a large rectangular opening with a size of 160×400 (depth \times width) mm. The opening was located at the mid of the shear span with a distance of 225 mm away from support and 225 mm away from the concentrated load. The distance between the two concentrated loads is 400 mm and the shear span is 850 mm, as shown in Fig. 3 (a). Beams with an opening were designed according to the plastic hinge method, [17]. The beams were reinforced with three steel bars with a diameter of 12 mm as a major reinforcement in the tension zone and two of a 10 mm diameter at the compression zone. Additional longitudinal bars were provided as two 10 mm diameter steel bars at the top and bottom chords of the opening, and diagonal bars for crack control were also added at the corner of the opening. Steel stirrups of a 6 mm diameter were used at 90 mm spacing along the top and bottom chords.

Fig. 3 Beams description, (a) Opening location, (b) Steel reinforcement at the opening

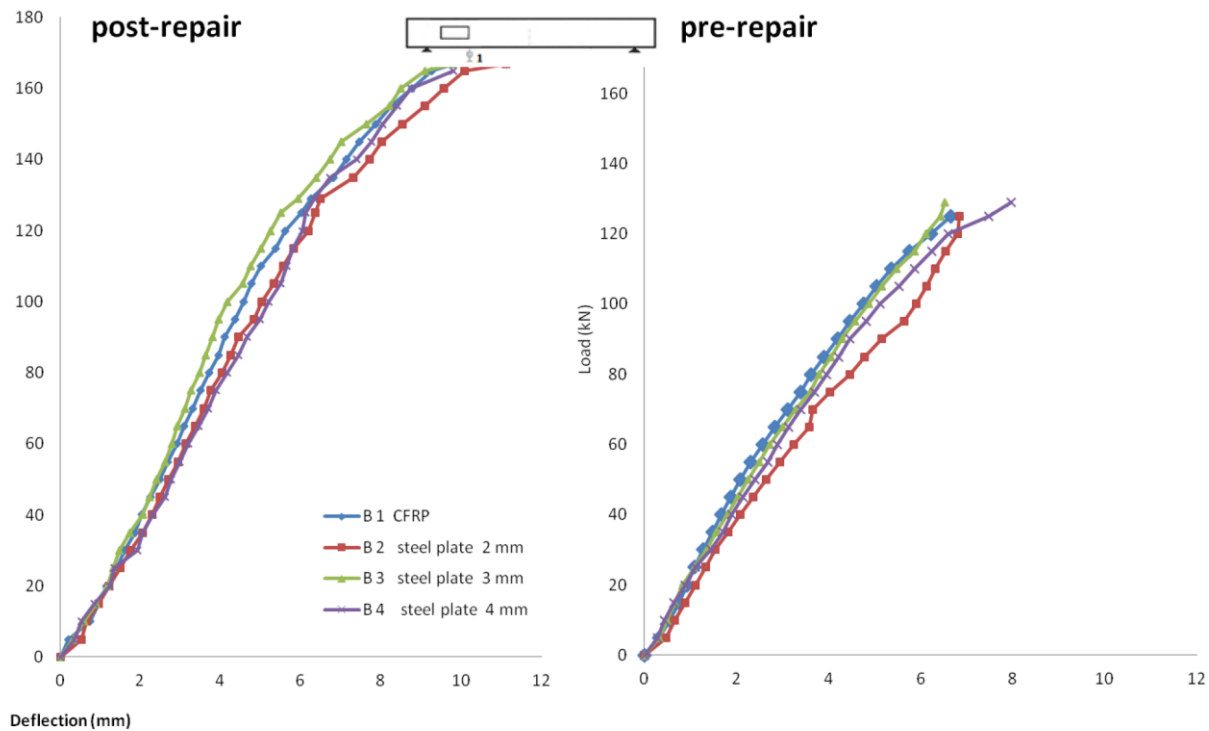
**Fig. 4** Load–deflection curves at the edge of the opening at pre and post repair stages

The load-deflection relationship at the mid span and below the edge of the opening is presented in this section. All the beams showed lower deflection at the mid span as compared to the deflection at the edge of the opening. For deflection at the edge of the opening, the reduction in deflection values found to be 10 % for CFRP, as shown in Table 4. For steel plates, the reductions in deflection were 7 %, 9 %, and 10 % for thicknesses of 2 mm, 3 mm and 4 mm, respectively. Thus, it is clear that the externally bonded plates applied around the web opening are capable of reducing 10 % of the deflection at pre-repair stage.

The beam B2, which was repaired by a steel plate with a thickness of 2mm, shows an effect on deflection at the edge of the opening, where at load of 128 kN the deflection is 6.98 mm and 6.49 mm at pre and post repair stages, respectively. For beam B3, good effect on the load capacity and a good effect on deflection were proved. The highest value of deflection was 6.52 mm obtained at the edge of the opening and it was at the pre-repaired stage at a failure load of 129 kN. However, at the post-repair stage, the deflection for the same load of 129 kN was 5.92 mm. As shown in Fig. 4, which shows the load against deflection at edge of opening curves at pre and post repair stages, the highest effect on deflection was for beams B1 and B4, while the lowest effect on deflection was for beam B2. The value of deflection for beam B1 at the pre-repair stage was 6.58 mm at a failure load of 125.2 kN, while the deflection was 5.95 mm at the post-repair stage at the same load of 125.2 kN.

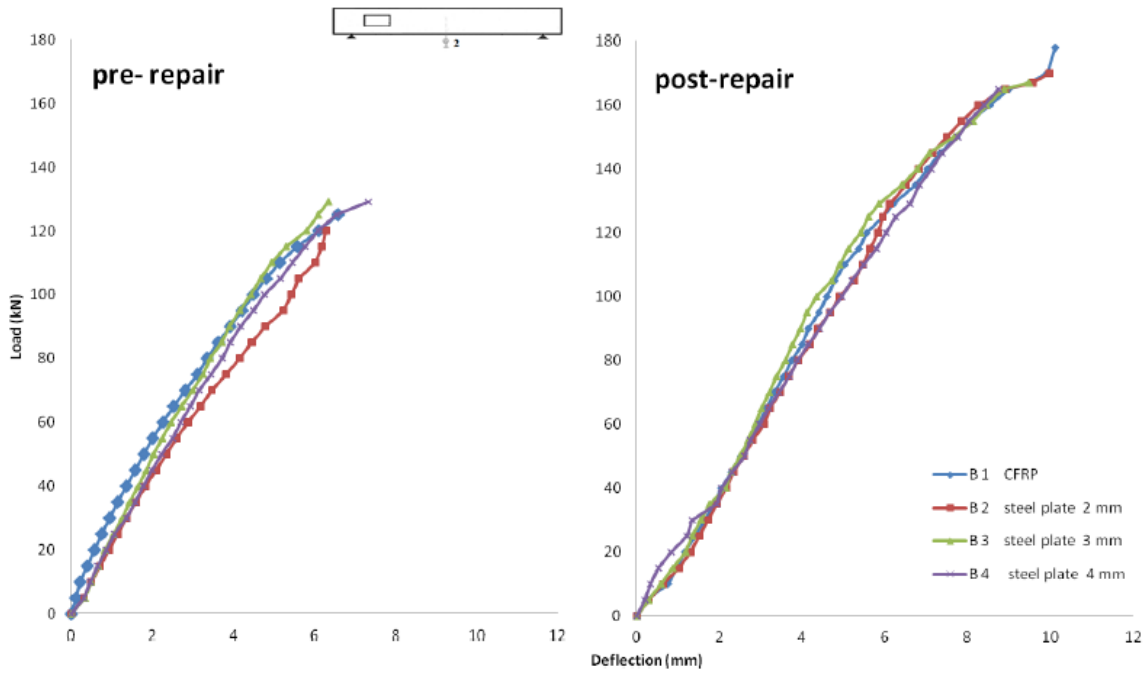
Fig 5. Load against deflection curves at the mid-span at pre and post repair stages

For beam B3, the value of deflection at the pre-repair stage at failure load of 129 kN was 6.35 mm, while at post-repair stage it was 5.85 mm at the same load of 128 kN. The value of deflection for beam B4 at the pre-repair stage was 6.74 mm at a failure load of 129.3 kN, while at the post-repair stage the deflection was 6.14 mm at the same load of 129.3 kN. The result shows that the influence of steel plates on deflection at the edge of the opening increases with the increase in steel plate thickness. The results indicate that the CFRP and steel plates have good effectiveness in reducing the deflection for the repaired beams at the edge of the opening and mid-span of the beam. From Fig. 5, which shows the load against deflection at mid-span curves at pre and post repair stages, it can be seen that curves for repaired beams show

somewhat similar behaviour because both CFRP and steel plates around the opening serve in resisting stress concentration at opening corners. Thus, it is delaying the cracking and controlling width and propagation of cracks. The highest value of deflection was obtained was located at the edge of the opening. The results are in agreement with Tan et al. [20], who found that for beams with an opening, the maximum deflection usually occurs at the high moment end of the opening. The decrease in deflection is smaller for the repaired beams, since the CFRP and steel plates prevent cracks from developing and widening. Furthermore, some contribution to the stiffness of beams was caused by the CFRP and steel plate outside the cracking region. The result shows that increasing steel plate thickness has little effect on reducing the deflection.

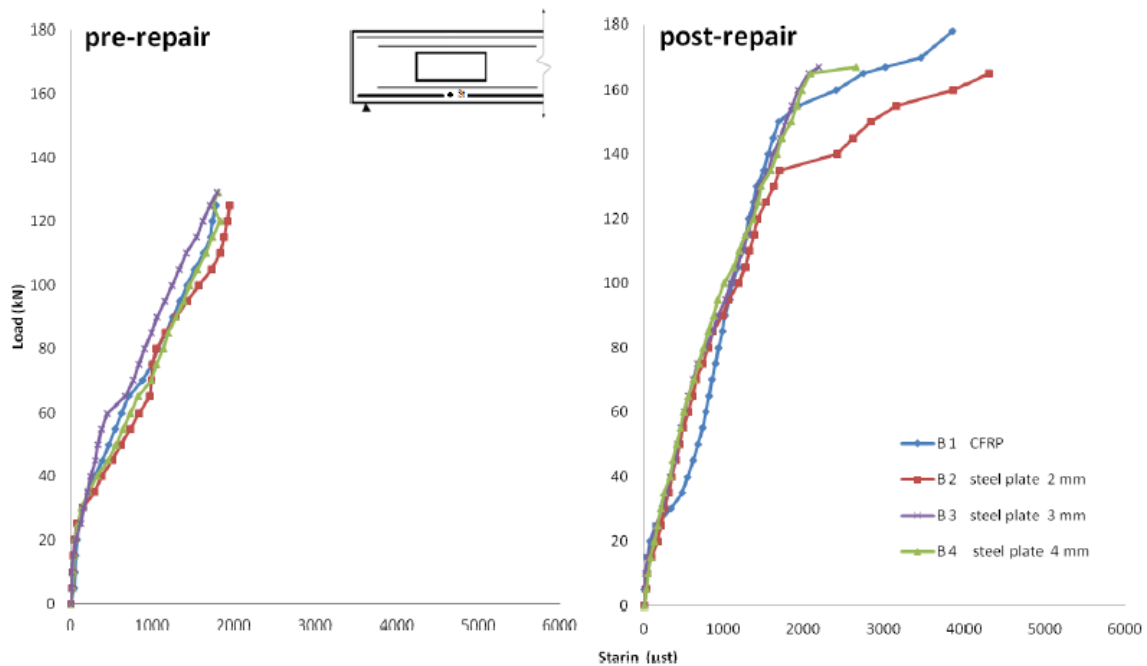
Fig. 6 Load against steel bar strain of (St) at pre and post repair stages

The load-strain relationship of steel reinforcement is presented in this section. The strain gauge (St) was attached onto the main steel reinforcement bar at the middle of the opening in the bottom chord. Fig. 6 shows the load against steel bar strain of the strain gauge (St) at the pre and post repair stages. For all the beams at the pre-repair stage, the strain gauge (St) shows an increase in strain value with the

increase in applied load and reaches its yielded strain at the ultimate load. At the post-repair stage, the externally bonded CFRP and steel plate shared the strain with steel bars where the strain gauge (St) reached strain values less than the strain at the pre-repair stage at same load. This was subjected to a different in the decrease of strain values percentage a depending on the material and thickness that were used, as shown in Table 5.

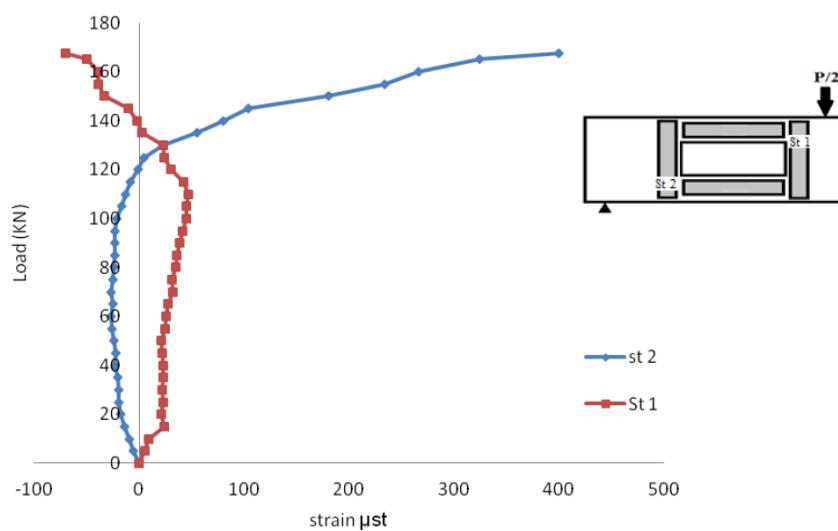
Fig. 9 Load against strain of externally bonded steel plates of beam B3

strain of CFRP and steel plates. This is due to the fact that the concrete failed before allowing the repair materials to reach the ultimate strain values. It can be observed from Figs. 7 to 10 that the externally bonded plates start to share the strain in the beam from the start of the applied load. The results are in agreement with Khalifa and Intomio [20], who found that the maximum CFRP vertical strain measured at failure corresponded to 14 % of the reported CFRP ultimate strain. This value is not absolute, because it greatly depends on the location of the strain gauge with respect to a crack.

As can be seen from Fig. 7, for beam B1 the maximum CFRP strain measured at failure was in strain ST1. For beam B3, the steel plate strain measured at failure was deferent at each location, because the value of the strain greatly depends on the location of the strain gauge with respect to a crack, as shown in Fig. 9. It can be observed from Fig. 10 that for beam B4, the maximum CFRP strain measured at failure was in strain ST1, on the bottom chord of the opening. CFRP and steel plates were not fractured or debonded from the concrete surface, and this ultimately indicates that CFRP and steel plates could provide additional strength if the beams did not fail by concrete diagonal shear cracks.

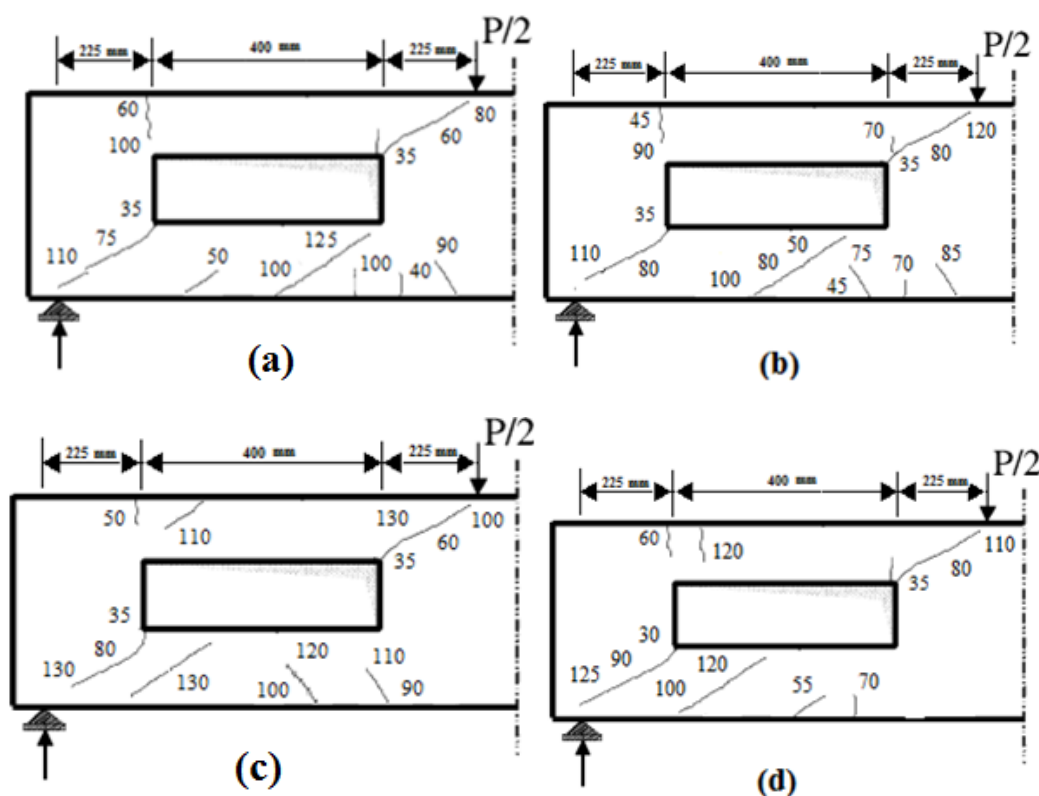
Fig. 11 Crack patterns and failure modes of beams at the pre-repair stage (a) Beam B1, (b) Beam B2, (c) Beam B3, (d) Beam B4

The crack pattern and the failure modes for all beams at pre and post repair stages are presented in this section. Figs. 11 and 12 show the crack pattern and the failure mode for all the beams at the pre and post repair stages, respectively. The failure modes of all the beams are similar because the failure occurs due to failure in concrete as diagonal shear failure before the externally bonded plates reach the ultimate strain. It can be seen from Fig. 11 (b) that the first diagonal crack for beam B2 was observed at the corner of the opening at a load of 35 kN; additional cracks were formed with the increase of the applied load. Failure of the beam occurred when the total applied load reached 128 kN. At the post-repair stage, many cracks were formed at the solid span of the beam, and the failure of the beam occurred at a load of 163.4 kN. At failure, concrete diagonal shear failure was observed around the

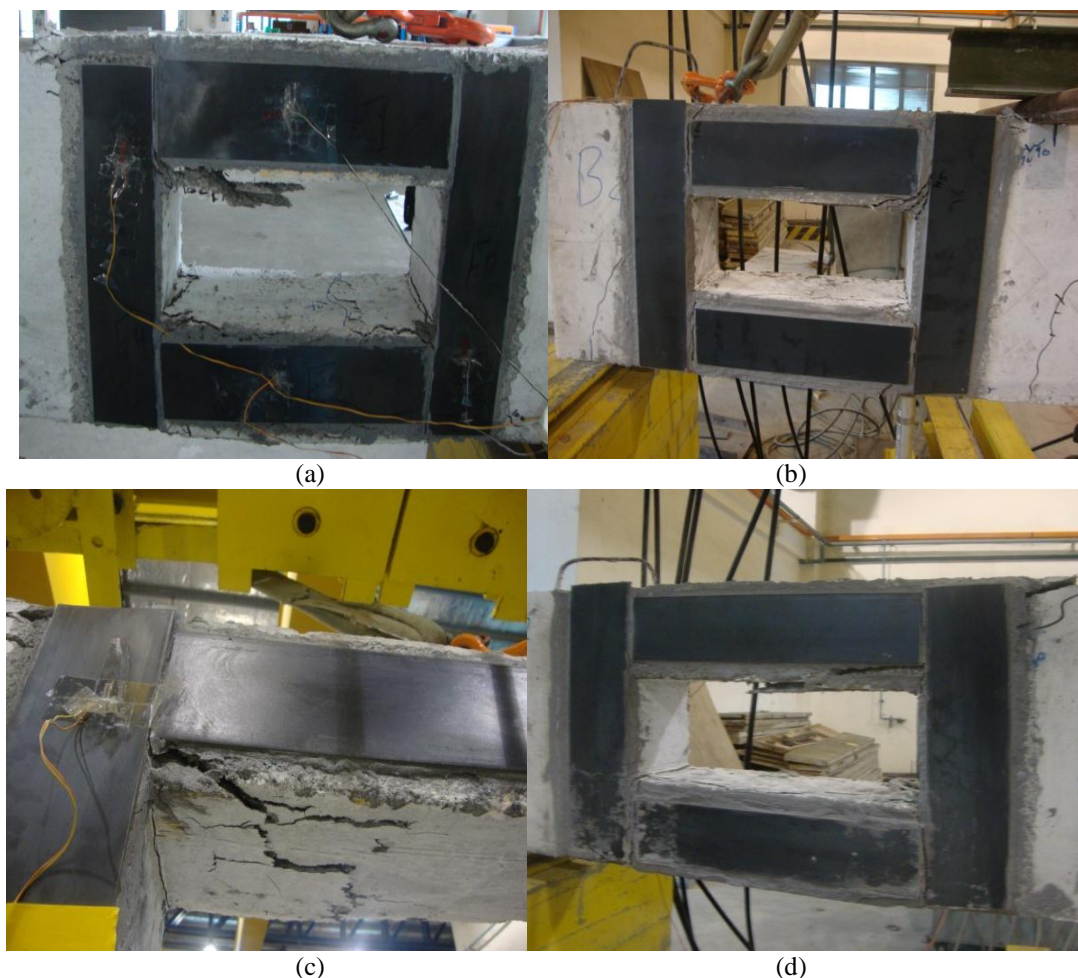
Fig. 12 Failure modes of beams at the post-repair stage (a) Beam B1, (b) Beam B2, (c) Beam B3, (d) Beam B4

opening, as shown in Fig. 12 (b).

This mode of failure is called splitting failure, which is due to relatively high longitudinal compressive stress developed at the top of the chords, which created transverse tension, and led to splitting failure, as according to Khalifa and Nanni [22]. The CFRP sheet did not fracture or debond from the concrete surface at the ultimate load. As can be seen from Fig. 11 (d), the first diagonal crack for beam B4 was observed at the corner of the opening at a load of 35 kN, additional cracks were formed with the increase of the applied load. Failure of the beam occurred when the total applied load reached 129.3 kN. As shown in Fig. 12 (d) for beam B4 at the post-repair stage, many cracks were formed at the solid span of the beam and the failure of the beam occurred at a load of 170 kN. At failure, crushing of the concrete was observed on the top and bottom face of the chord members, due to high compressive stress in concrete before the externally bonded plates reach the maximum strain.
