Technical Note

Repair effectiveness of CFRP and steel plates in RC beams with web opening: effect of plate thickness

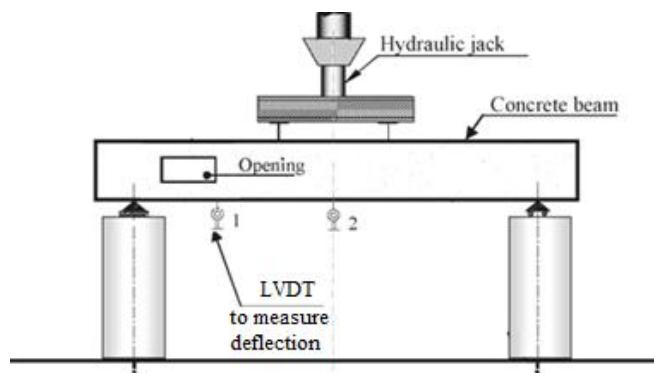
Fig. 1 Test set-up

All beams were tested as simple supported beams subjected to a four-point load, as illustrated in Fig. 1. A universal testing machine with 300 kN capacity was used in order to apply the load on a steel distribution I-beam, which was used to generate the two concentrated loads on the beam. The load was applied gradually with a speed of 4 kN/min and was then released with the same average. Two linear variable differential transformers (LVDT) were used in each test to monitor vertical deflection at two locations, edge of the opening and mid-span of the beam as shown in Fig. 1. For each beam, one strain gauge was attached to the main flexure steel bars below the opening, as shown in Fig. 2 (a). For all the beams, two strain gauges were attached directly to the CFRP and steel plate on the sides of beams to monitor strain variation in CFRP and steel plates, as shown in Fig. 2 (b). All the used electrical devices (load cell, LVDT, and strain gauges) are attached to the date logger in order to monitor the variation in load, deflection and train values, corresponding to applied loads. The readings were carried out at each 5 kN load step and up to the ultimate applied load. All the beams were subjected to failure load at the pre-repair stages. The beams were then unloaded by bringing back the loading to zero.

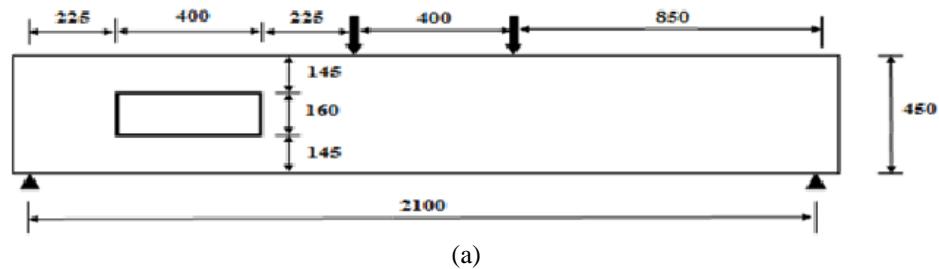
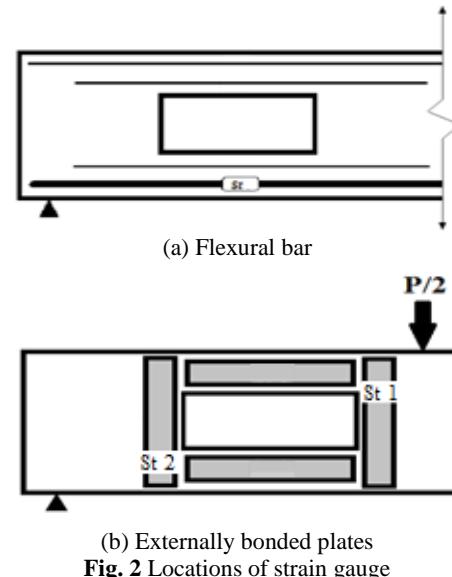
Fig. 2 Locations of strain gauge

The behaviour of load-strain relationship for externally bonded CFRP and steel plates is presented in this section. Strain gauge are fixed at two locations, one locations is on the opening corner near the support (ST2) and another location is at the opening corner near the point of applied load (ST1), as shown in Fig. 2(b). The load against strain curves for beams B1, B2, B3 and B4 are shown in Figs. 7, 8, 9 and 10, respectively. The recorded strains indicate that the value of strain for all beams did not reach the ultimate

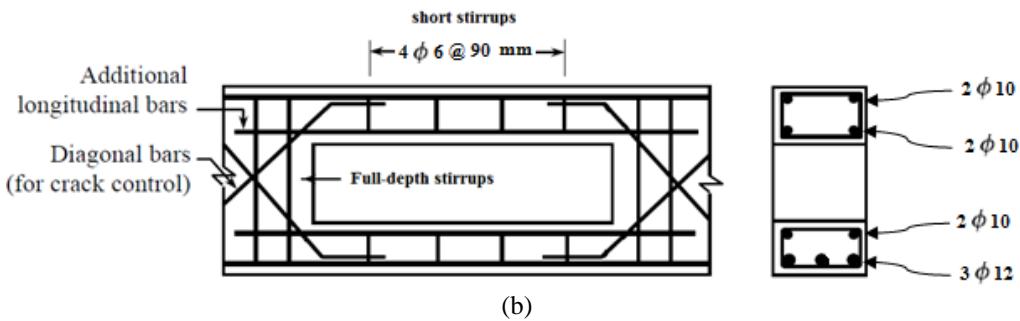
Fig. 3 Beams description, (a) Opening location, (b) Steel reinforcement at the opening

All the RC beams contain a large rectangular opening with a size of 160×400 (depth \times width) mm. The opening was located at the mid of the shear span with a distance of 225 mm away from support and 225 mm away from the concentrated load. The distance between the two concentrated loads is 400 mm and the shear span is 850 mm, as shown in Fig. 3 (a). Beams with an opening were designed according to the plastic hinge method, [17]. The beams were reinforced with three steel bars with a diameter of 12 mm as a major reinforcement in the tension zone and two of a 10 mm diameter at the compression zone. Additional longitudinal bars were provided as two 10 mm diameter steel bars at the top and bottom chords of the opening, and diagonal bars for crack control were also added at the corner of the opening. Steel stirrups of a 6 mm diameter were used at 90 mm spacing along the top and bottom chords.

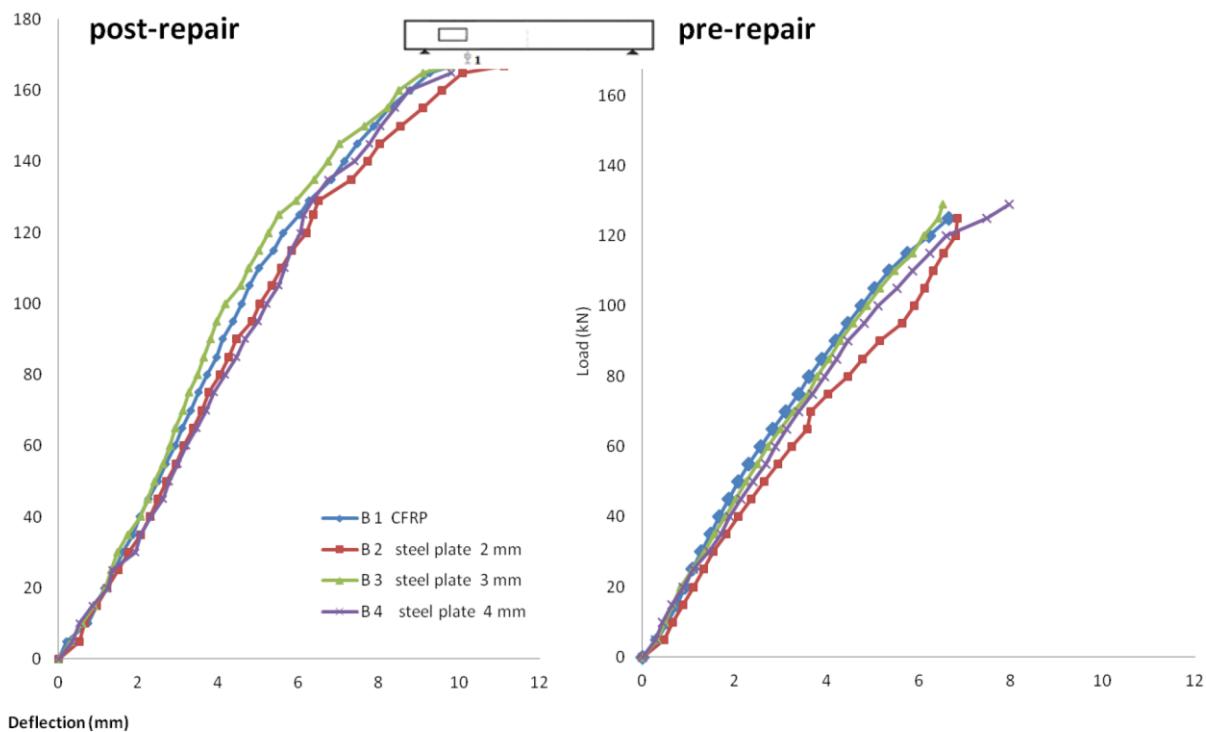
**Fig. 4** Load-deflection curves at the edge of the opening at pre and post repair stages

The load-deflection relationship at the mid span and below the edge of the opening is presented in this section. All the beams showed lower deflection at the mid span as compared to the deflection at the edge of the opening. For deflection at the edge of the opening, the reduction in deflection values found to be 10 % for CFRP, as shown in Table 4. For steel plates, the reductions in deflection were 7 %, 9 %, and 10 % for thicknesses of 2 mm, 3 mm and 4 mm, respectively. Thus, it is clear that the externally bonded plates applied around the web opening are capable of reducing 10 % of the deflection at pre-repair stage.

The beam B2, which was repaired by a steel plate with a thickness of 2mm, shows an effect on deflection at the edge of the opening, where at load of 128 kN the deflection is 6.98 mm and 6.49 mm at pre and post repair stages, respectively. For beam B3, good effect on the load capacity and a good effect on deflection were proved. The highest value of deflection was 6.52 mm obtained at the edge of the opening and it was at the pre-repaired stage at a failure load of 129 kN. However, at the post-repair stage, the deflection for the same load of 129 kN was 5.92 mm. As shown in Fig. 4, which shows the load against deflection at edge of opening curves at pre and post repair stages, the highest effect on deflection was for beams B1 and B4, while the lowest effect on deflection was for beam B2. The value of deflection for beam B1 at the pre-repair stage was 6.58 mm at a failure load of 125.2 kN, while the deflection was 5.95 mm at the post-repair stage at the same load of 125.2 kN.

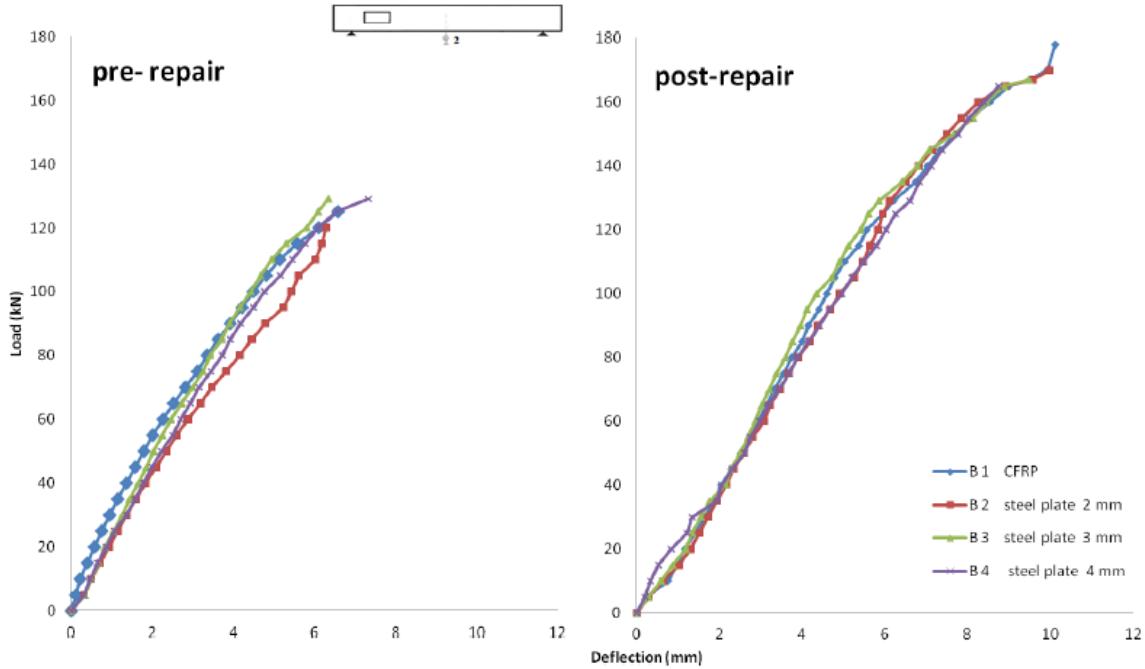
Fig 5. Load against deflection curves at the mid-span at pre and post repair stages

For beam B3, the value of deflection at the pre-repair stage at failure load of 129 kN was 6.35 mm, while at post-repair stage it was 5.85 mm at the same load of 128 kN. The value of deflection for beam B4 at the pre-repair stage was 6.74 mm at a failure load of 129.3 kN, while at the post-repair stage the deflection was 6.14 mm at the same load of 129.3 kN. The result shows that the influence of steel plates on deflection at the edge of the opening increases with the increase in steel plate thickness. The results indicate that the CFRP and steel plates have good effectiveness in reducing the deflection for the repaired beams at the edge of the opening and mid-span of the beam. From Fig. 5, which shows the load against deflection at mid-span curves at pre and post repair stages, it can be seen that curves for repaired beams show

somewhat similar behaviour because both CFRP and steel plates around the opening serve in resisting stress concentration at opening corners. Thus, it is delaying the cracking and controlling width and propagation of cracks. The highest value of deflection was obtained was located at the edge of the opening. The results are in agreement with Tan et al. [20], who found that for beams with an opening, the maximum deflection usually occurs at the high moment end of the opening. The decrease in deflection is smaller for the repaired beams, since the CFRP and steel plates prevent cracks from developing and widening. Furthermore, some contribution to the stiffness of beams was caused by the CFRP and steel plate outside the cracking region. The result shows that increasing steel plate thickness has little effect on reducing the deflection.

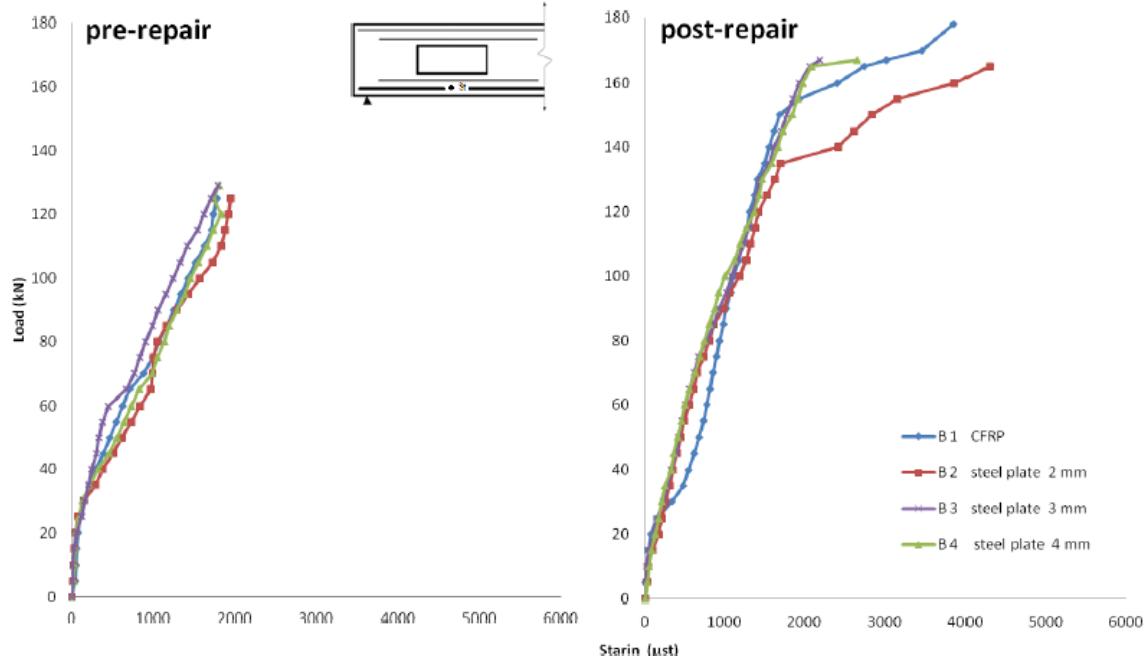
Fig 6 Load against steel bar strain of (St) at pre and post repair stages

The load-strain relationship of steel reinforcement is presented in this section. The strain gauge (St) was attached onto the main steel reinforcement bar at the middle of the opening in the bottom chord. Fig. 6 shows the load against steel bar strain of the strain gauge (St) at the pre and post repair stages. For all the beams at the pre-repair stage, the strain gauge (St) shows an increase in strain value with the

increase in applied load and reaches its yielded strain at the ultimate load. At the post-repair stage, the externally bonded CFRP and steel plate shared the strain with steel bars where the strain gauge (St) reached strain values less than the strain at the pre-repair stage at same load. This was subjected to a different in the decrease of strain values percentage a depending on the material and thickness that were used, as shown in Table 5.

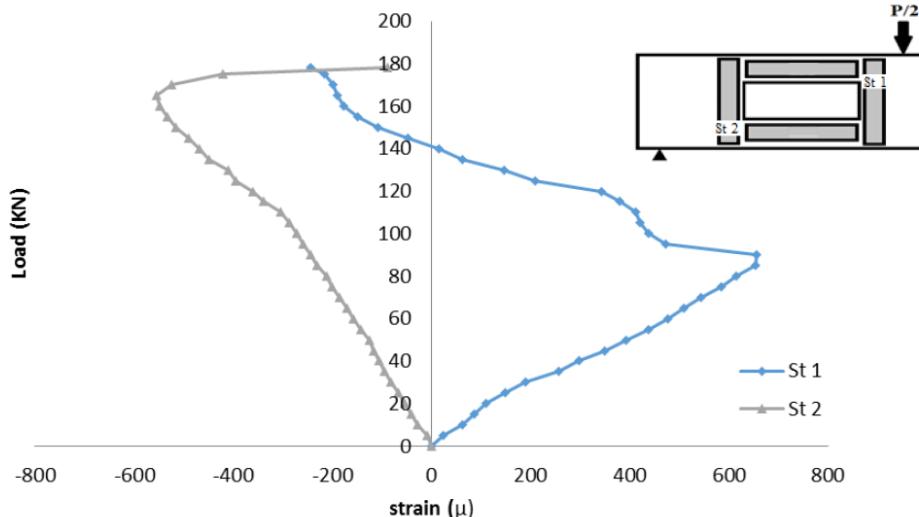
Fig. 7 Load against strain of externally bonded CFRP plates of beam B1

As can be seen from Fig. 7, for beam B1 the maximum CFRP strain measured at failure was in strain ST1. For beam B3, the steel plate strain measured at failure was deferent at each location, because the value of the strain greatly depends on the location of the strain gauge with respect to a crack, as shown in Fig. 9. It can be observed from Fig. 10 that for beam B4, the maximum CFRP strain measured at failure was in strain ST1, on the bottom chord of the opening. CFRP and steel plates were not fractured or debonded from the concrete surface, and this ultimately indicates that CFRP and steel plates could provide additional strength if the beams did not fail by concrete diagonal shear cracks.

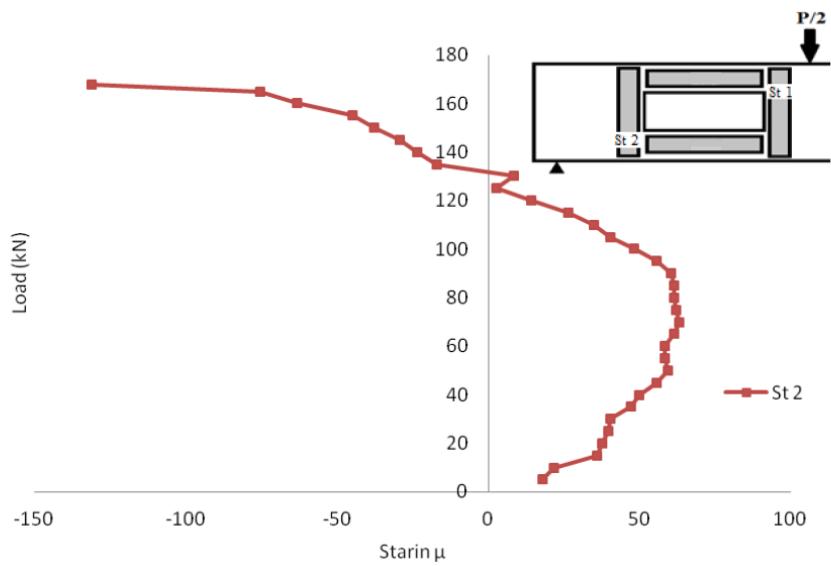
Fig. 8 Load against strain of externally bonded steel plate of beam B2

strain of CFRP and steel plates. This is due to the fact that the concrete failed before allowing the repair materials to reach the ultimate strain values. It can be observed from Figs. 7 to 10 that the externally bonded plates start to share the strain in the beam from the start of the applied load. The results are in agreement with Khalifa and Intomio [20], who found that the maximum CFRP vertical strain measured at failure corresponded to 14 % of the reported CFRP ultimate strain. This value is not absolute, because it greatly depends on the location of the strain gauge with respect to a crack.

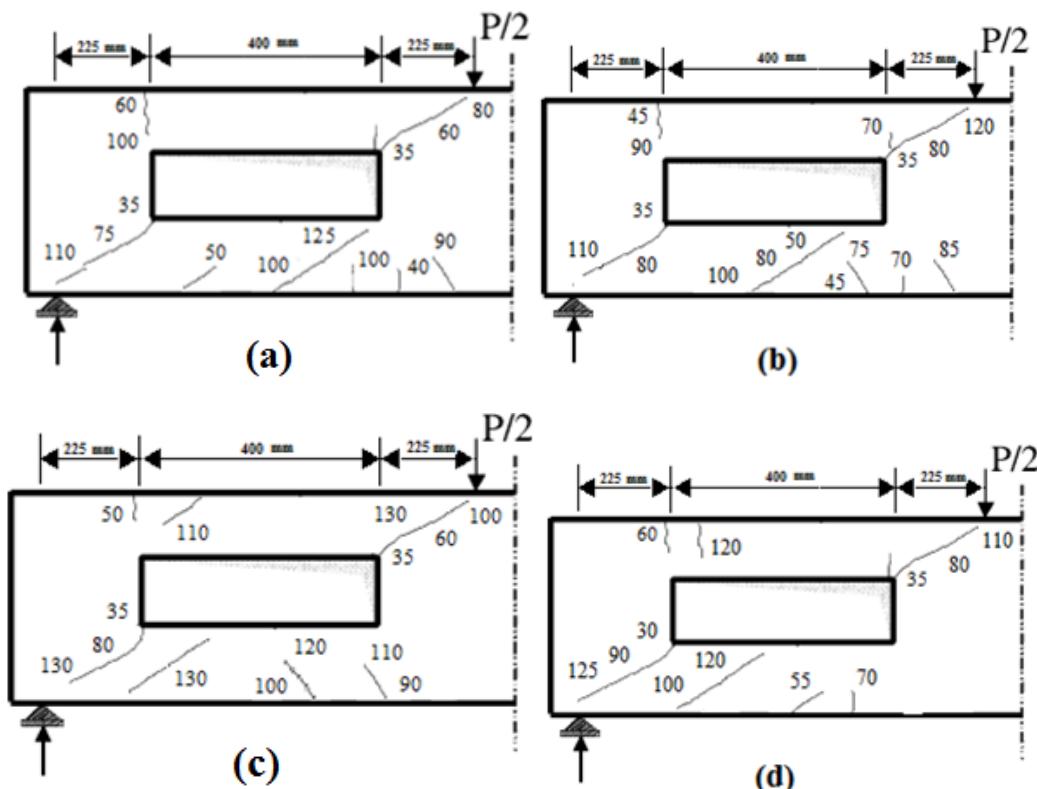
Fig. 11 Crack patterns and failure modes of beams at the pre-repair stage (a) Beam B1, (b) Beam B2, (c) Beam B3, (d) Beam B4

The crack pattern and the failure modes for all beams at pre and post repair stages are presented in this section. Figs. 11 and 12 show the crack pattern and the failure mode for all the beams at the pre and post repair stages, respectively. The failure modes of all the beams are similar because the failure occurs due to failure in concrete as diagonal shear failure before the externally bonded plates reach the ultimate strain. It can be seen from Fig. 11 (b) that the first diagonal crack for beam B2 was observed at the corner of the opening at a load of 35 kN; additional cracks were formed with the increase of the applied load. Failure of the beam occurred when the total applied load reached 128 kN. At the post-repair stage, many cracks were formed at the solid span of the beam, and the failure of the beam occurred at a load of 163.4 kN. At failure, concrete diagonal shear failure was observed around the

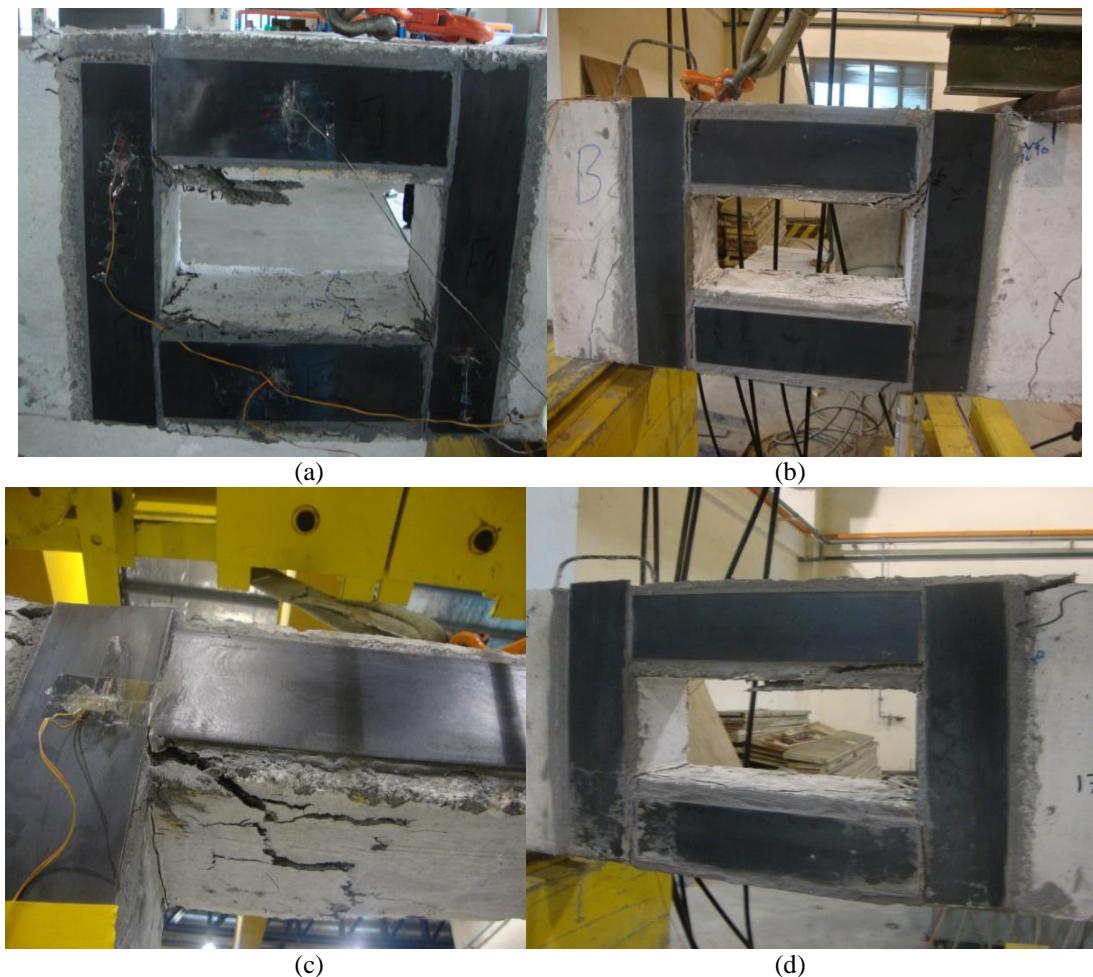
Fig. 12 Failure modes of beams at the post-repair stage (a) Beam B1, (b) Beam B2, (c) Beam B3, (d) Beam B4

opening, as shown in Fig. 12 (b).

This mode of failure is called splitting failure, which is due to relatively high longitudinal compressive stress developed at the top of the chords, which created transverse tension, and led to splitting failure, as according to Khalifa and Nanni [22]. The CFRP sheet did not fracture or debond from the concrete surface at the ultimate load. As can be seen from Fig. 11 (d), the first diagonal crack for beam B4 was observed at the corner of the opening at a load of 35 kN, additional cracks were formed with the increase of the applied load. Failure of the beam occurred when the total applied load reached 129.3 kN. As shown in Fig. 12 (d) for beam B4 at the post-repair stage, many cracks were formed at the solid span of the beam and the failure of the beam occurred at a load of 170 kN. At failure, crushing of the concrete was observed on the top and bottom face of the chord members, due to high compressive stress in concrete before the externally bonded plates reach the maximum strain.
