Investigation of long term coupled effect of high temperature and constant high humidity on corrosion rehabilitated patches of reinforced concrete structures

Abstract

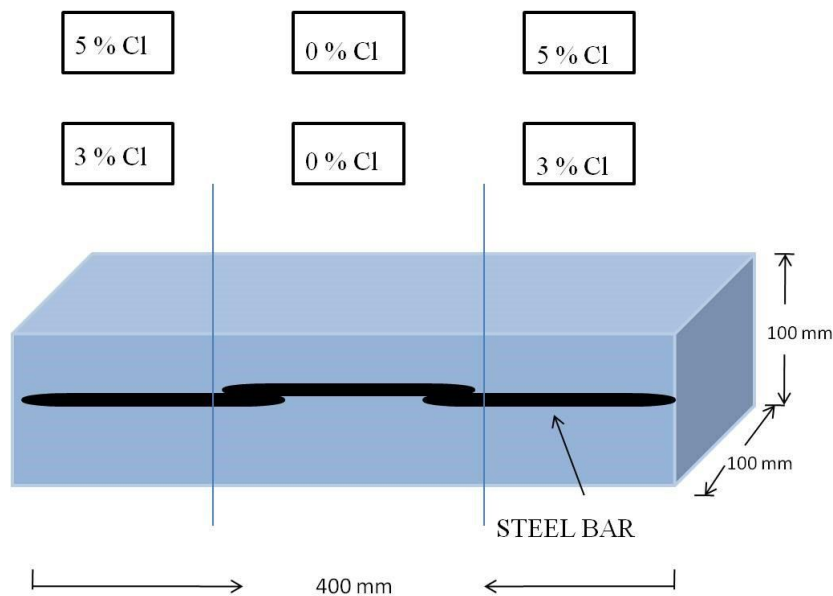
Fig. 2 Schematic representation of the identical test specimen

elsewhere [10]. The schematic diagram of these specimens is shown in Fig. 2 and the complete mixing procedure is shown in Fig. 3. Since the objective of this research is to find the long term coupled effect of varying temperature and high humidity on macro-cell corrosion phenomenon, these specimens were kept at 50°C, 40°C and 30°C temperature conditions and 85% relative humidity in environment control chambers for 2 years.

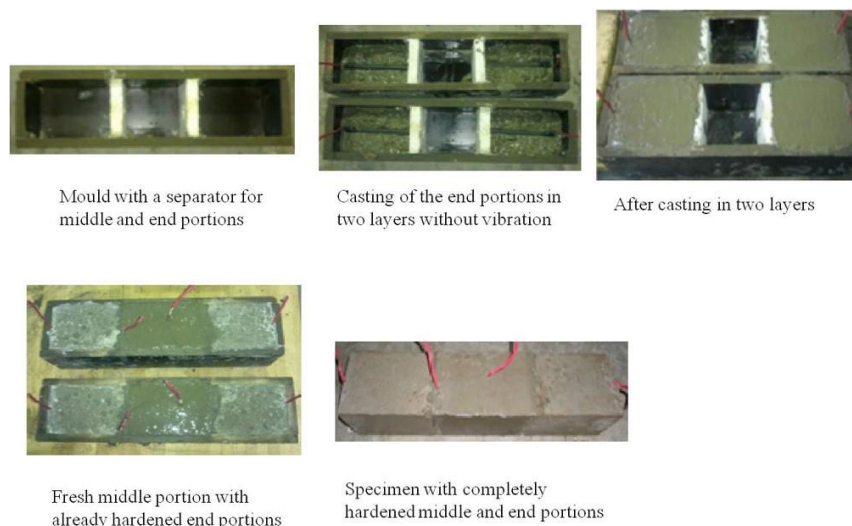
Figure 3 Specimens preparation

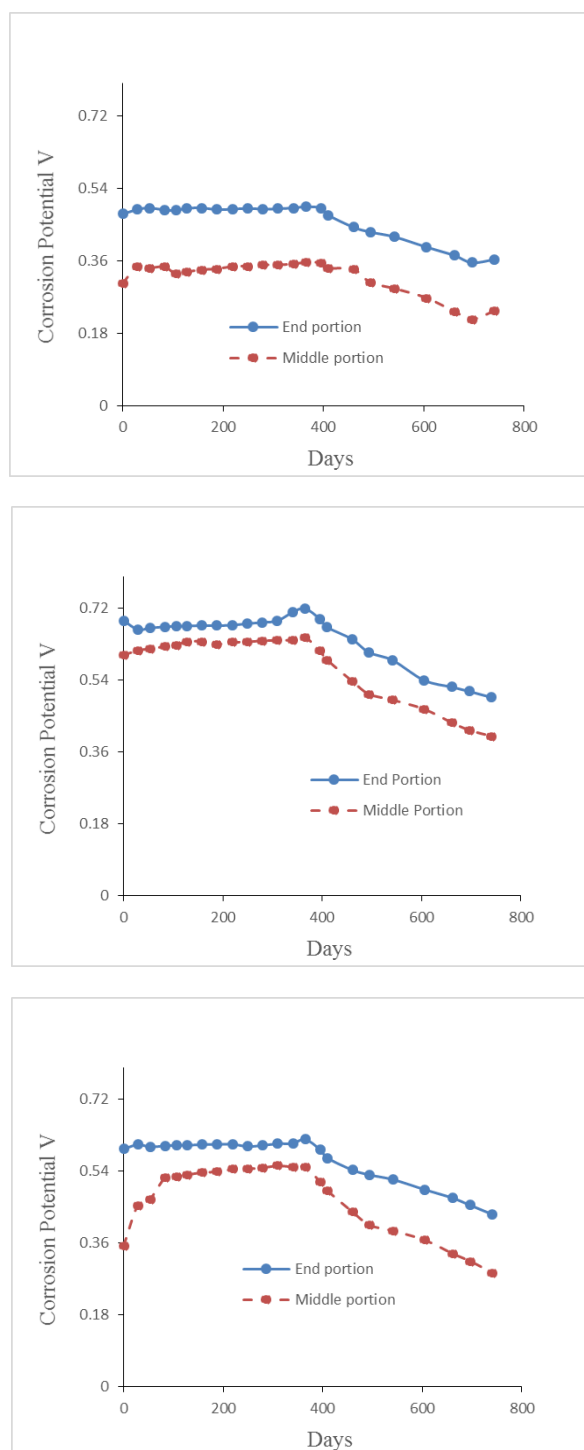
Fig. 5 (a-c) Corrosion potential measurement for 5% contaminated chloride specimen at the end kept at 30°C, 40°C and 50°C

1) At the middle non contaminated portion of the specimen having 5% chloride at the end portions and kept at 50°C (#1 and #2), the maximum corrosion of **-0.235** Volts was found after 2 years as compared to **-0.285** Volts at 30°C in the middle zero chloride portion of the same specimens (#5 and #6). However previously, much higher readings of these specimens were obtained on completion of one year observations [10]. The reason of this phenomenon could be the long term coupled effect of temperature and constant high humidity due to which the decline in corrosion potential after two years was significant. The results are shown in Figs. 5 and 6.

2) The maximum corrosion potential reading of the specimens #1 and #2 was found **-0.363** Volts as compared to high chloride induced potentials of **-0.432** Volts (figure 5) of the same specimens #5 and #6 at 30°C (figure 4)

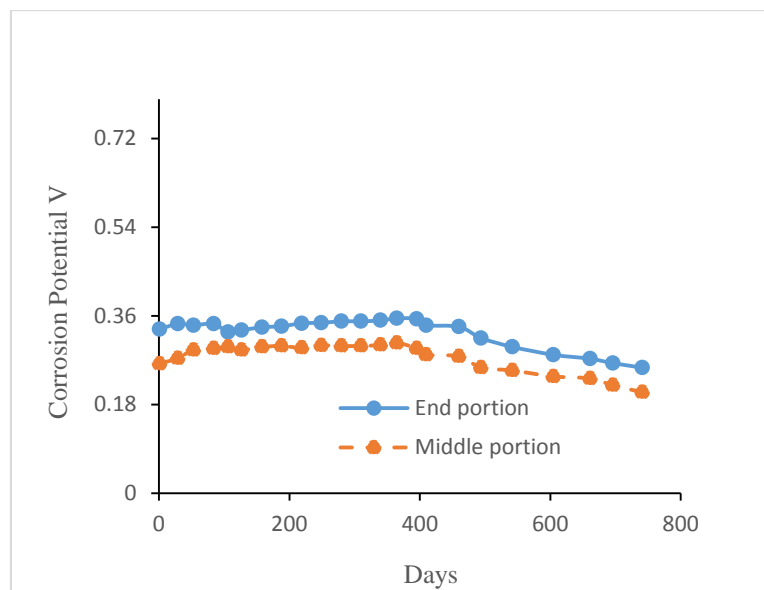
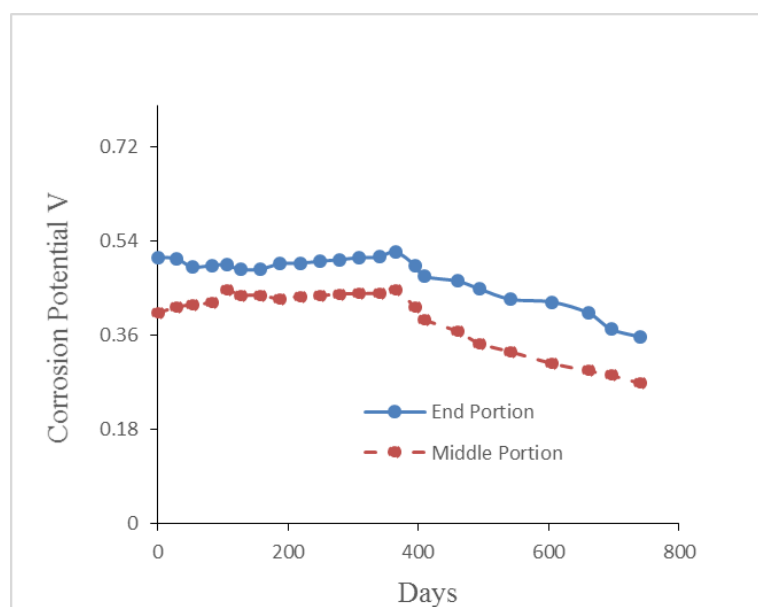
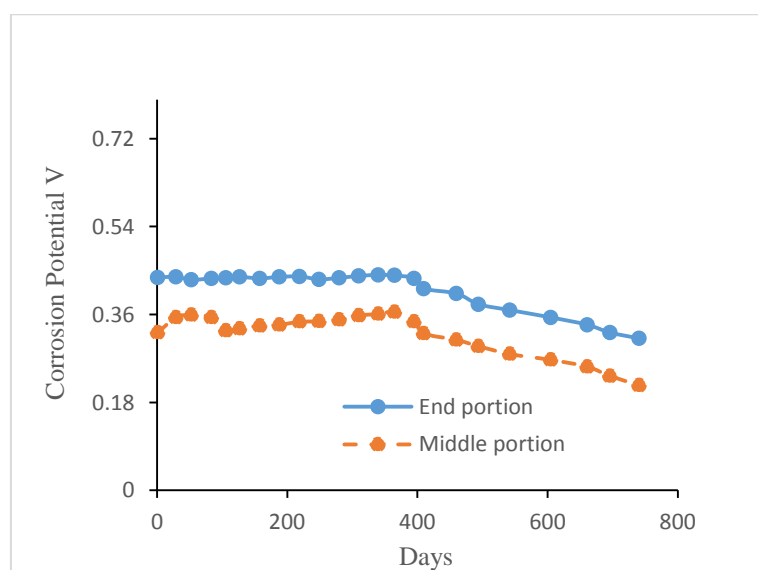
Fig. 6 (a-c) Corrosion potential measurement for 3% chloride contaminated specimen at the end kept at 30°C, 40°C and 50°C

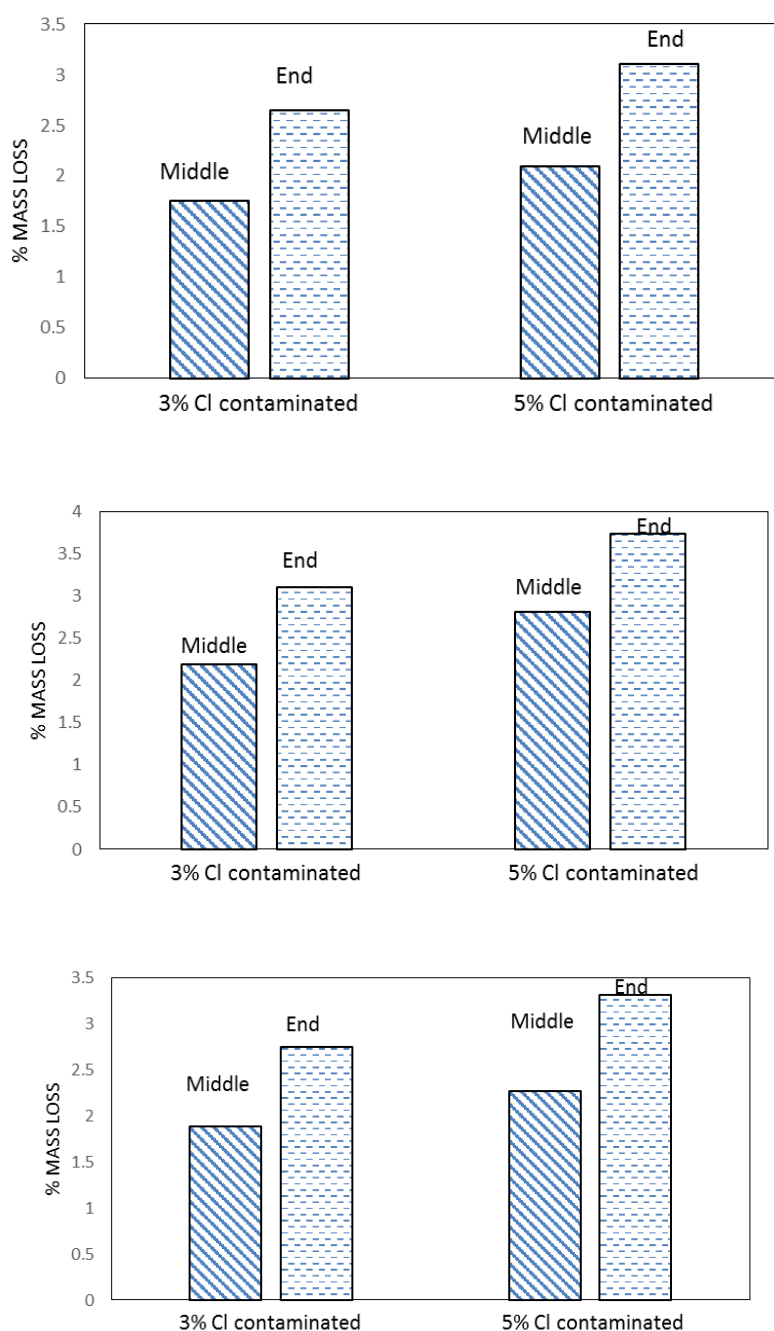
Fig. 7 % Mass loss for 3% and 5% chloride contaminated specimen at the end kept at 30°C, 40°C and 50°C

steel of the end portion of the same specimen kept at 50°C gave the highest % mass loss of 3.31 and middle steel gave 2.27 % mass losses which was lower than the mass losses at 40°C. The results are shown in Fig. 7.

2) The steel from the end portions of 3 % chloride contaminated concrete specimens kept at 30°C, 40°C and 50°C gave 2.65, 3.11 and 2.75 % mass loss respectively. While the middle steels from the uncontaminated portion of these specimens gave 1.75, 2.19 and 1.88 % mass losses respectively as shown in figure 7. Similarly in the 3% chloride contaminated specimens reduced % mass losses at 50°C obtained as compared to the mass loss at 40°C, confirming the authenticity of the results of this research.

As it can be seen from gravimetric mass loss results of various specimens put in varying temperatures, shown in figure 7(a-c), the steels from the middle portion of all the specimens simulating the actual patch repair in field, were corroded and gave approximately 70% of the mass loss obtained in their respective contaminated end portions, indicating the chloride transfer and vulnerability of repaired portion against corrosion.
