International Journal of Civil Engineering

Technical Note

Application of cement grouting for stabilization of coarse materials

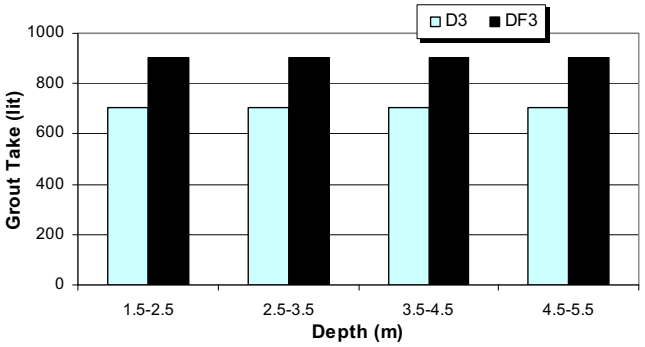
Fig. 5 Amount of grout take in D3 and DF3 grouting holes

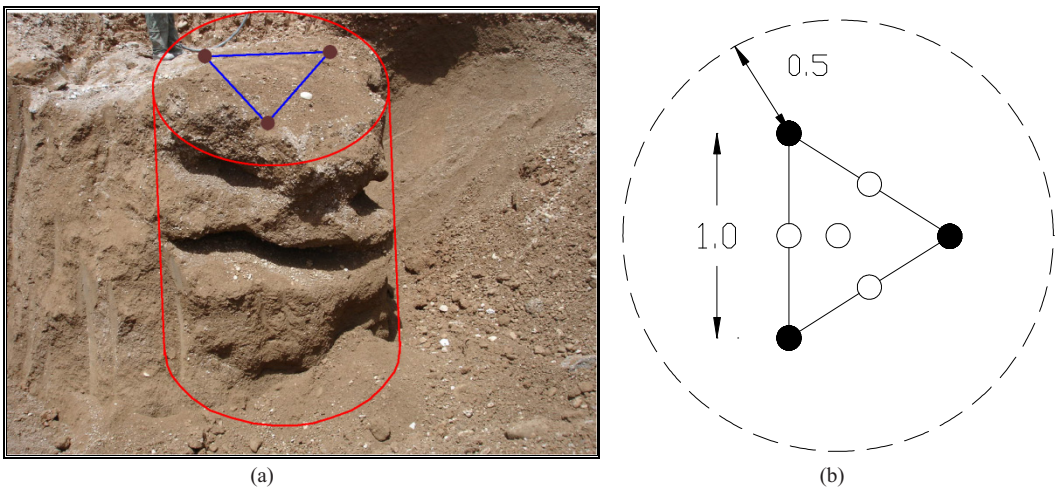
(a) (b)

The above pattern was confirmed through trenching of the trial platform after 48 hours (Fig. 6-a). The creation of a stable cylinder with the radius of about 0.5 m around the D holes is evident in Fig. 6-a. According to this actual observation, we were able to determine the pattern of the stabilization of the drain material through cement grouting. This pattern is shown in Fig. 6-b. We note that Fig.6-a shows that some parts of the drain remains untreated indicating that at least two rows of grouting lines are necessary for complete stabilization of the medium. In conclusion, the main findings of the trial grouting experiment can be summarized as follows:

Fig. 6 The stabilized drain around the D-series grouting holes (a) and the inferred stabilization pattern from it (b). Dimensions are in meters

1. A cement grout with the W:C proportion of 1:1.5 to 1:2 along with a 1 to 1.5 m hole spacing is appropriate for grouting of drain materials

2. Application of at least two grouting rows is necessary to achieve a uniformly treated medium

3. The amount of grout take in drain is about 700-900 lit/m

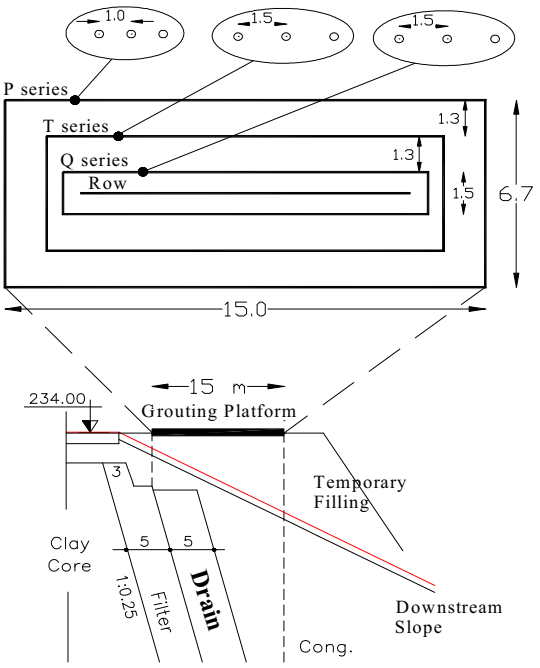
Due to the above considerations, three circles as well as a row of grout holes were used as shown in Fig. 7 including P series at the outer side, T series at the middle, Q series at the inner side, and a row of holes in the center of the Q series. The role of the P holes is to produce a confined environment to introduce the subsequent grouting of the T and Q holes. It is evident that the excessive grout takes in the grouting of the P holes is likely, thus it is important to perform these grouting with relatively low grouting pressures and a relatively shorter hole-spacing.

Fig. 7 Grouting holes and their location in the dam body. All dimensions are in meters

A hole spacing of 1 m along with a relatively dense grout having W/C ratio of 1/1.5 was applied to the P holes. Throughout the process of grouting in the P holes, the exerting pressure was below 5 bars and the amount of gout take was carefully controlled. Figure 8 presents examples of grout take in two adjacent holes from the P series. Note that in Fig. 8, the hole P13 was grouted prior to P12.

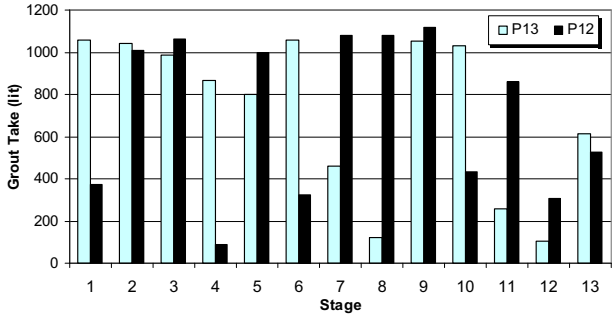
As can be seen, the average grout take in each stage is about 1000 lit except for some special stages which can be attributed to the possible local complexities. However, wherever the grout take in one stage is little, the amount of the grout take in the neighboring stage is high. This emphasizes again that at least two rows of grouting is necessary.

Fig. 8 Examples of grout take in two adjacent grouting holes from P-series grouting holes

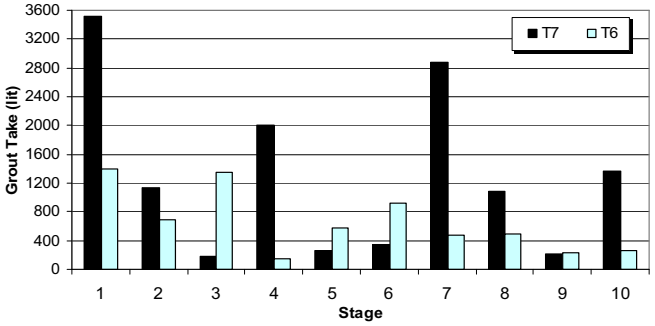
Fig. 9 Examples of grout take in two adjacent grouting holes from T-series grouting holes

Figures reveal that except at some limited stages, the total grout take in the T and Q holes is reduced which can be attributed to the effect of grouting in the P holes.

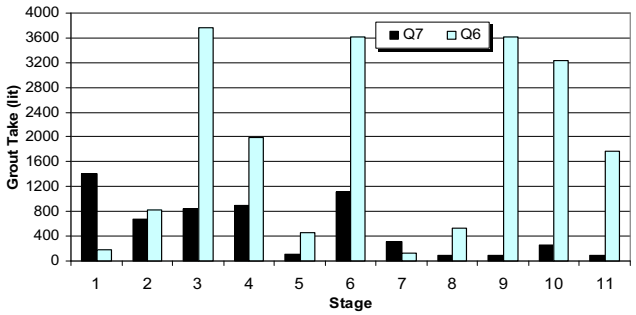
Fig. 10 Examples of grout take in two adjacent grouting holes from Q-series grouting holes
